Village of Northbrook

TO: RICHARD A. NAHRSTADT, VILLAGE MANAGER
FROM: KELLY HAMILL, PUBLIC WORKS DIRECTOR
DATE: February 27, 2018
SUBJECT: UPDATE ON FACILITIES ASSESSMENT AND SPACE NEEDS ANALYSIS

Facility Assessments

Northbrook Fleet Maintenance Garage
Northbrook Police Department
Northbrook Fire Station #11

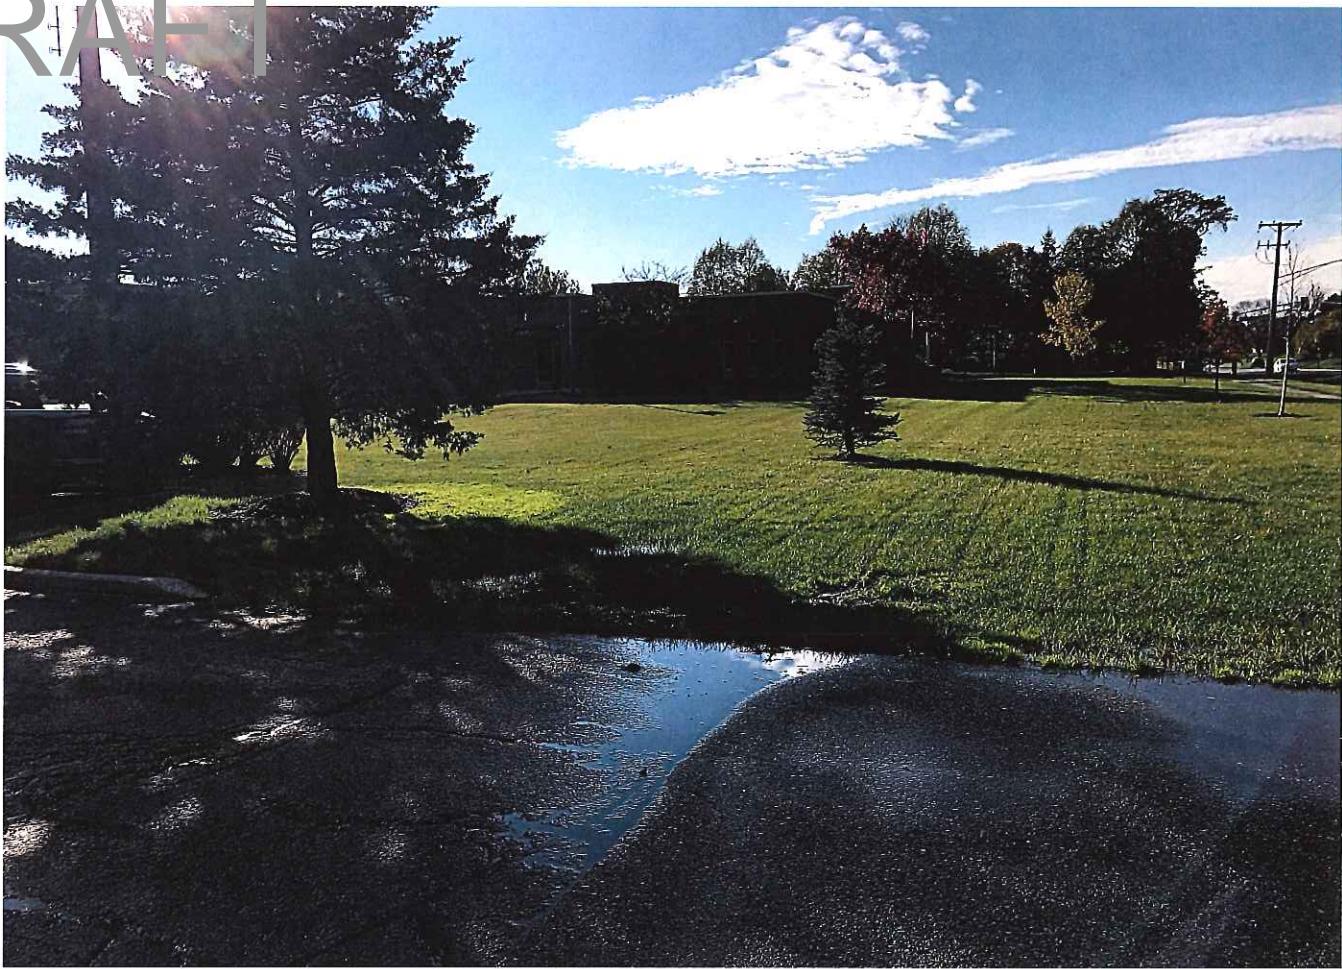
SITE EVALUATION (S)	(40)	NOTES REGARDING SITE CONDITIONS
1. Site Features	(10)	Poor – The grading around the North side of the building is saturated and drains poorly. The sidewalk on the North side of the site has ponding water. The grading on the Southeast side of the building has standing water and drains poorly. Maintenance reports indicate that the trench drain on the east side of the building at the bottom of the ramp to the underground garage repeatedly clogs. Therefore, rated Poor.

(S-1) Ponding water

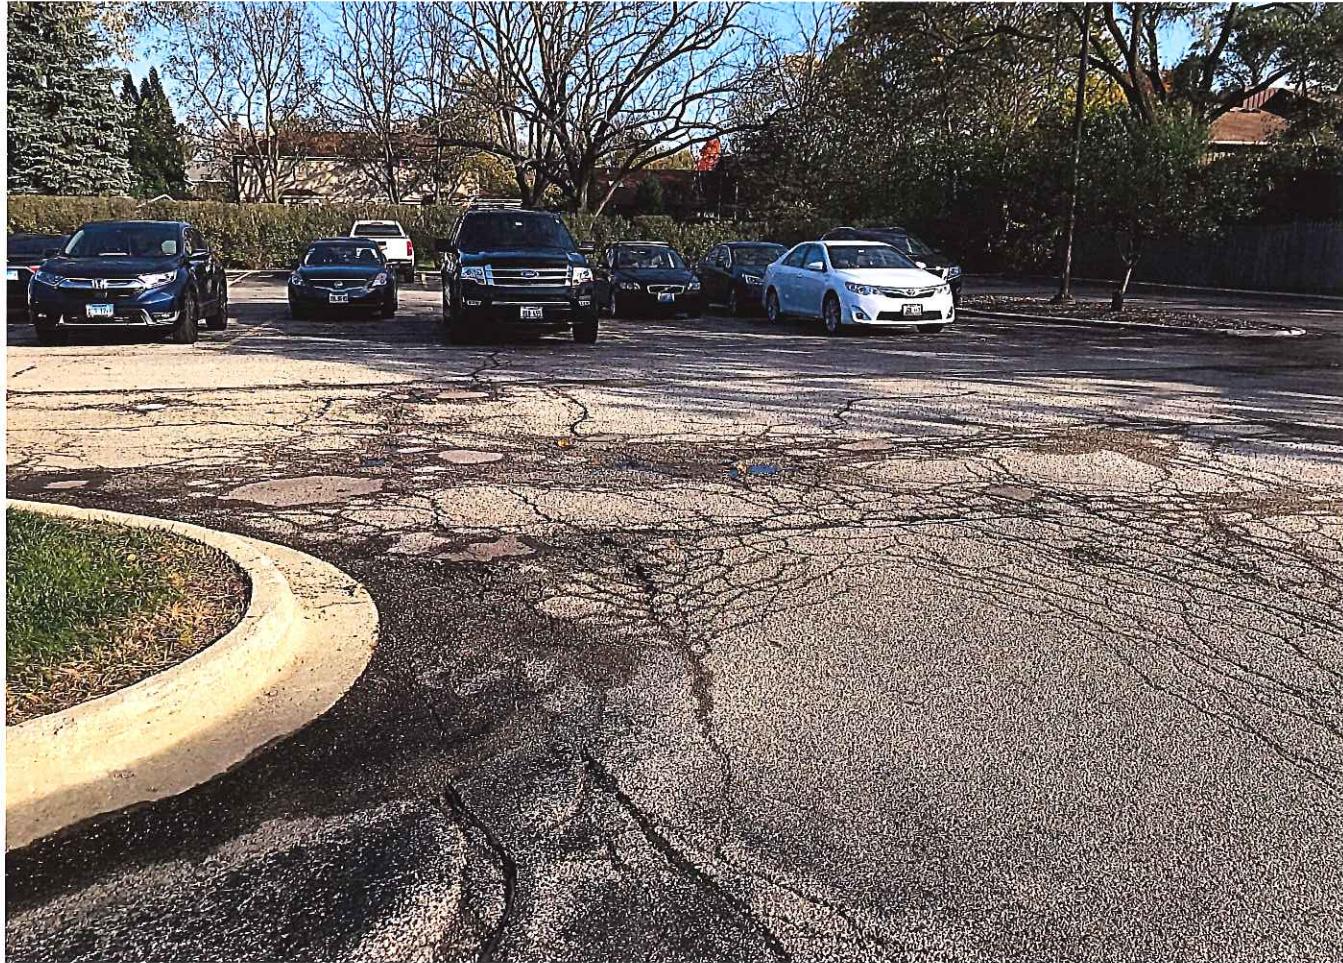
4. Parking Lots, Site Maintainability	(10)	Poor – Asphalt parking lot is older and has some significant deterioration. The exterior light poles are deteriorated. Some of the sidewalks have heaved and there are tripping hazards. The site is clear of debris and landscaping is maintained.

(S-4) Deteriorated parking lot paving

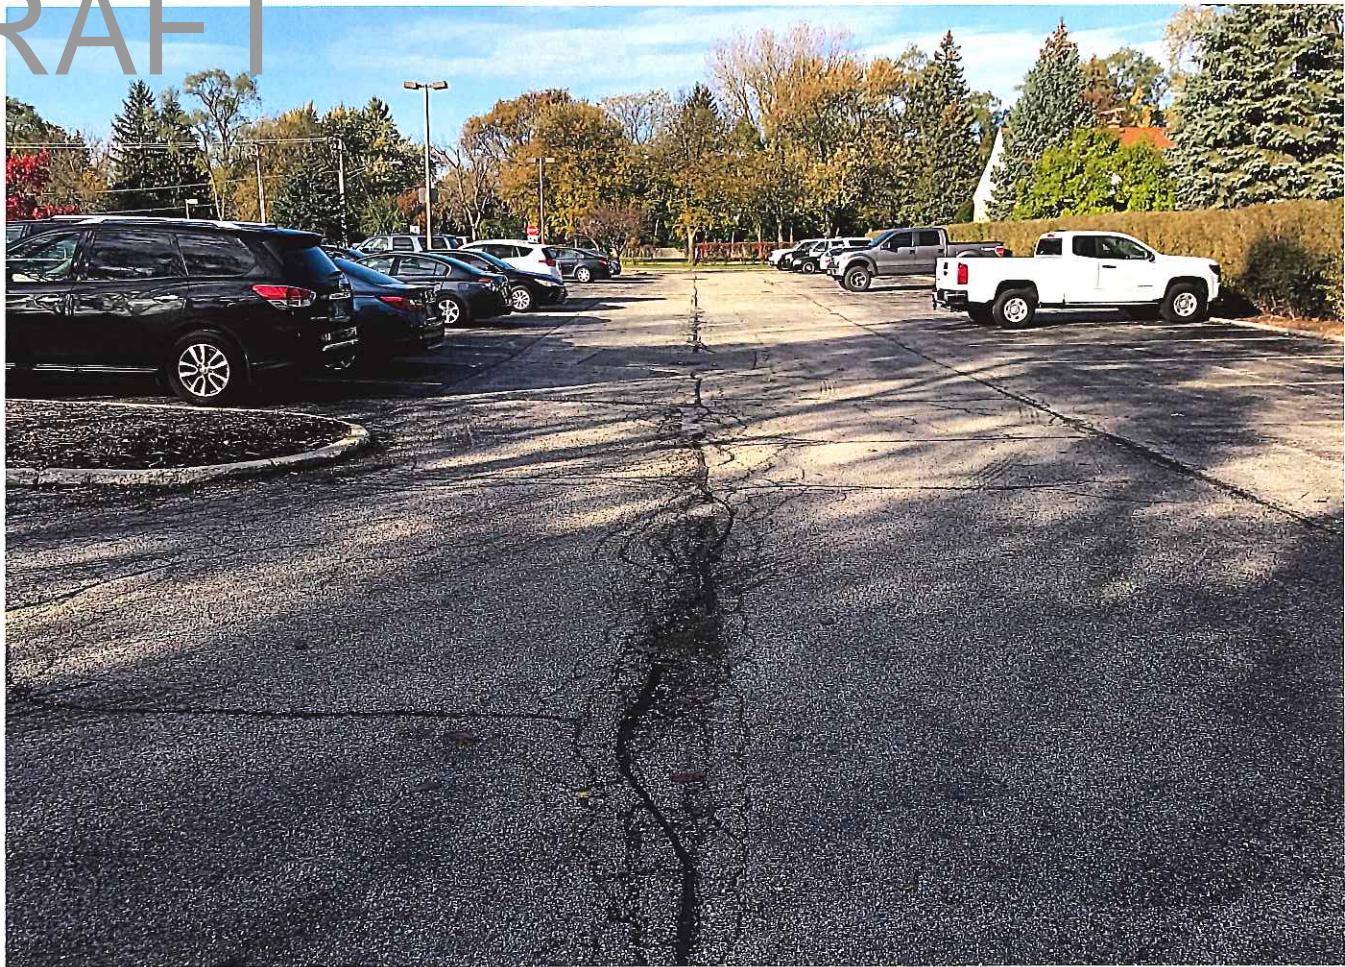
(S-4) Deteriorated parking lot paving

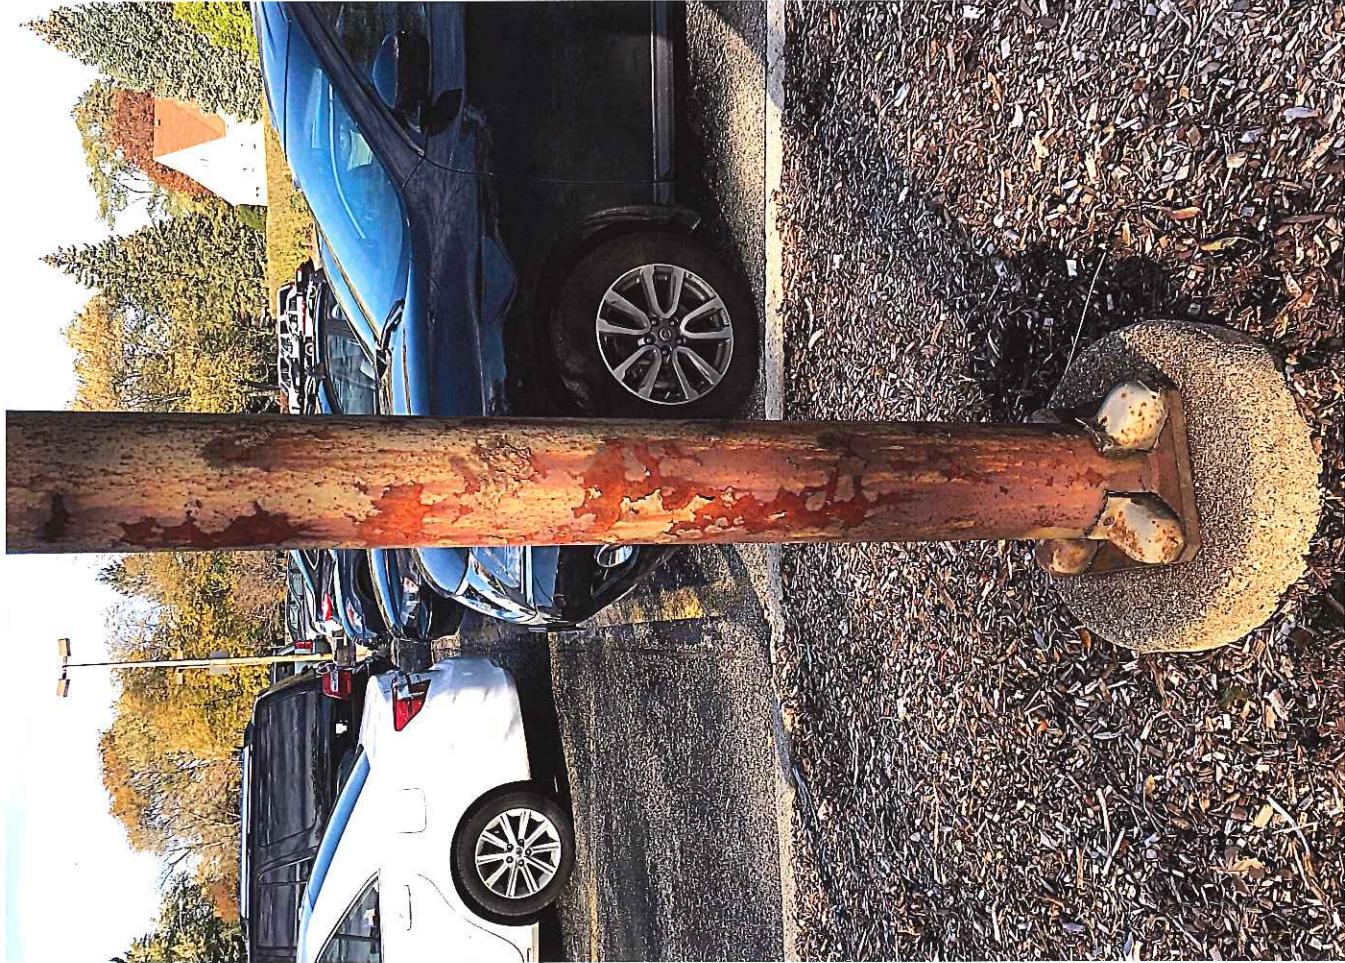
(S-4) Deteriorated site lighting poles

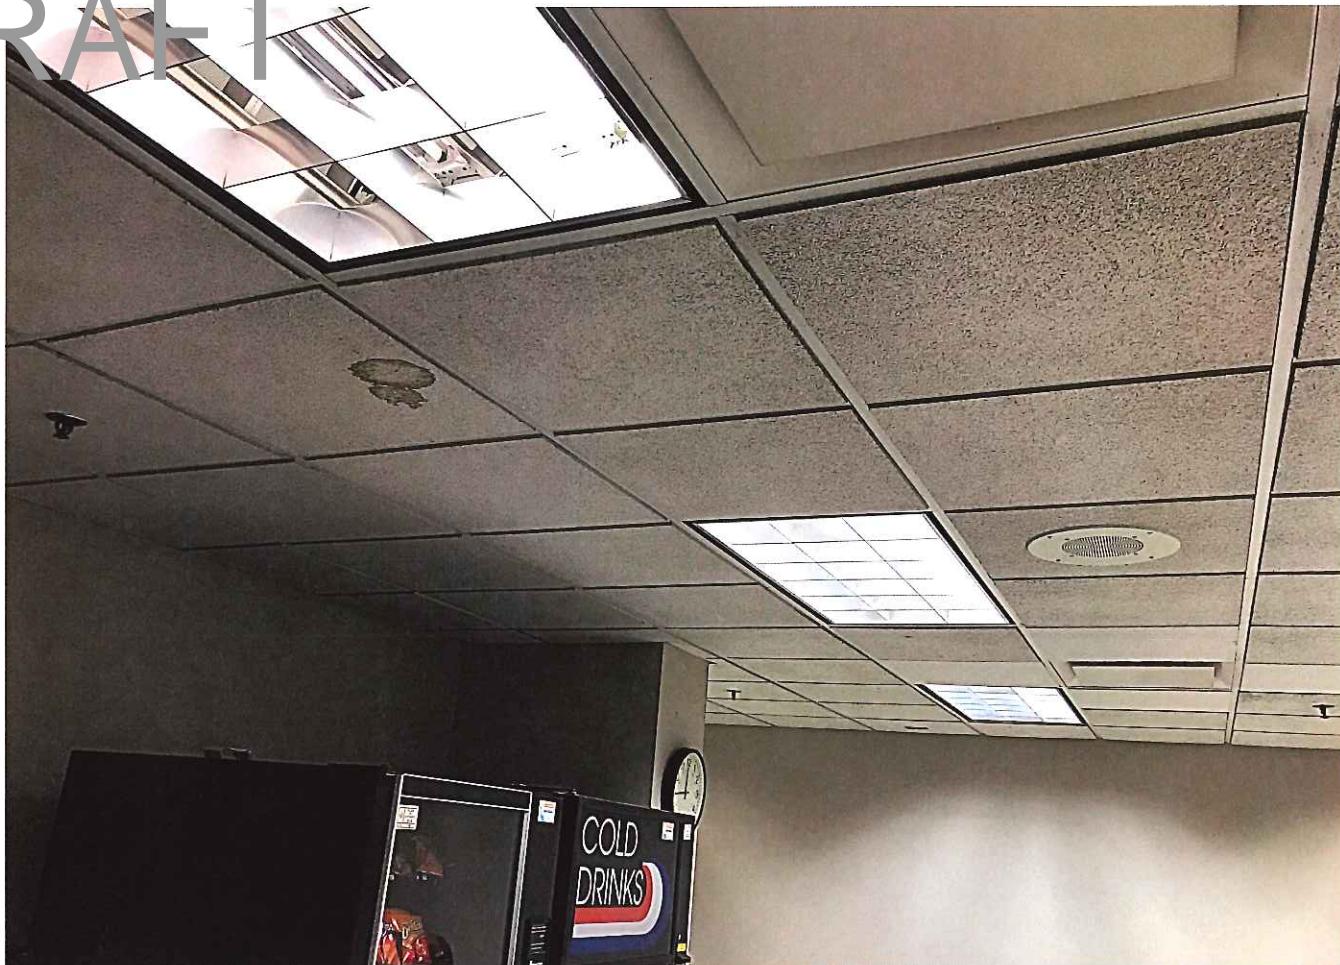
(A-7) Deteriorated interior finishes - ceiling, flooring, and casework

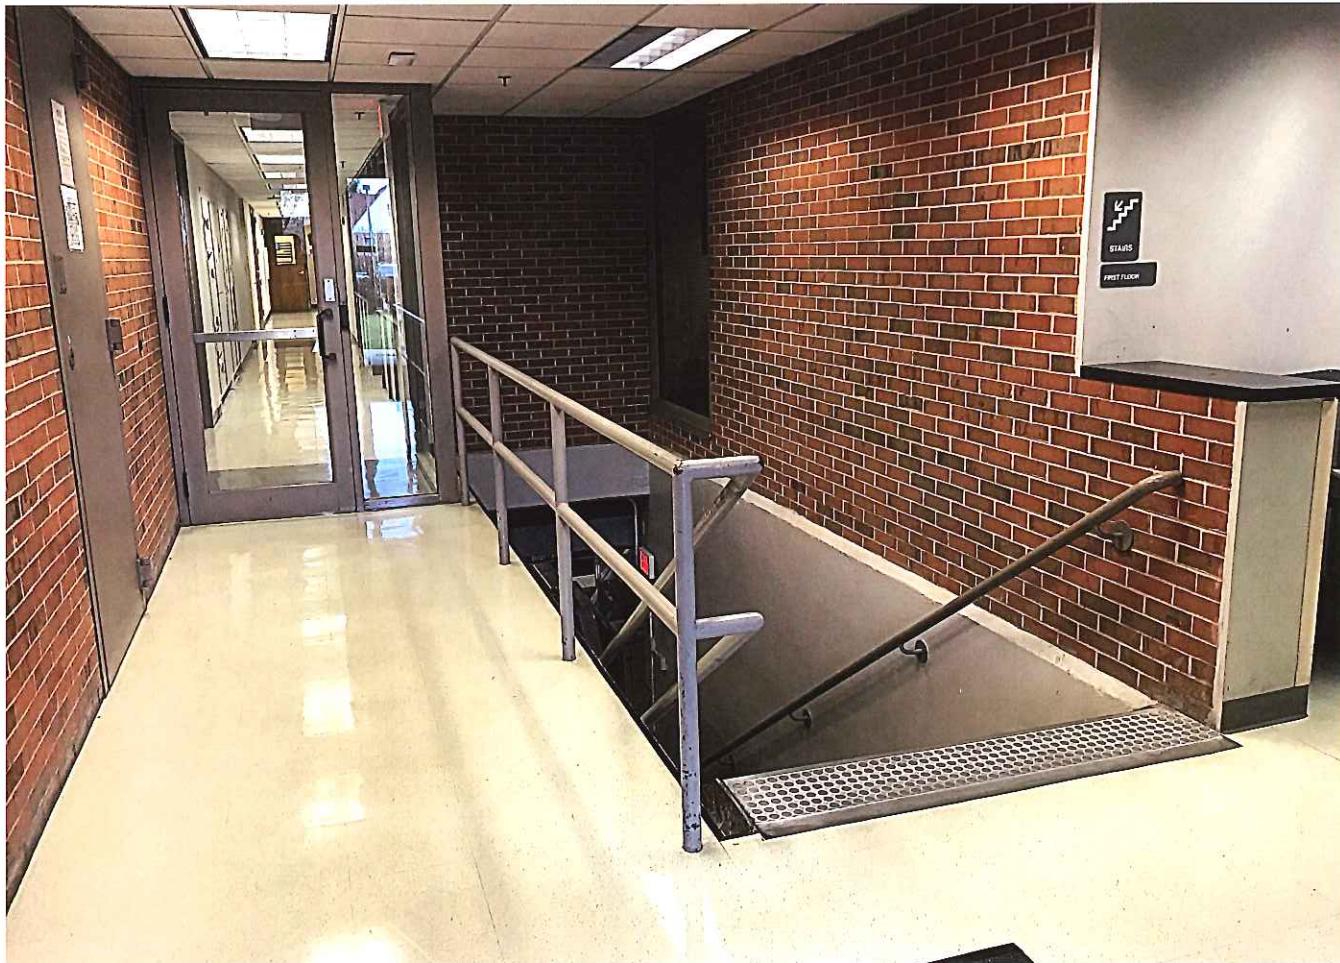
(BE-5) Missing guard rail

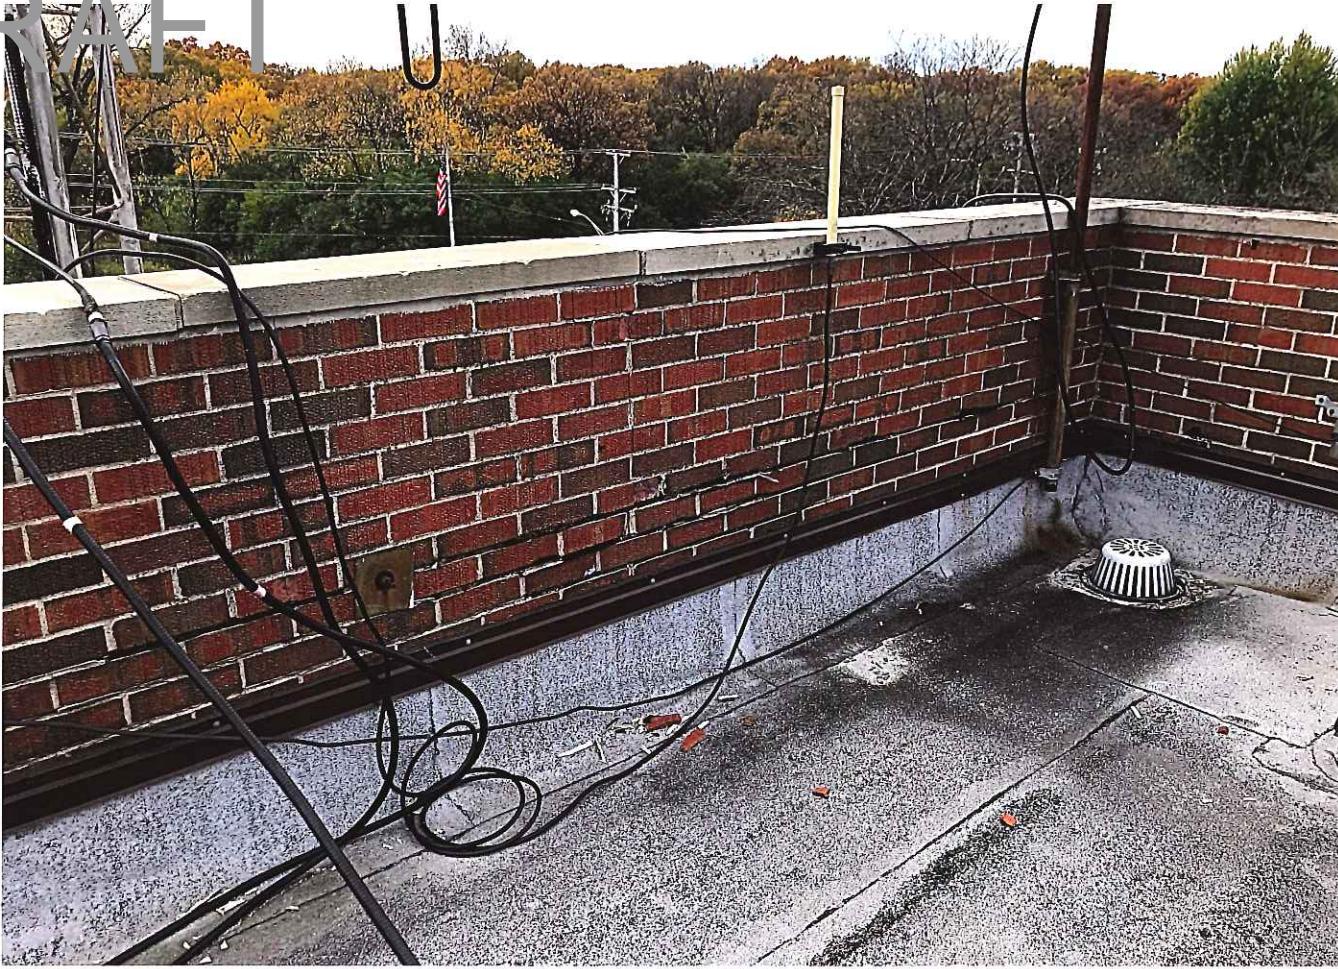
(ST-5) Masonry deterioration

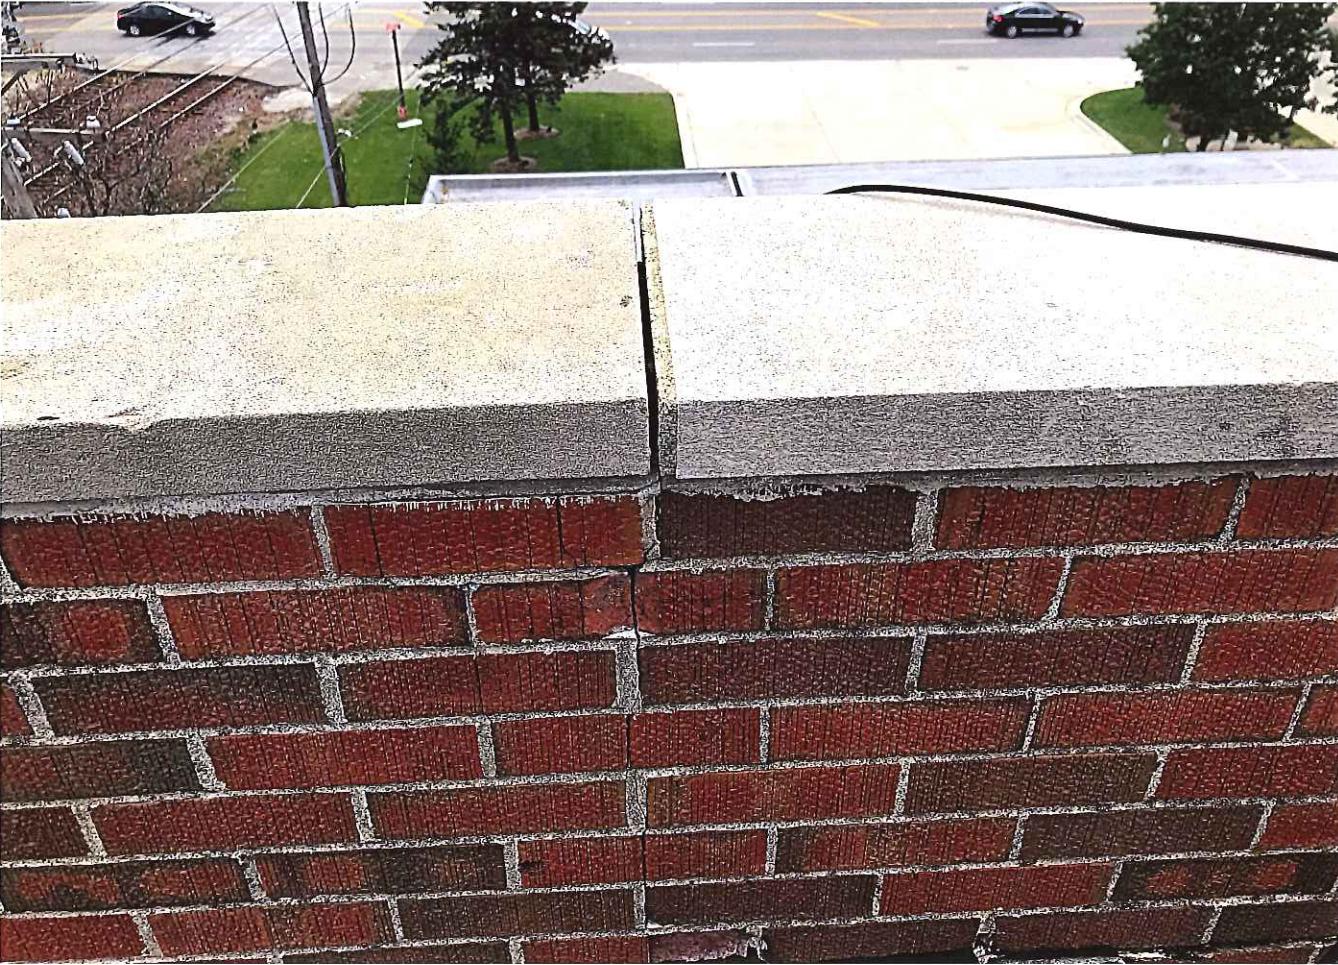
(ST-5) Masonry deterioration

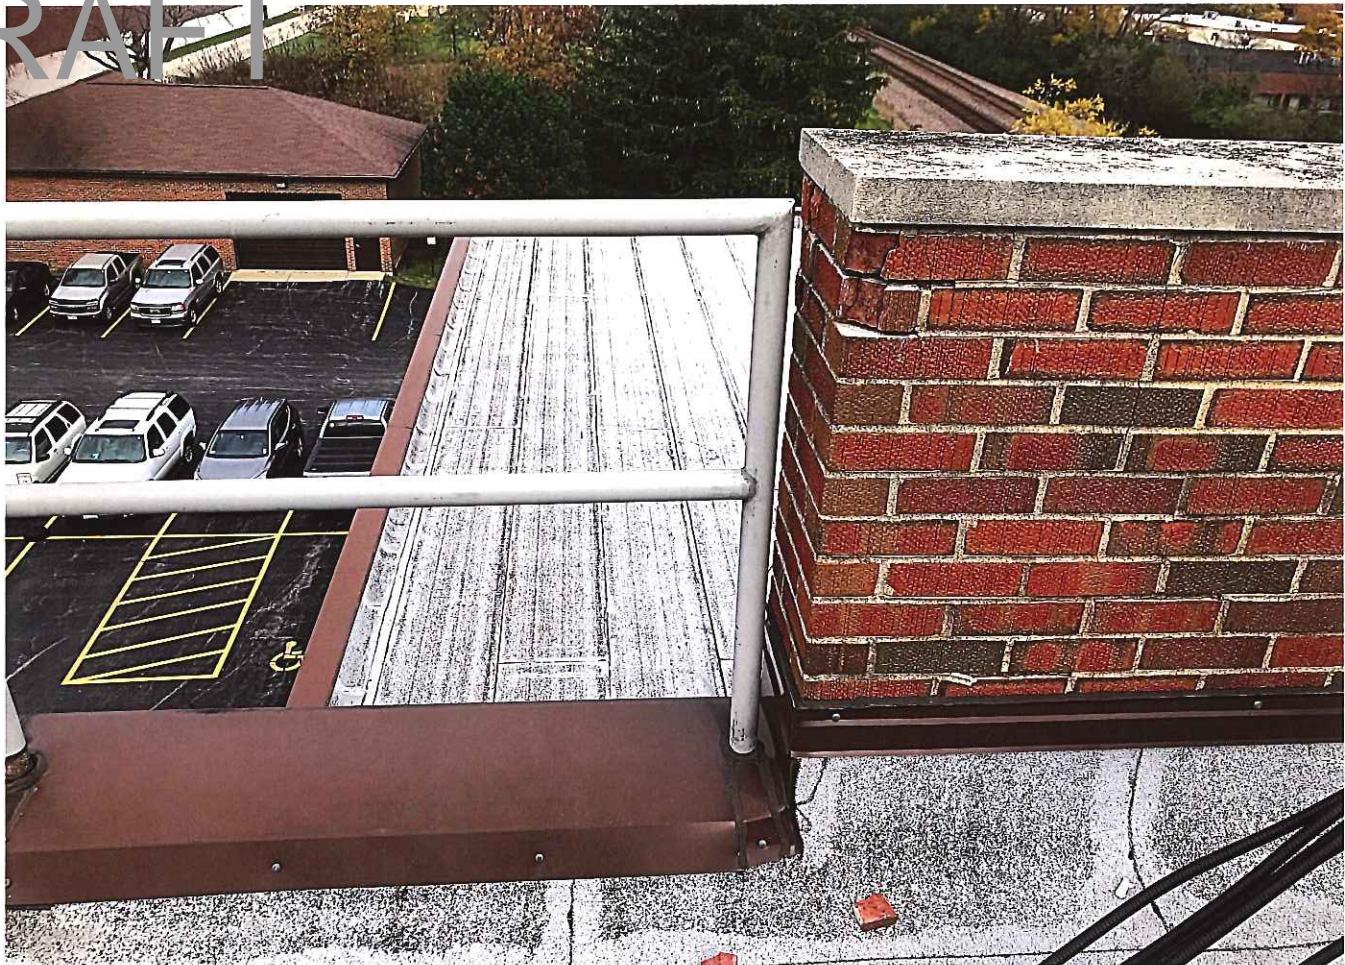
(ST-5) Masonry deterioration

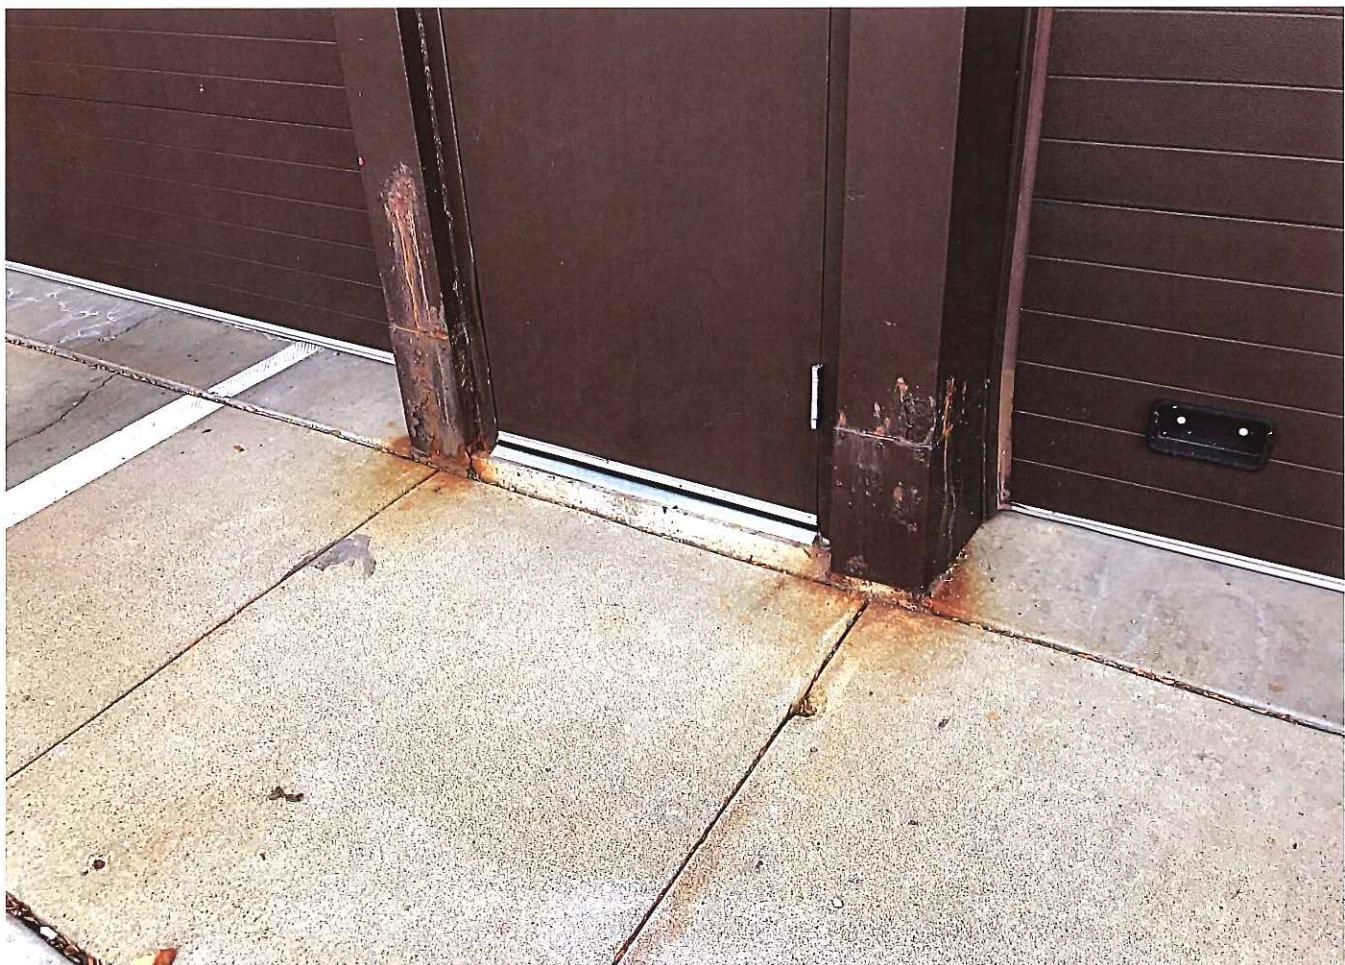
(ST-6) Steel column deterioration

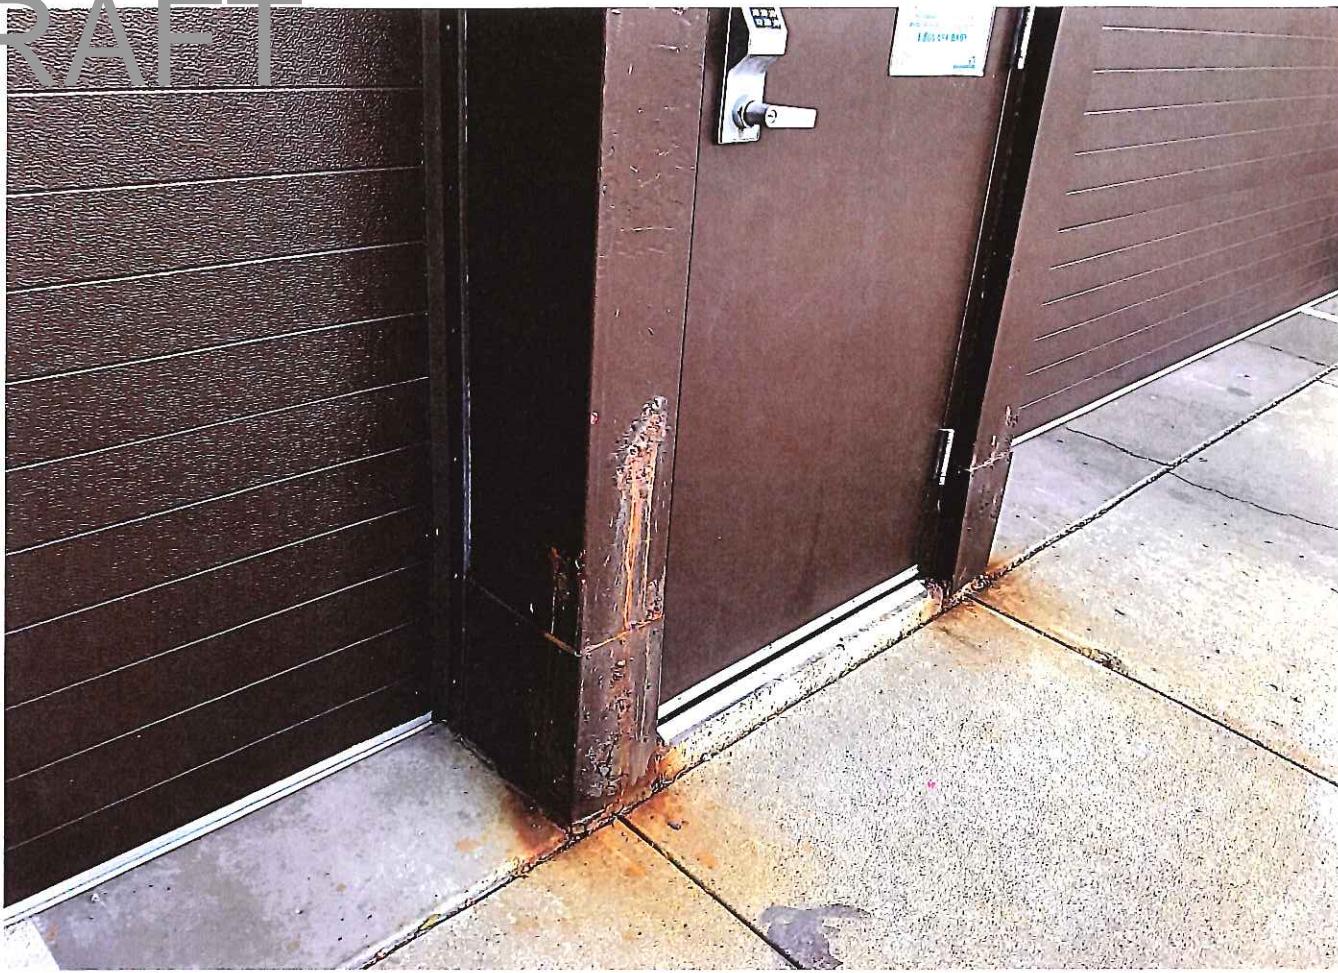
(ST-6) Steel column deterioration

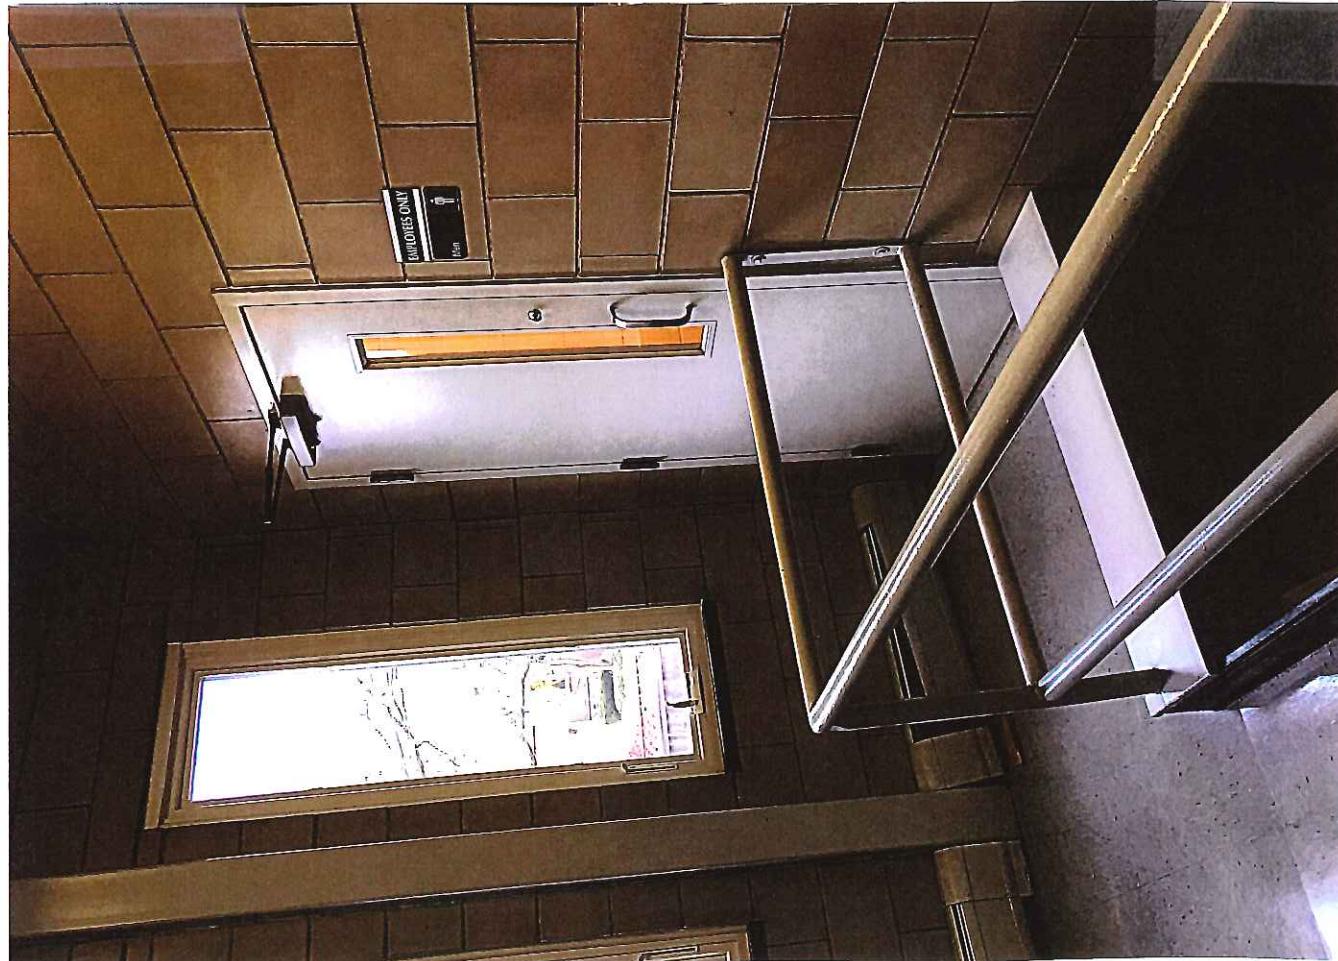
(BE-1) Missing door push/pull accessibility clearances

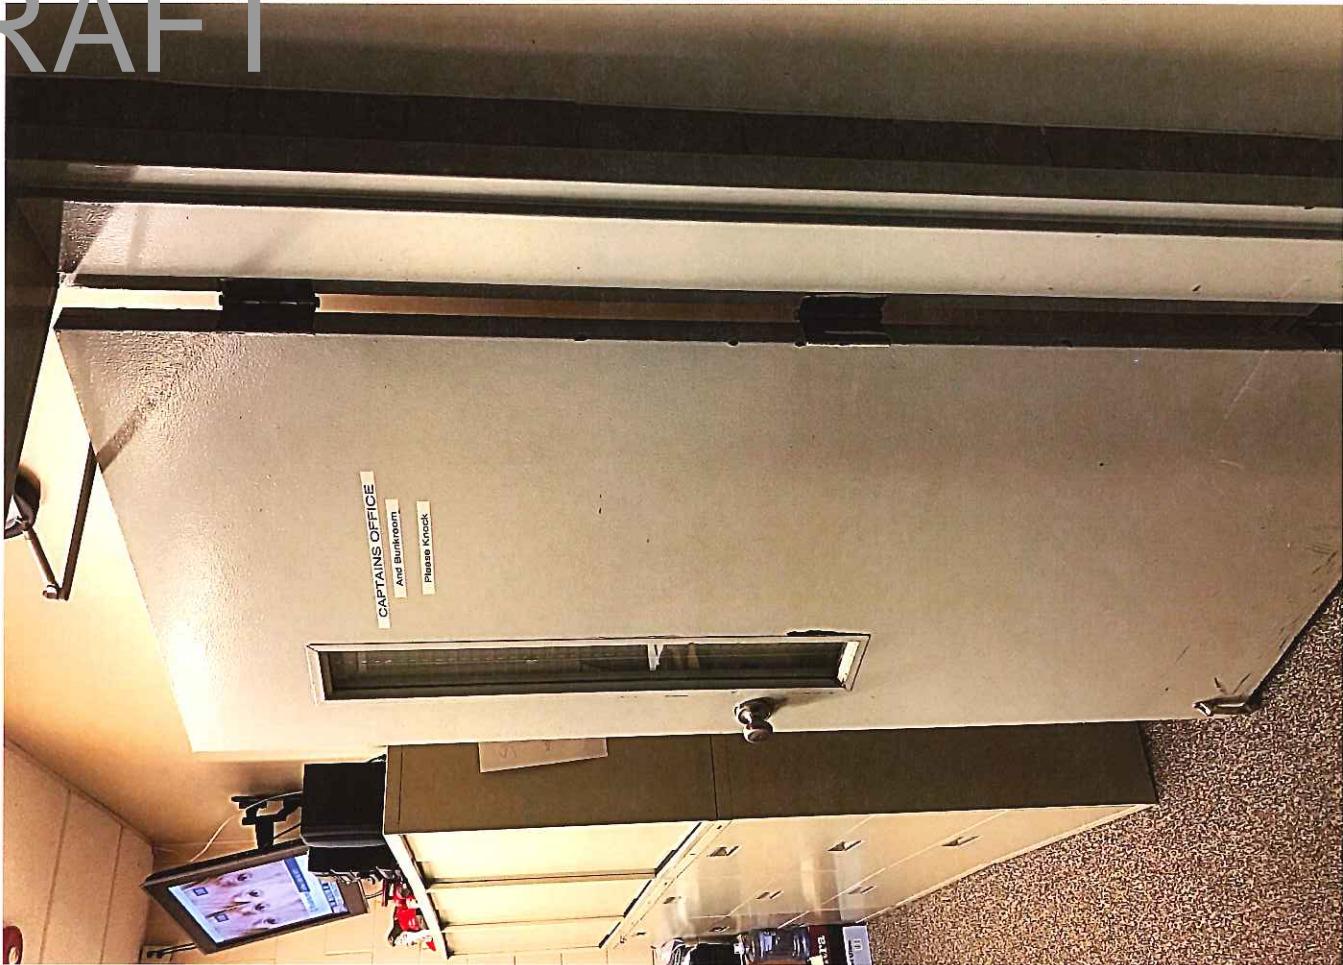
(BE-4) Hardware is approaching the end of its useful life - doesn't meet ADA

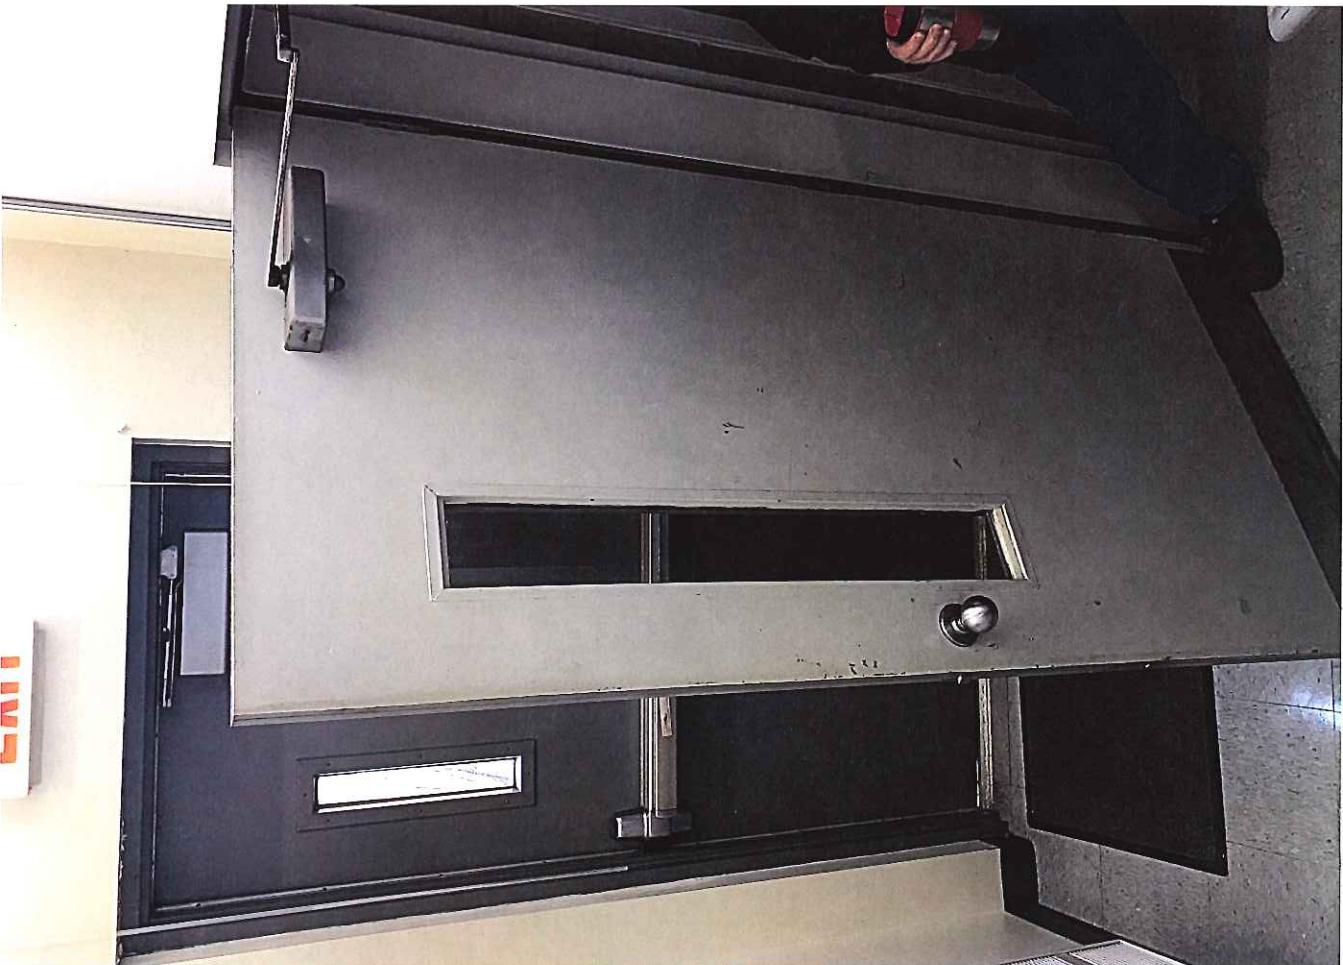
(BE-2) Exit door impedes egress through exit stair

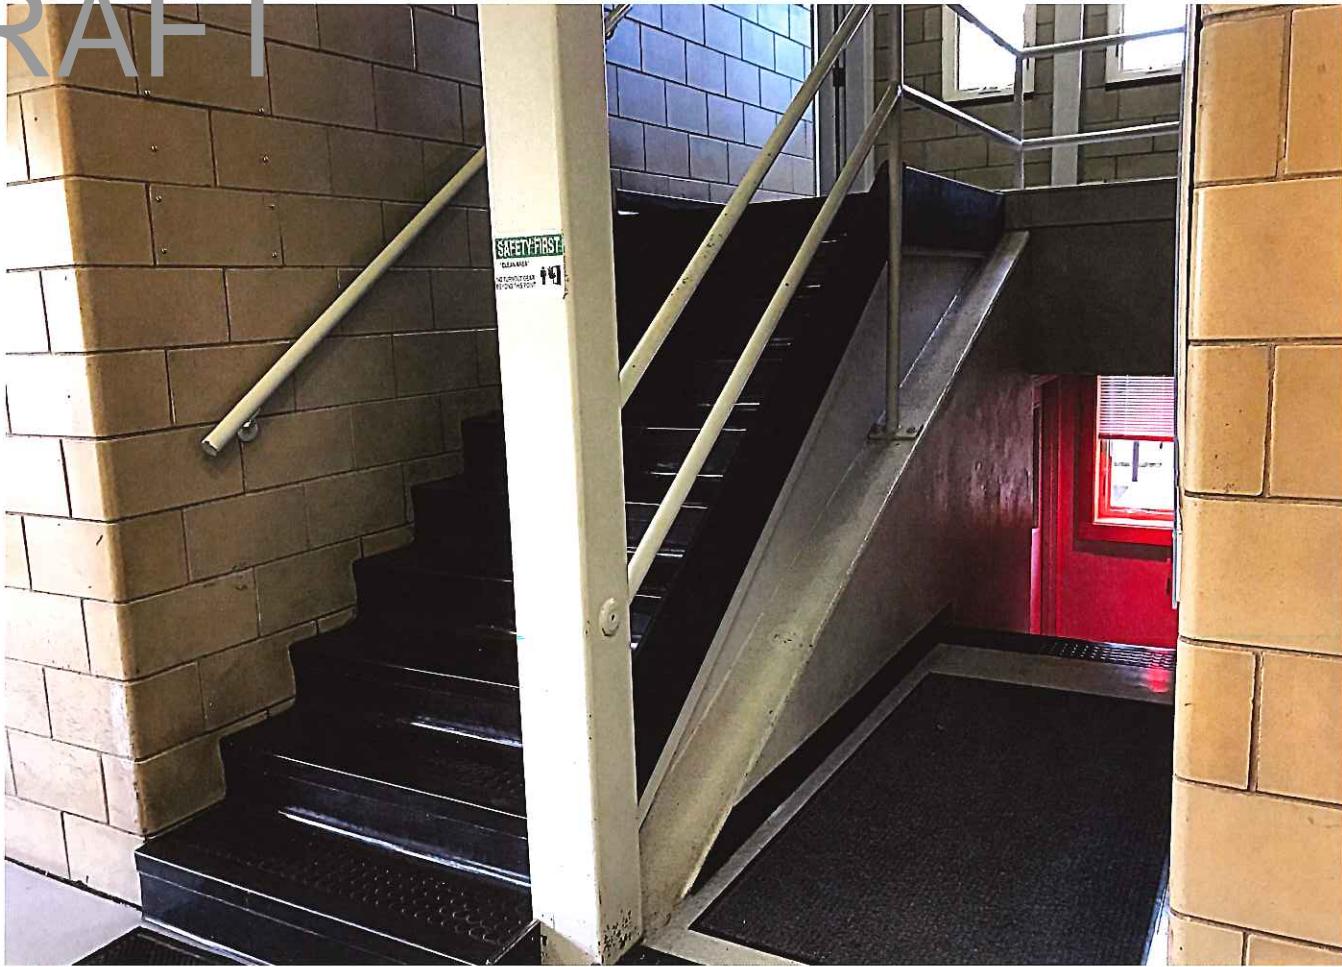
(BE-5) Exit stair is too steep, railings don't have proper continuation, there are no guard rails.

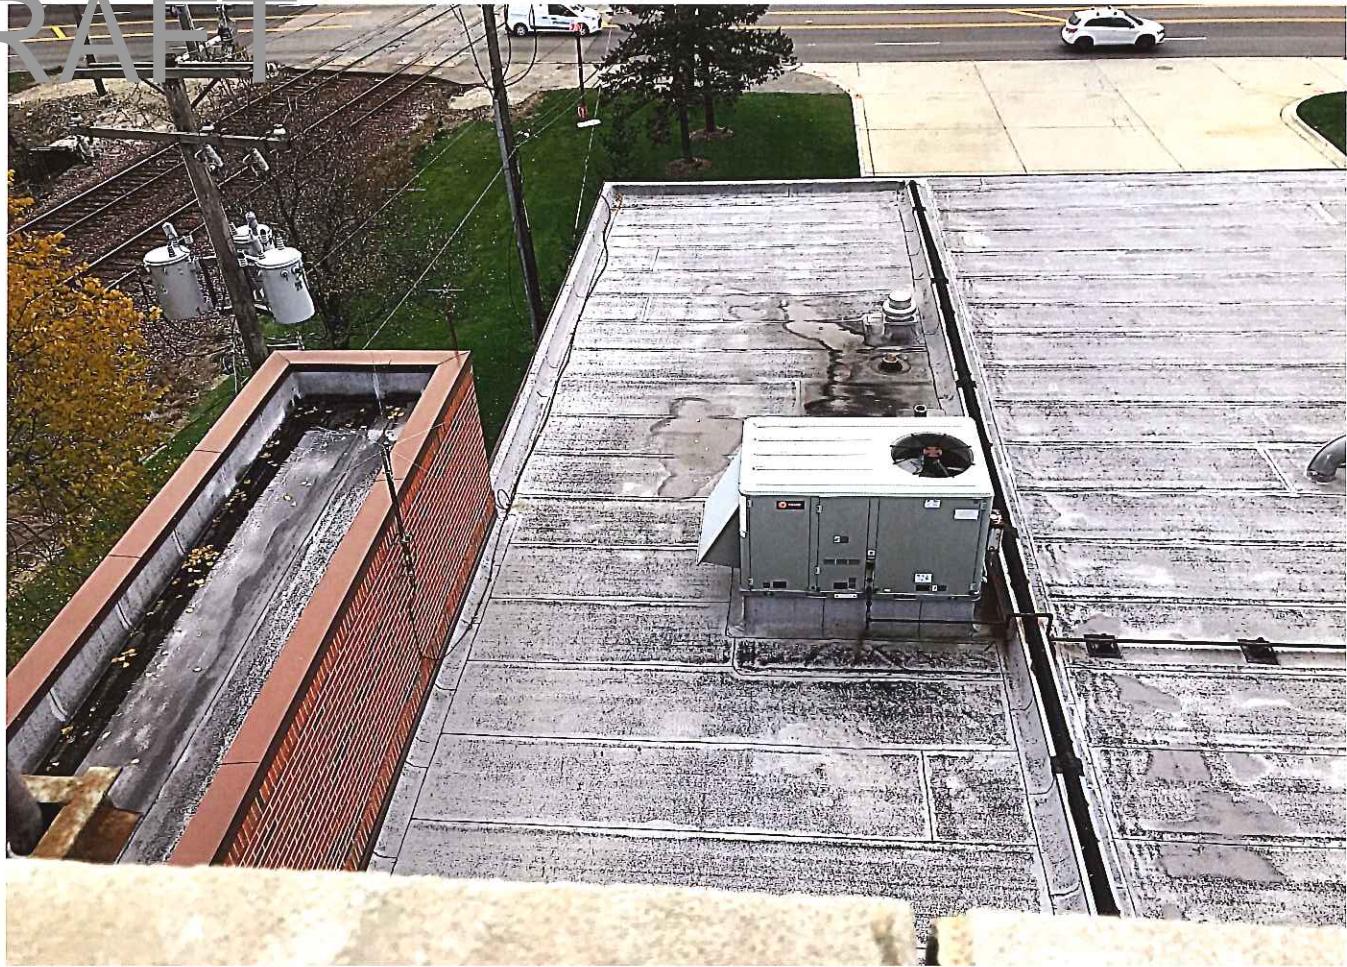
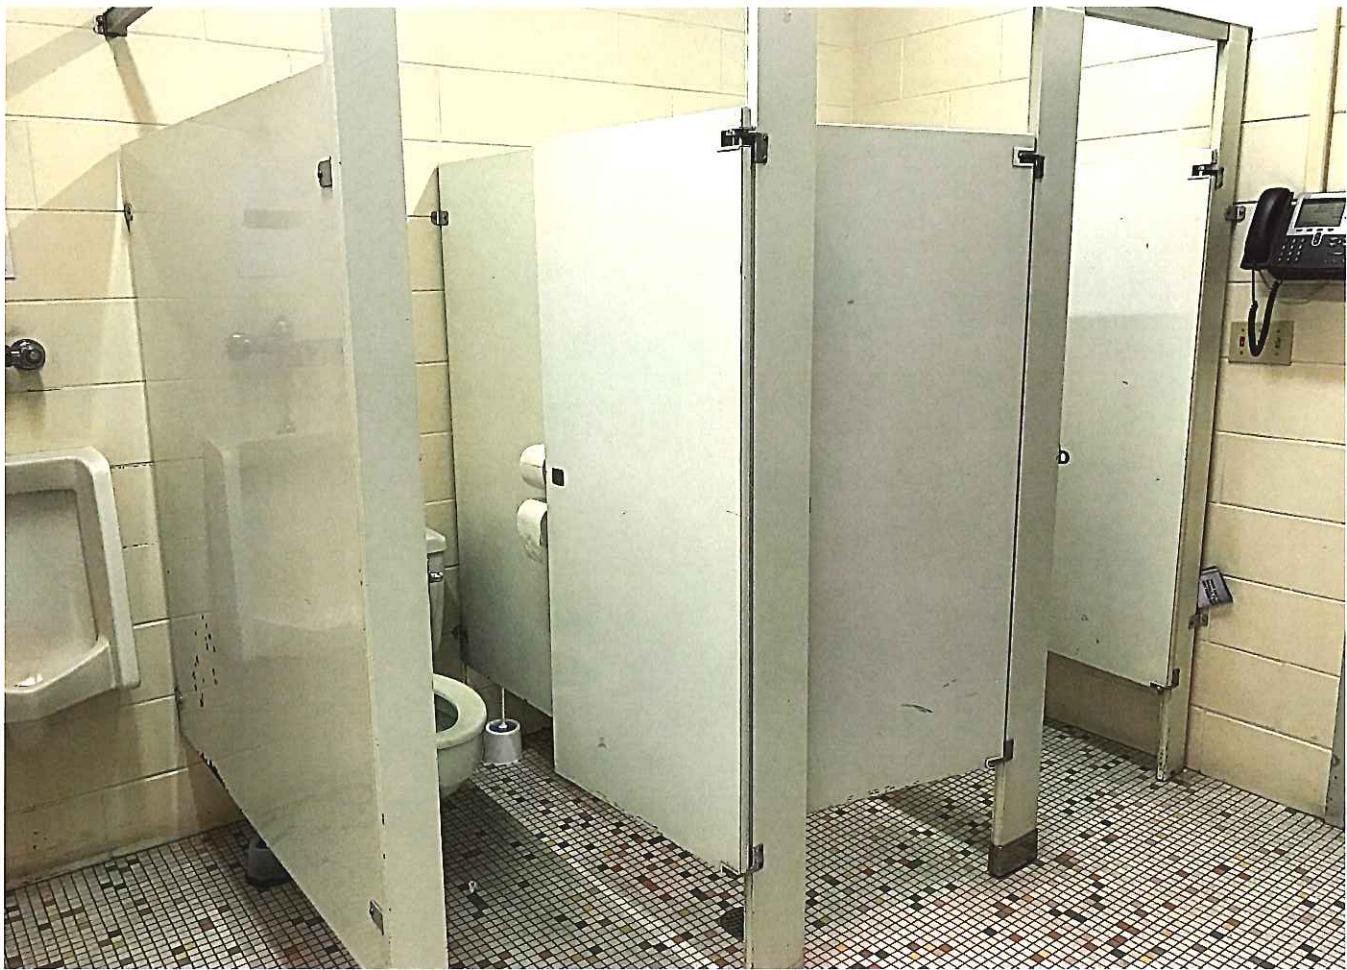
(BE-6 & A-6) No accessible toilet facilities or female toilet facilities - Finishes are worn
