Village of Northbrook

TO: RICHARD A. NAHRSTADT, VILLAGE MANAGER
FROM: KELLY HAMILL, PUBLIC WORKS DIRECTOR
DATE: February 27, 2018
SUBJECT: UPDATE ON FACILITIES ASSESSMENT AND SPACE NEEDS ANALYSIS

Facility Assessments

Northbrook Fleet Maintenance Garage
Northbrook Police Department
Northbrook Fire Station #11

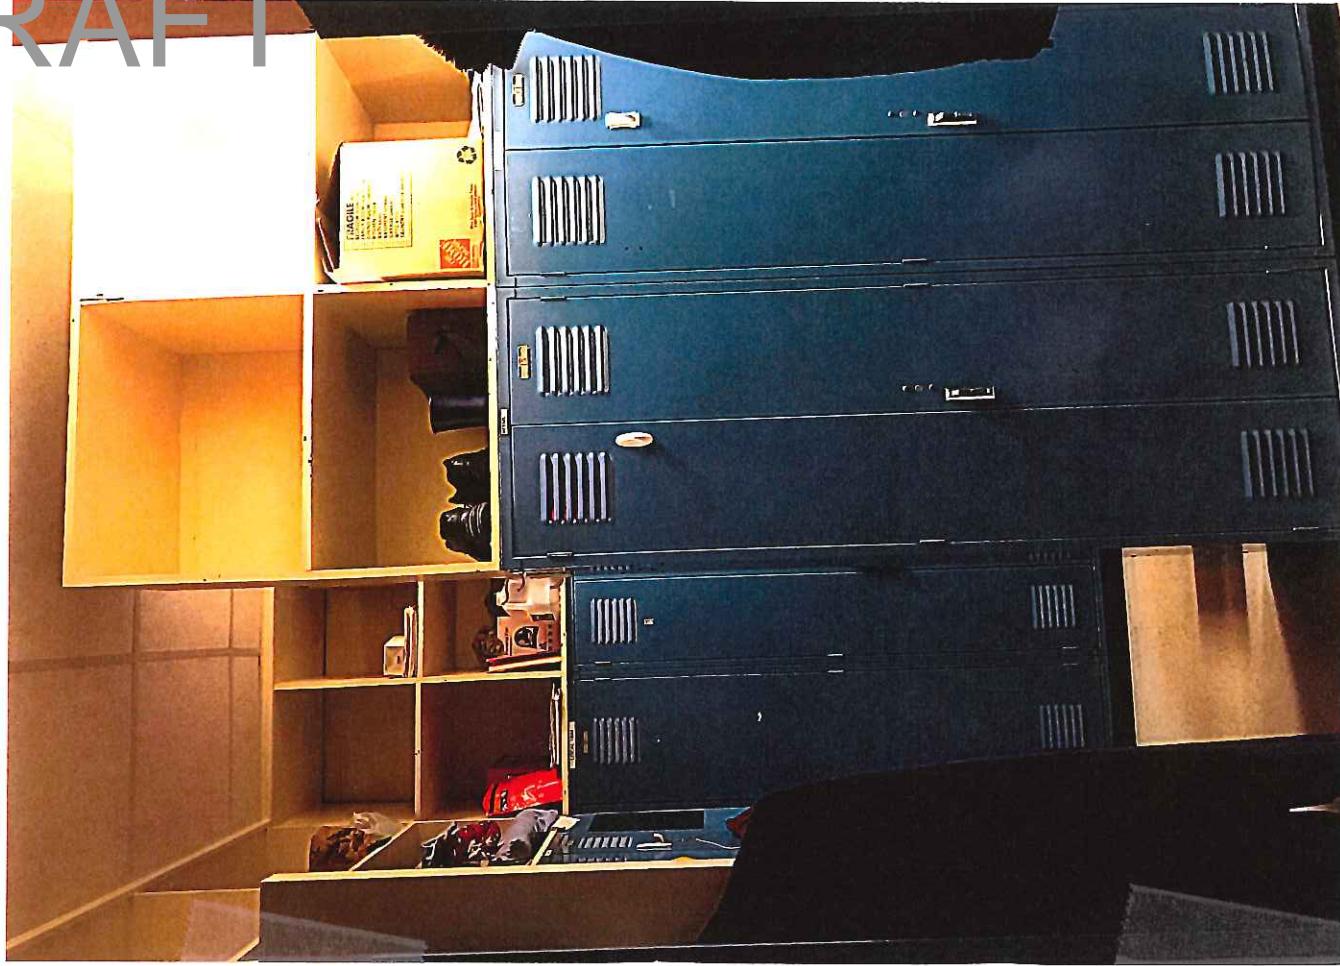
(A-7) Deteriorated finishes - flooring & ceiling. Storage on top of lockers doesn't meet code.

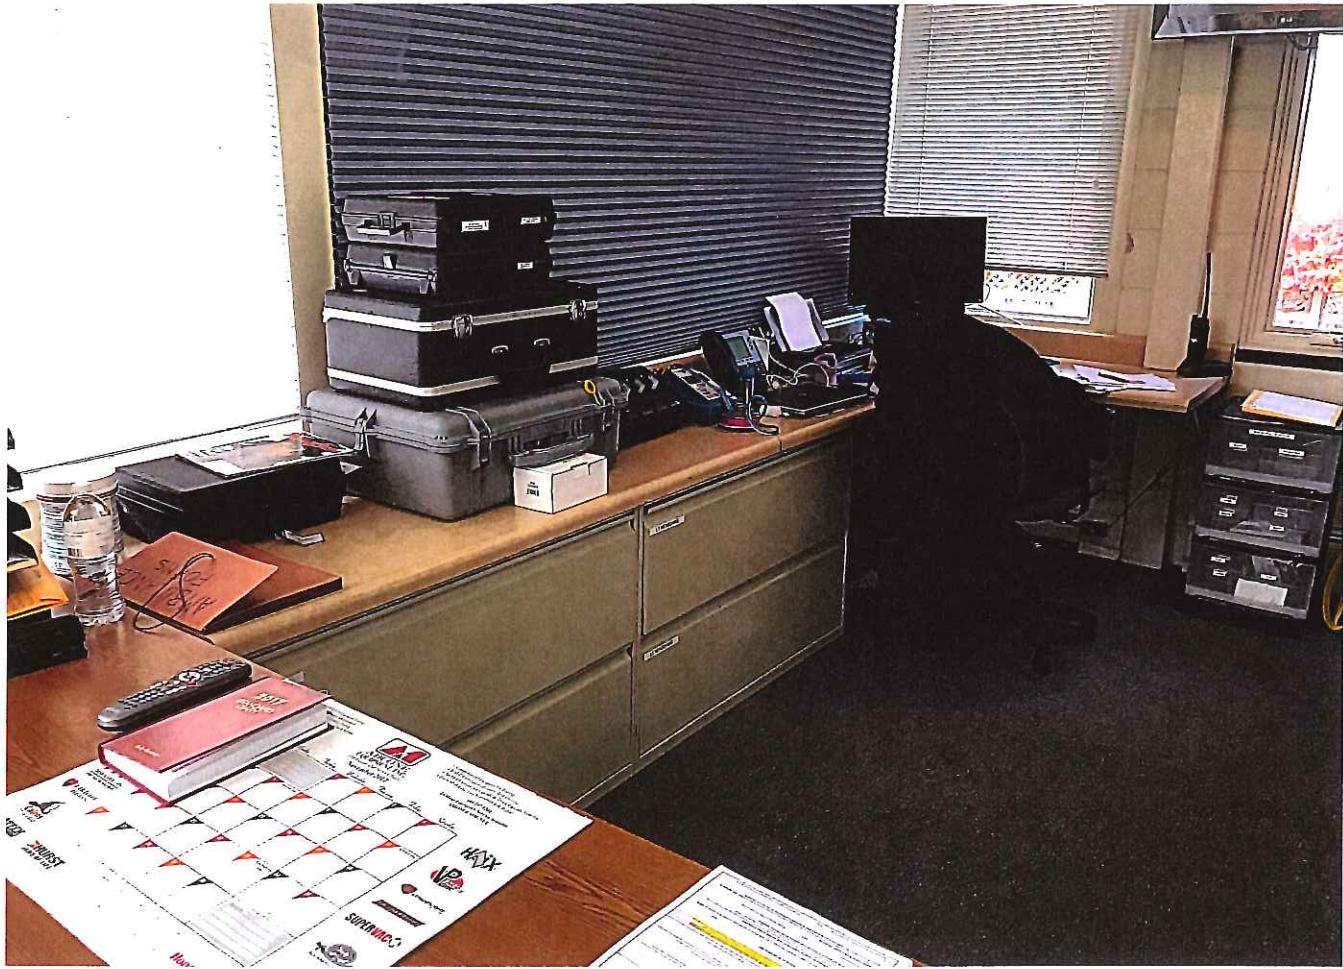
(A-8) Deteriorated finishes - flooring, ceiling, and casework is delaminating.

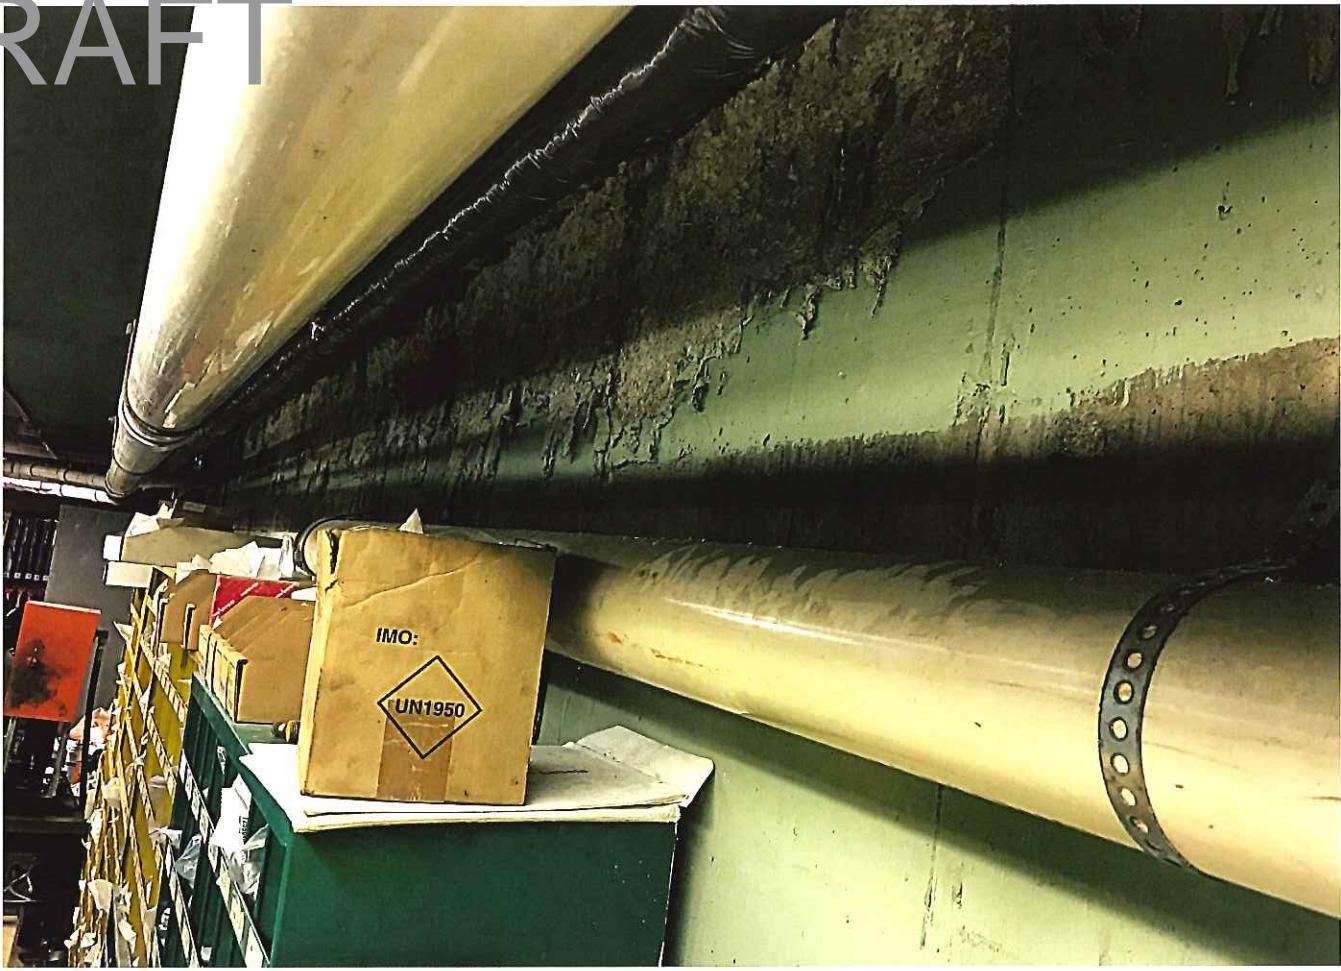
(S-2) Foundation seepage

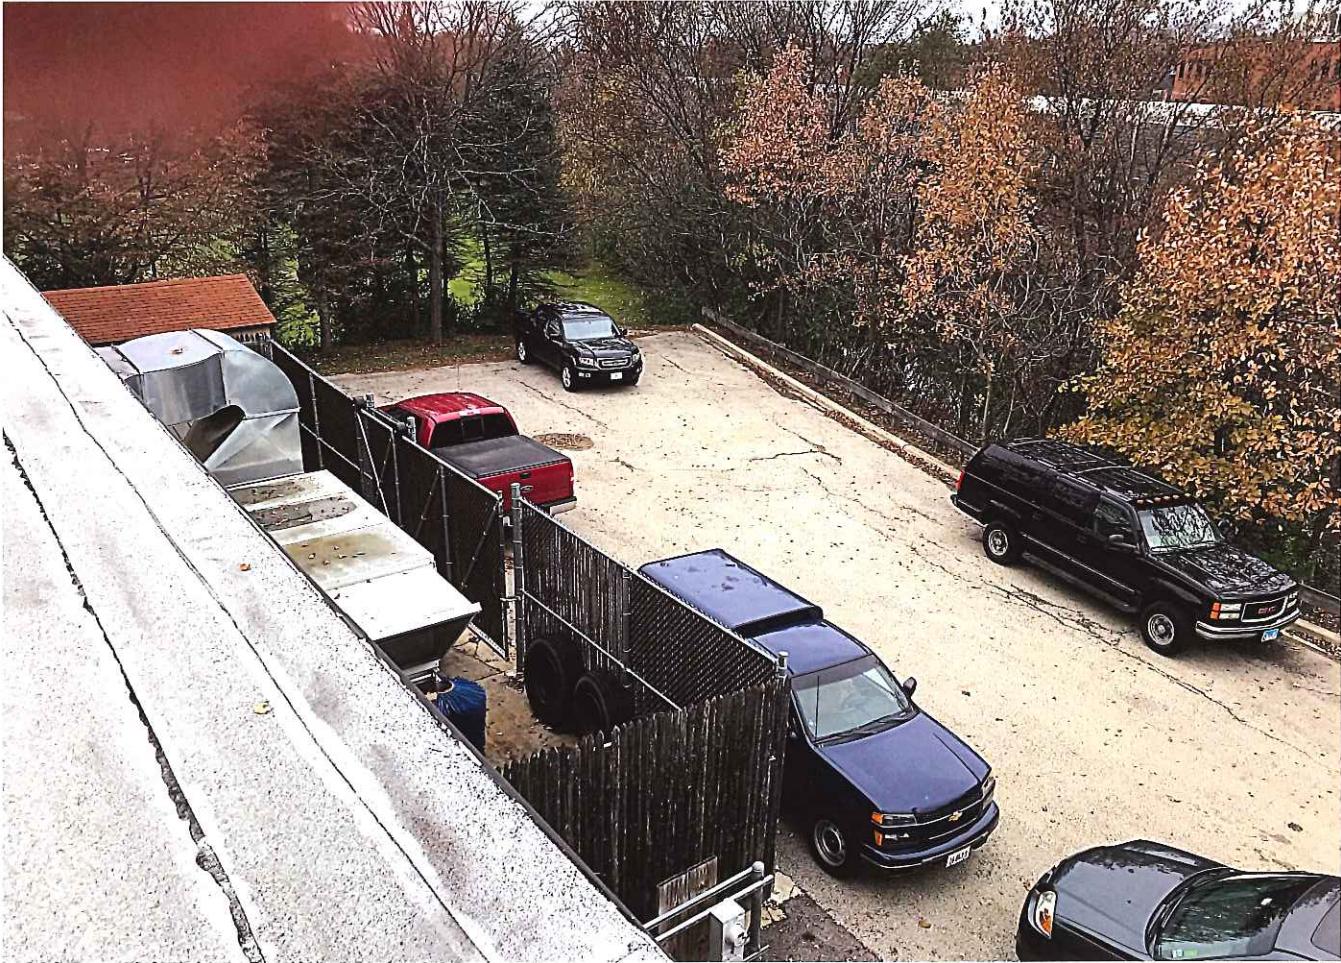
(S-3) Lack of staff parking

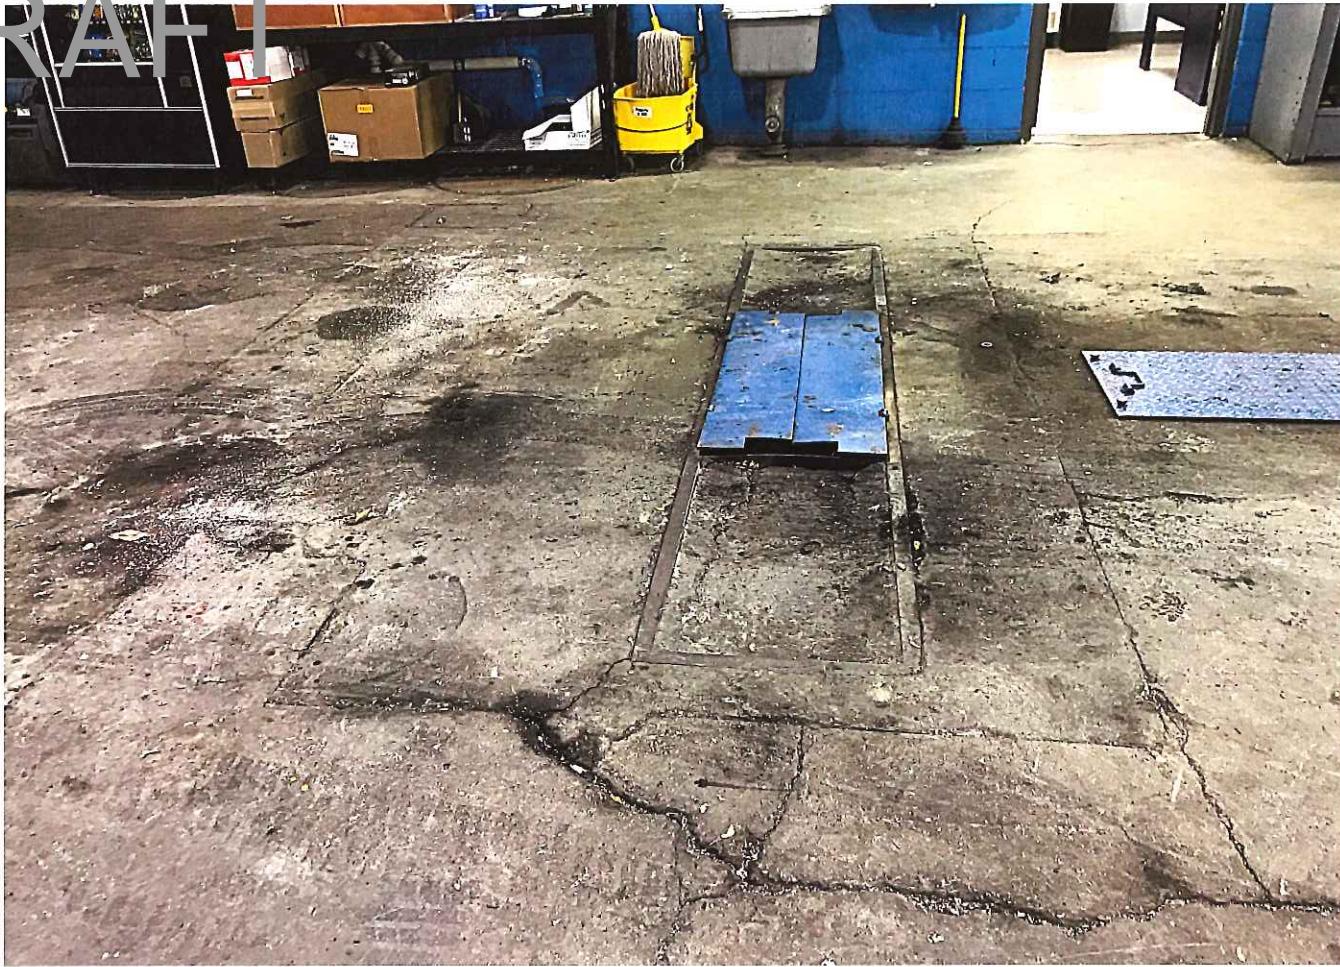
(ST-1) Pitting and Spalling concrete

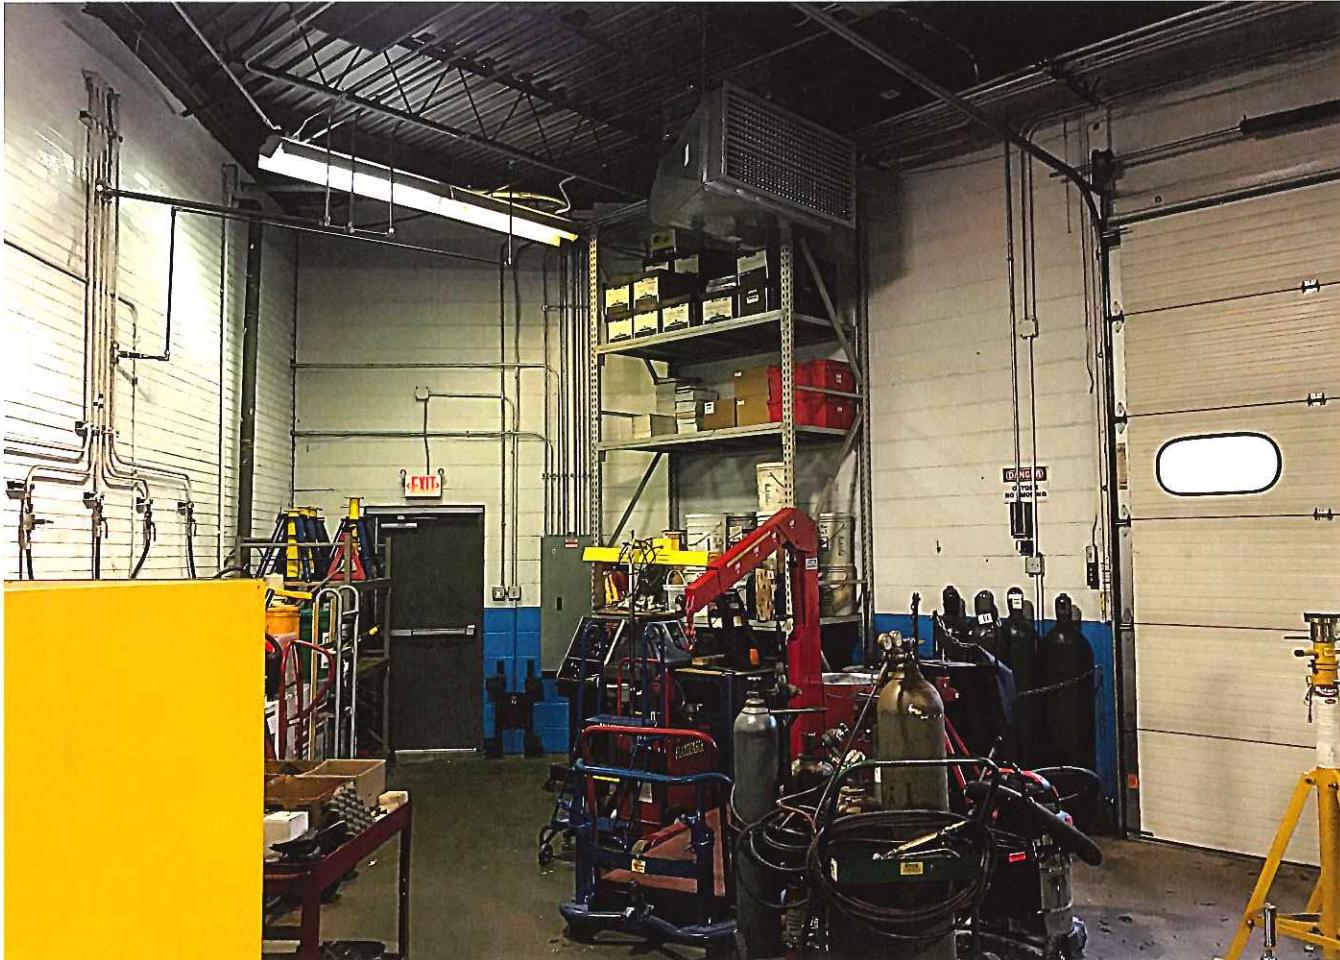
(BE-1) Poor egress corridor

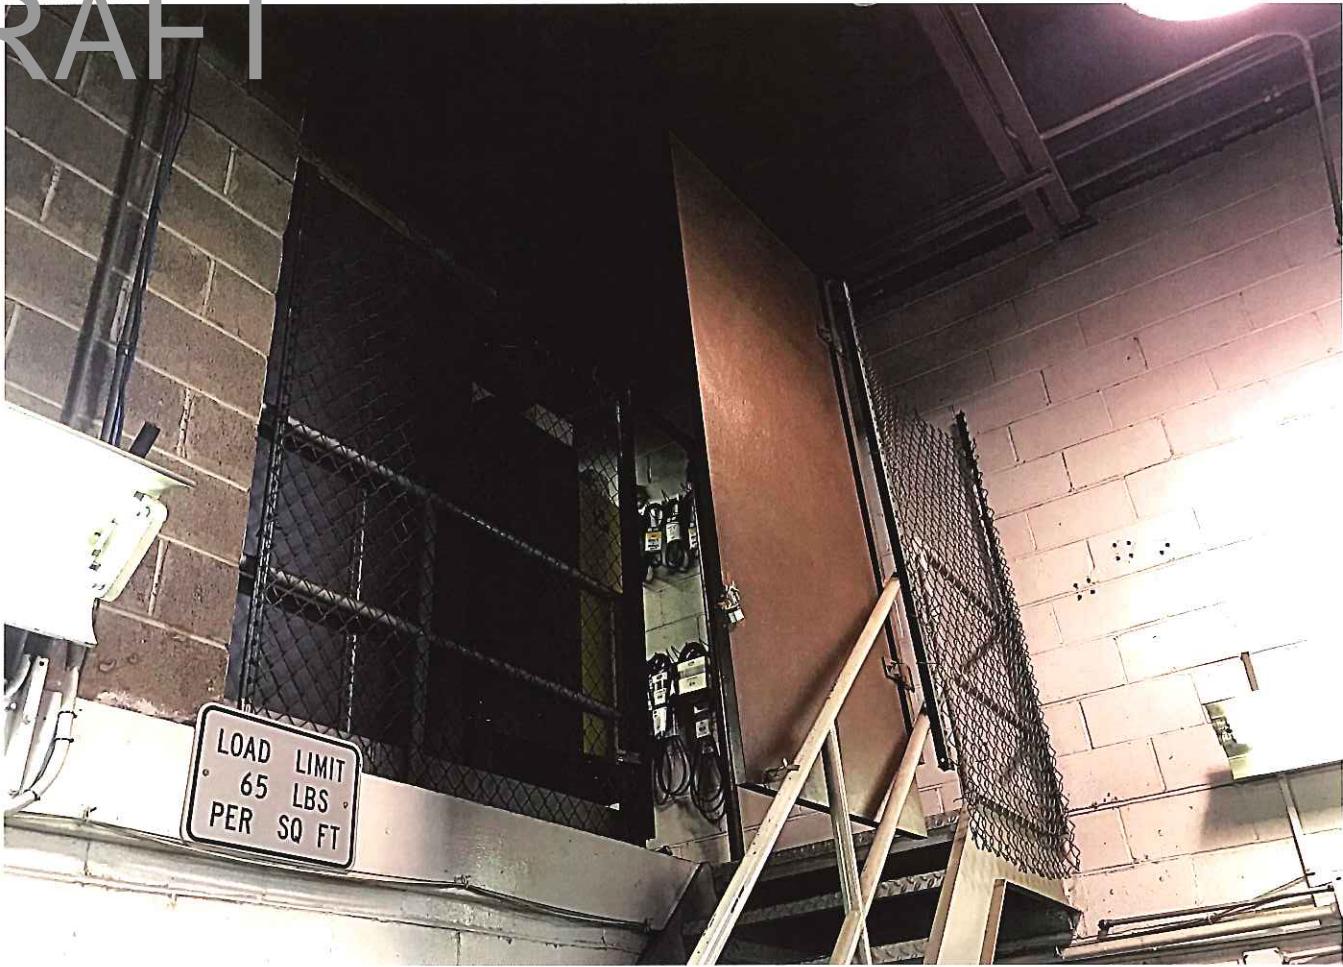
(BE-5) Poor stair landing/security configuration

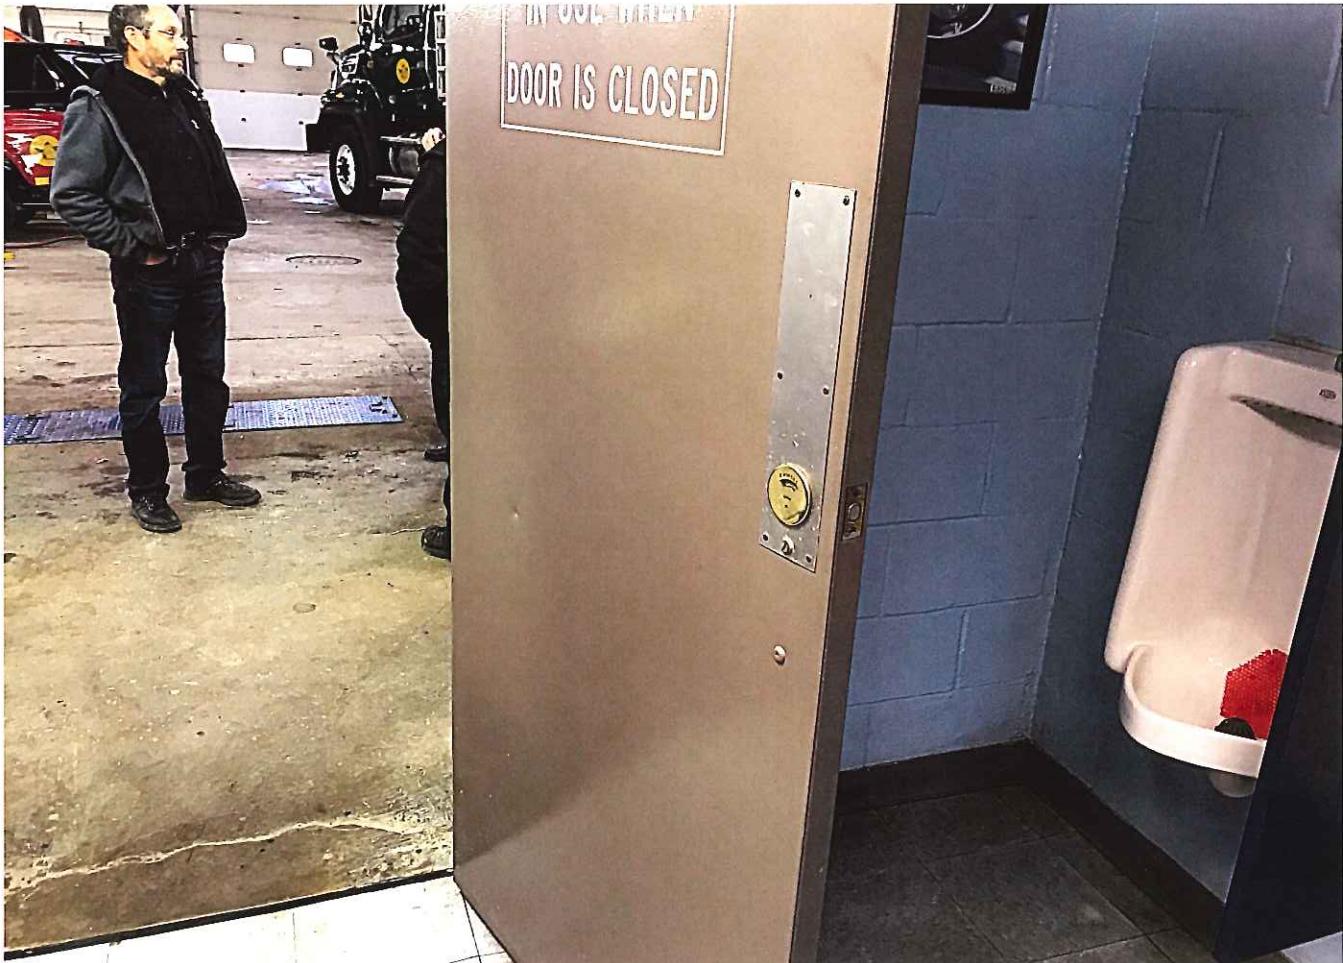
(BE-6) Missing accessible door hardware

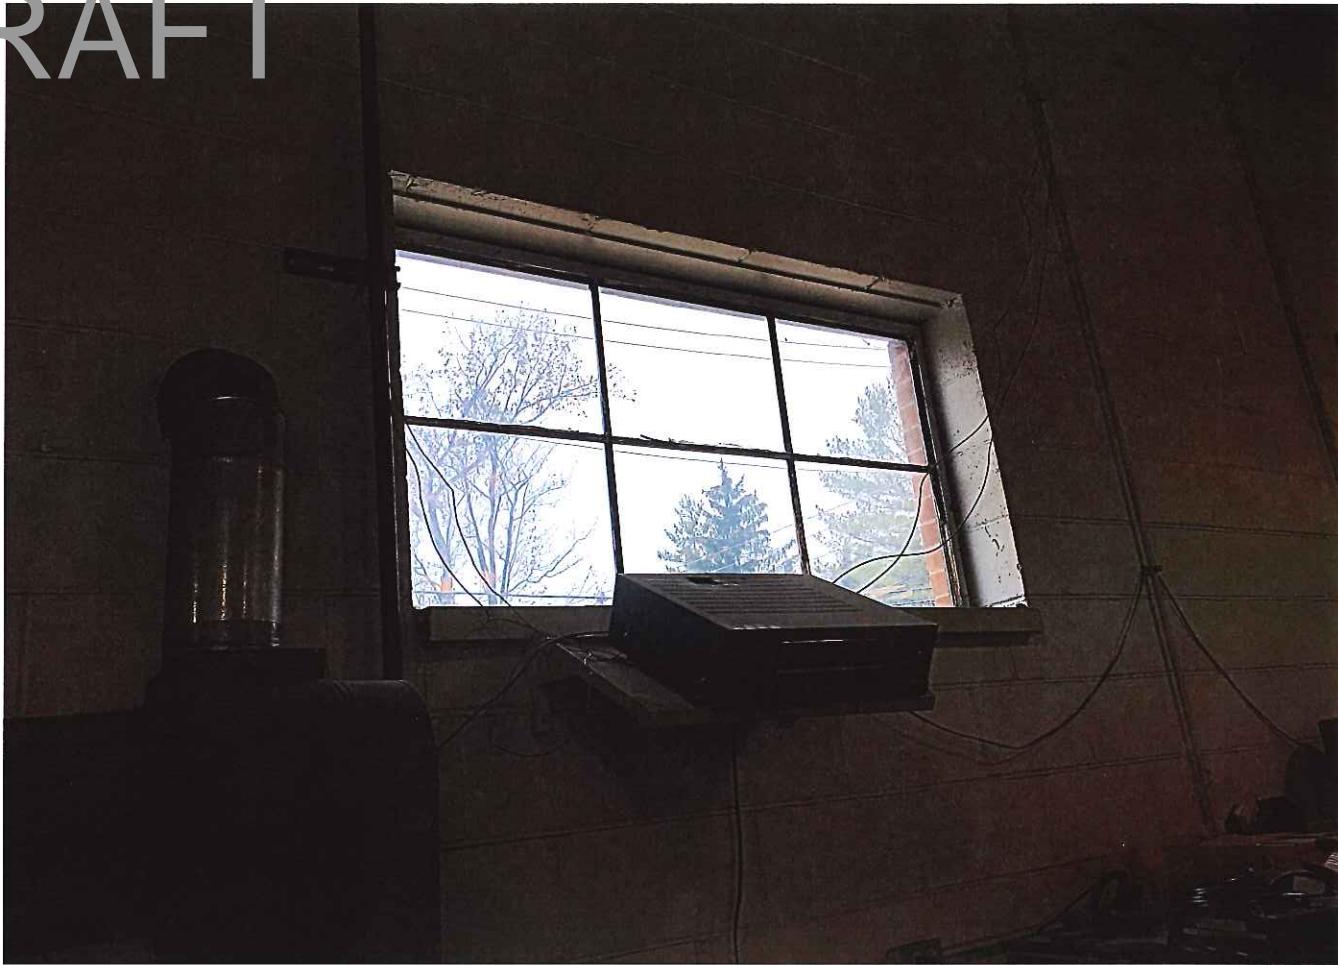
(A-1) Single pane windows

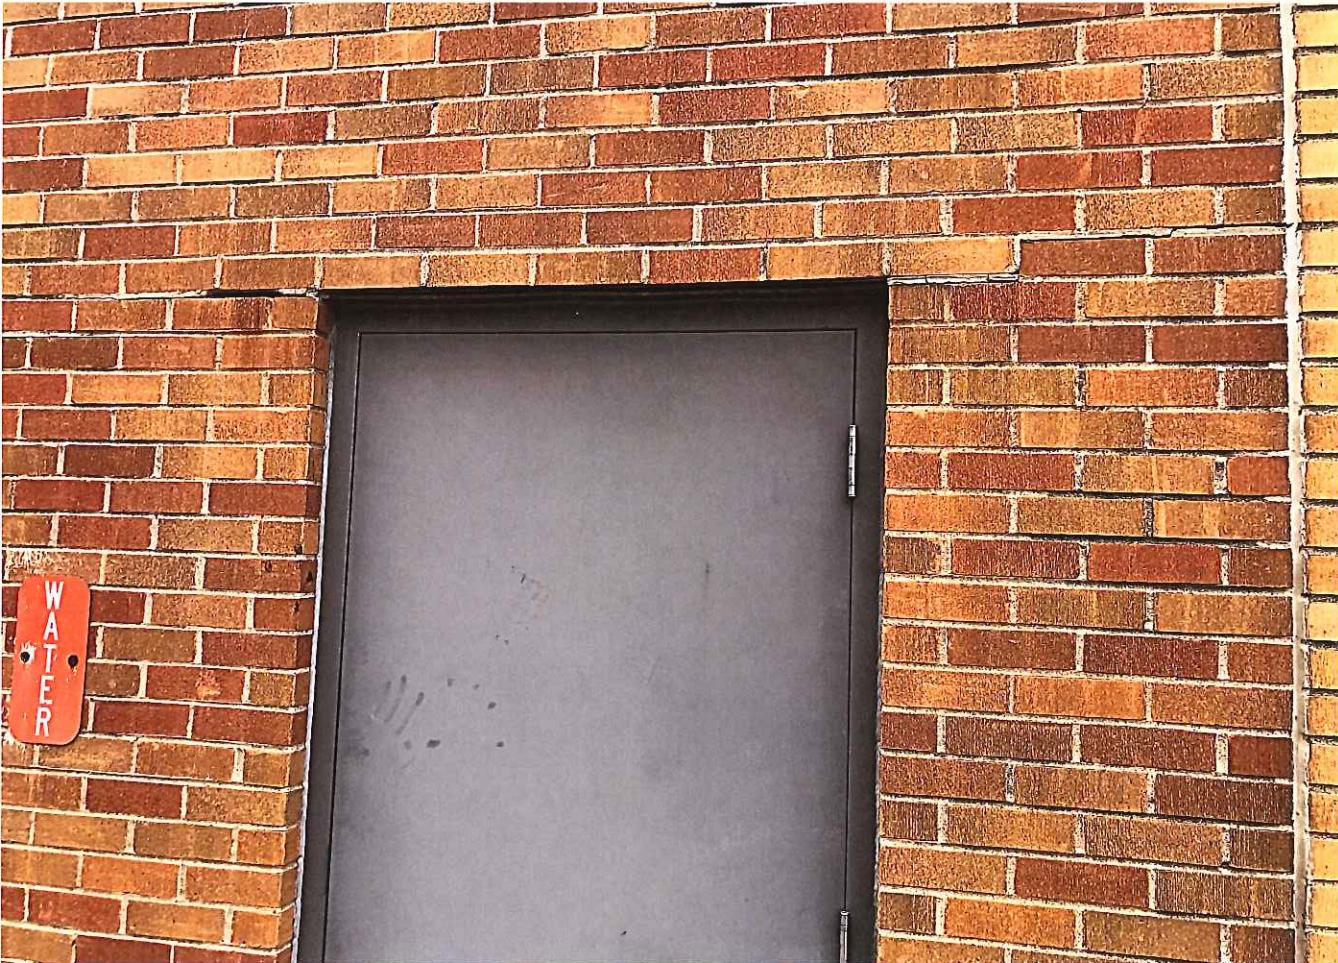
(A-3) Steel lintel is rust jacking

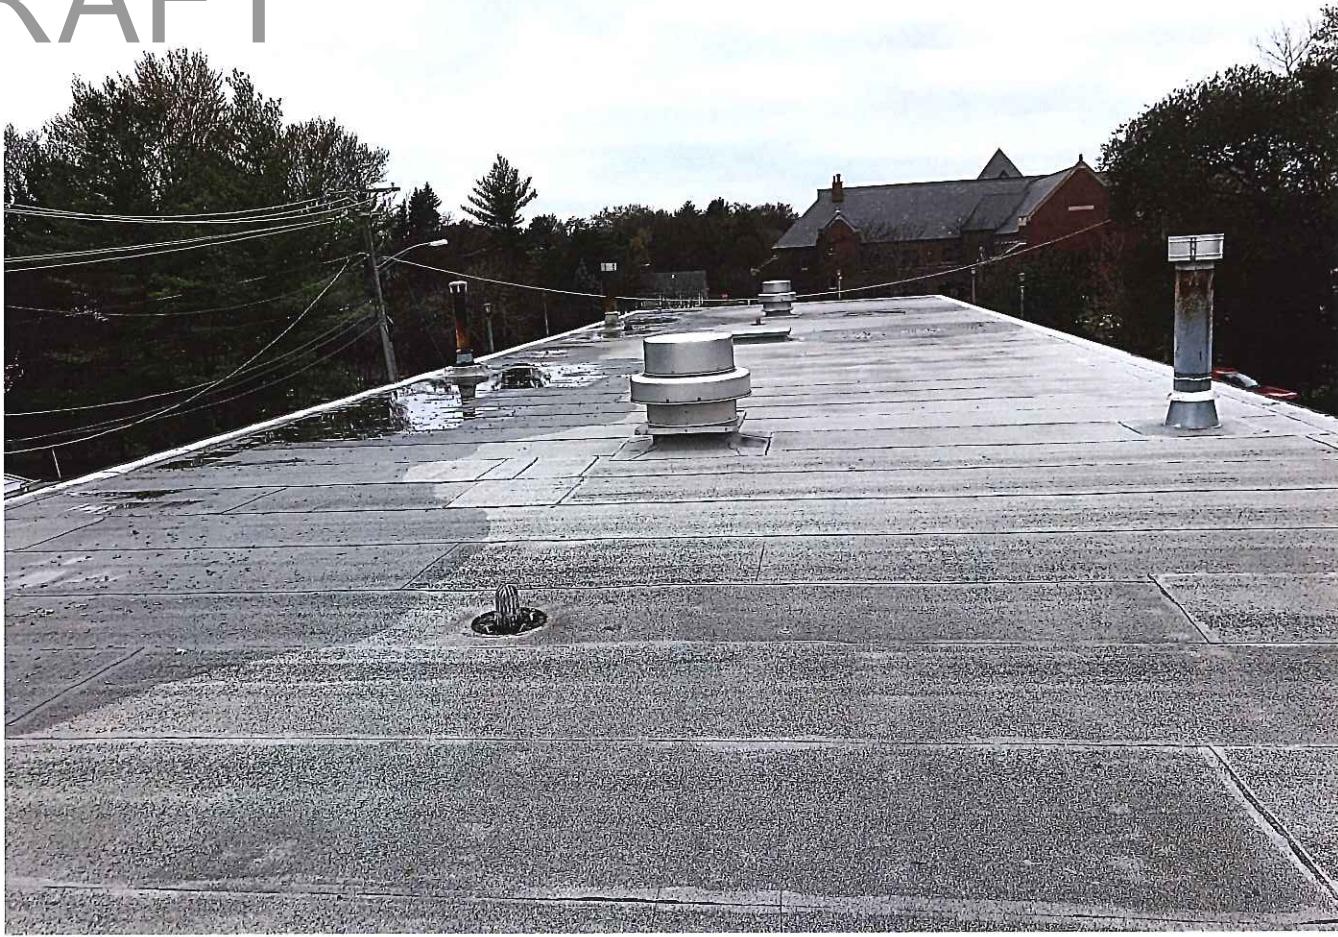
(A-4) Roofing

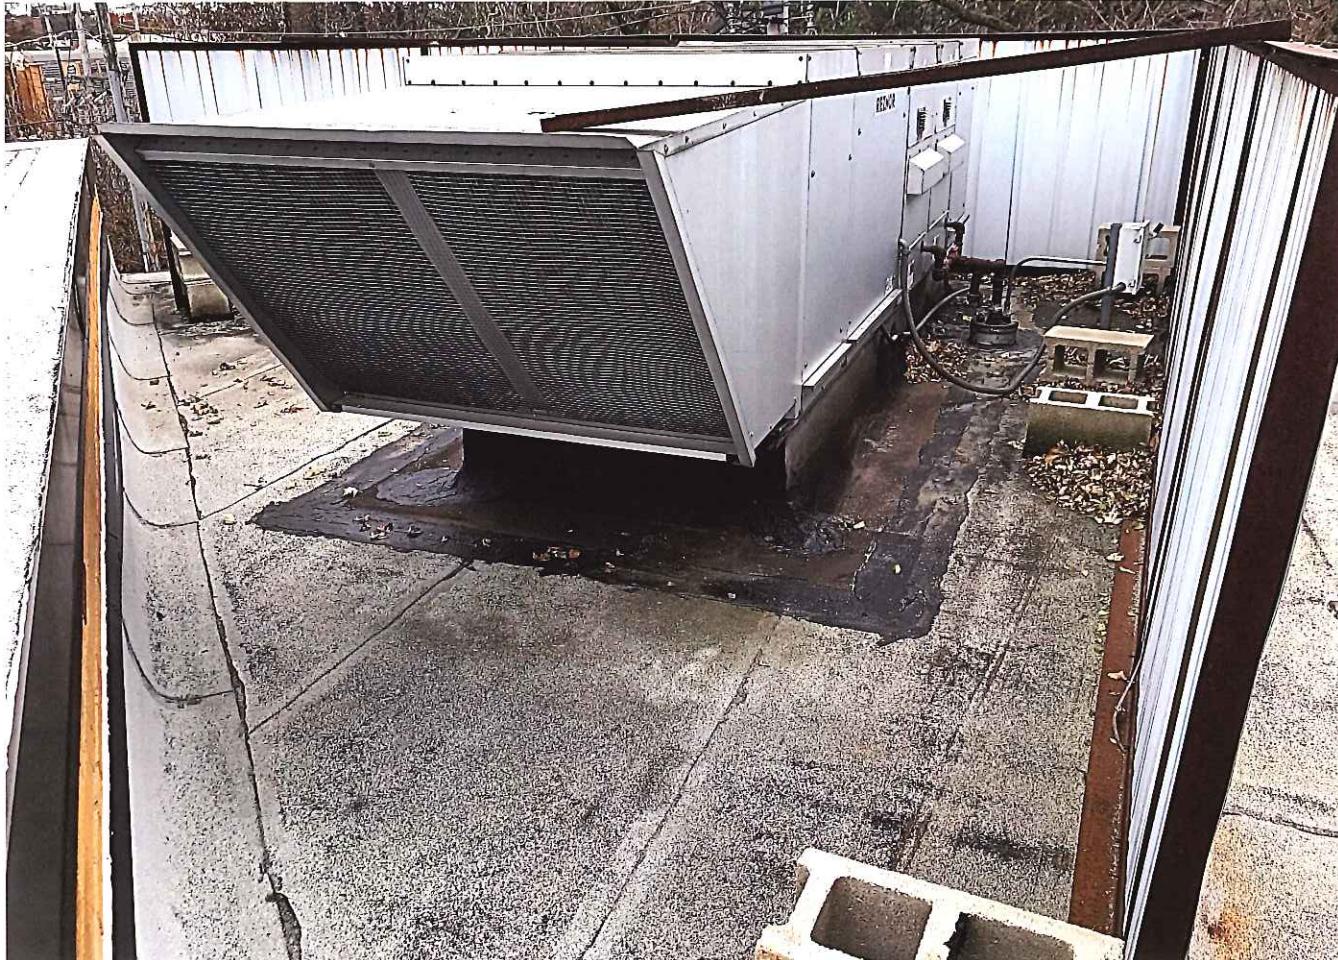
(A-4) Roofing

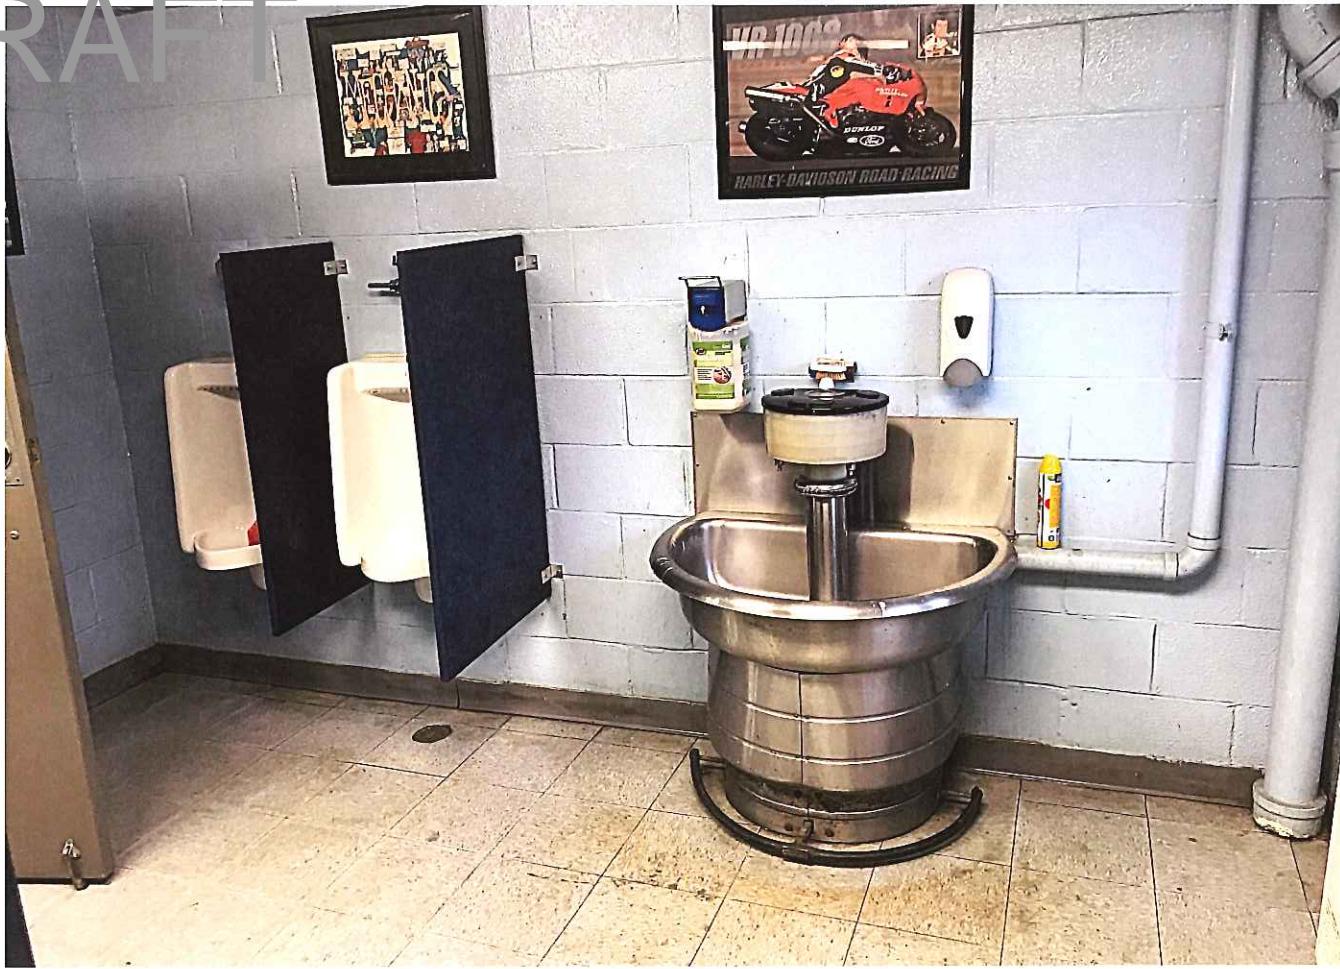
(A-6) Deteriorated finishes - floor, ceiling, partitions

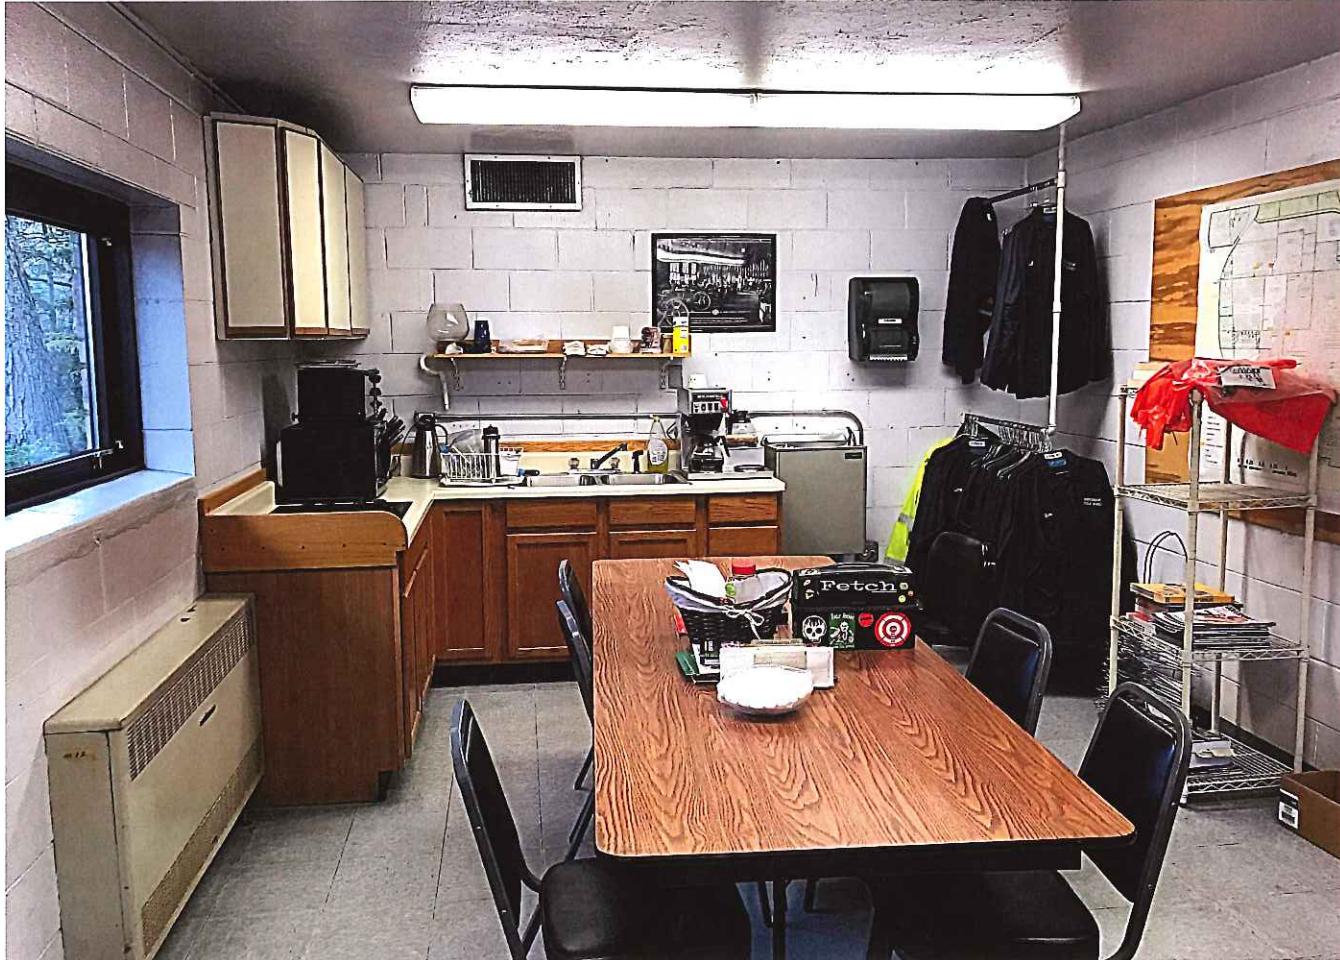
(A-7) Deteriorated finishes - floor, ceiling, counters

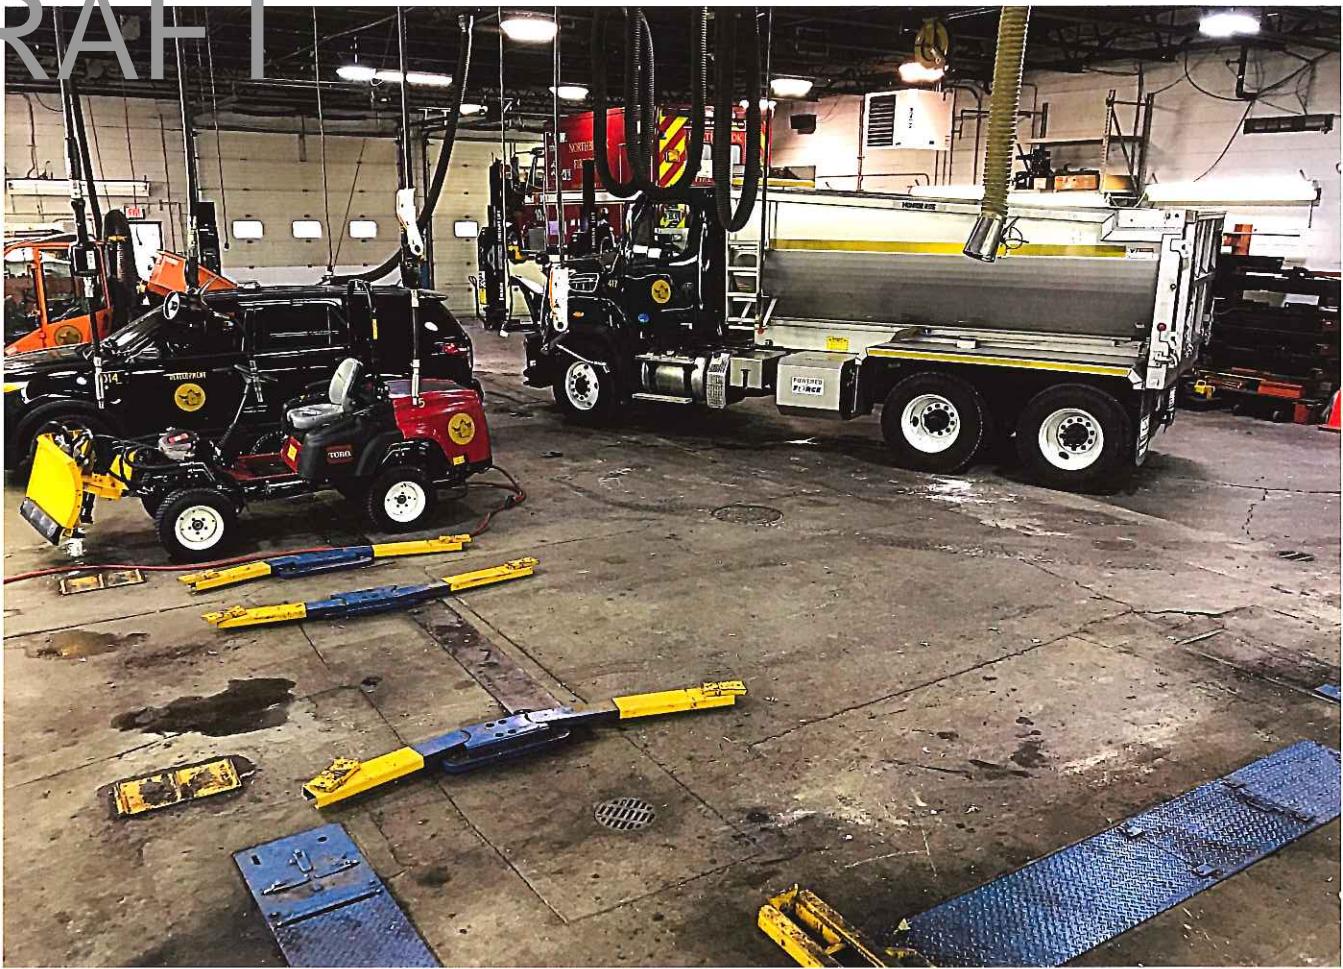
(A-8) Deteriorated concrete slabs and lifts

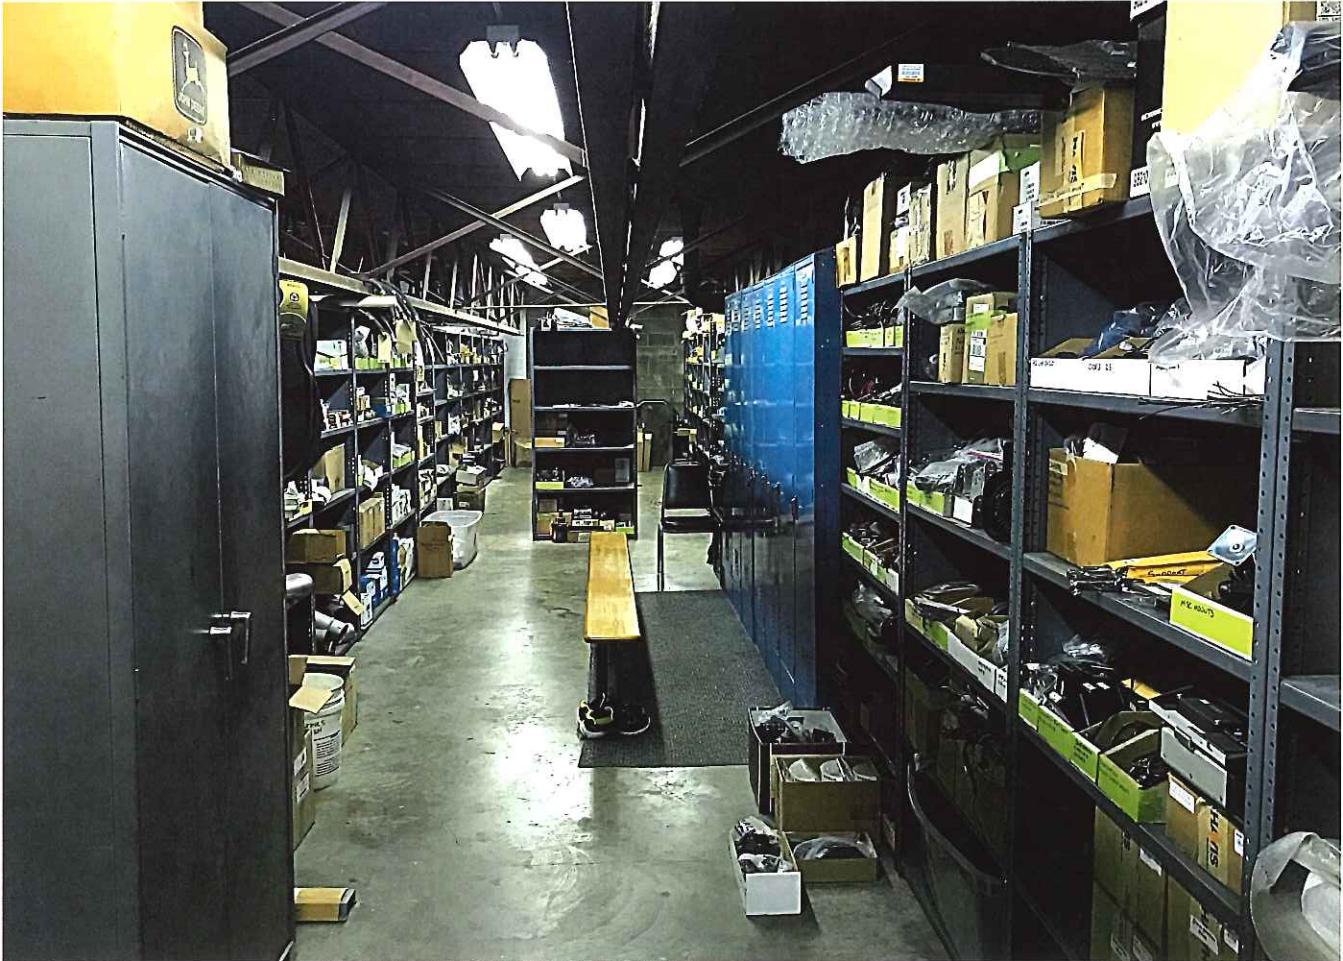
(A-11) Locker room in parts storage mezzanine

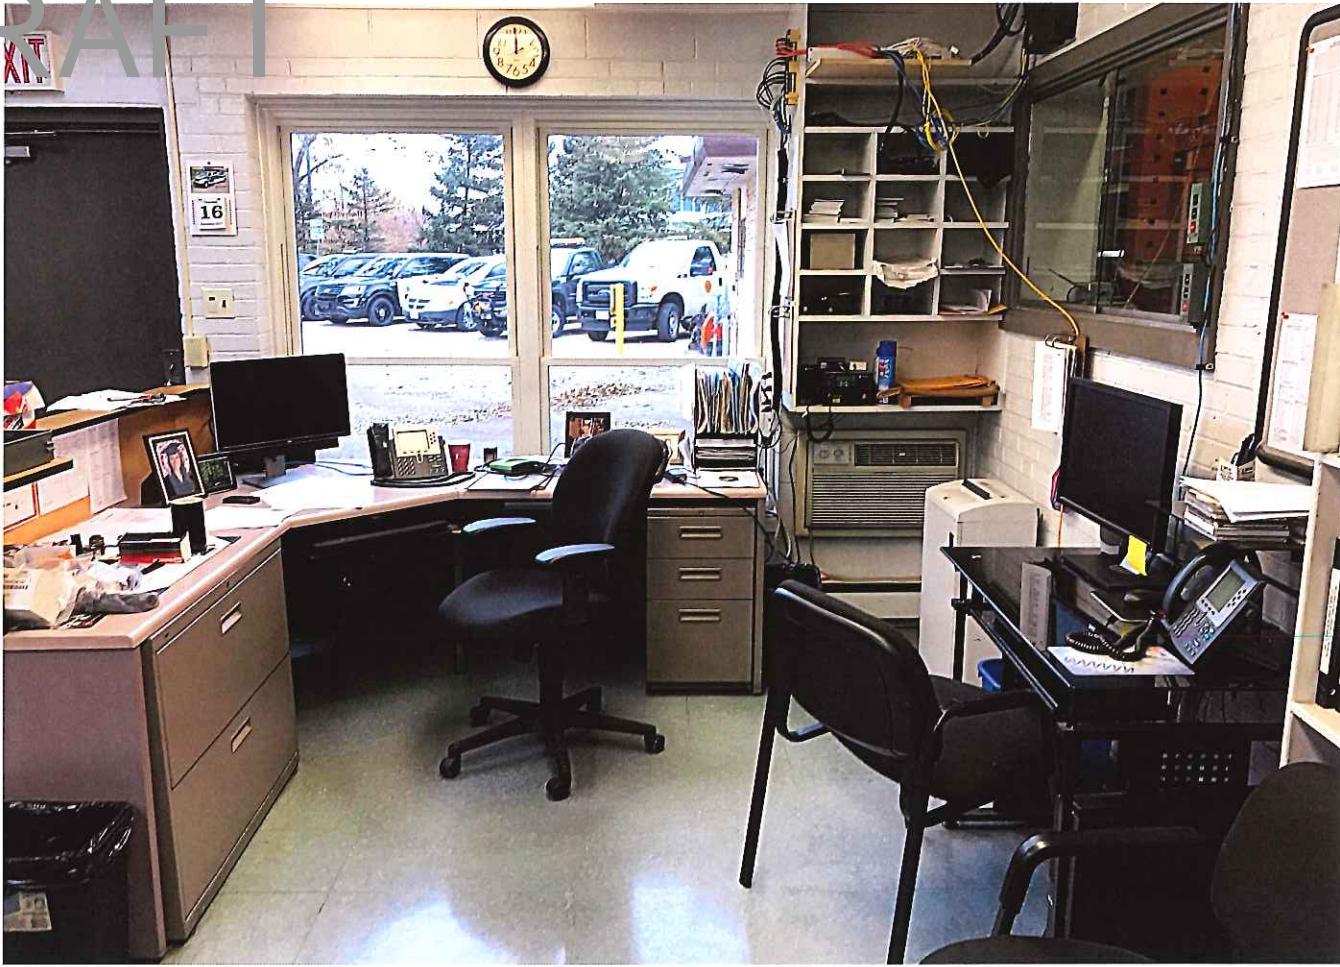
(M-3) Older model wall mounted ac unit
