Village of Northbrook

TO: RICHARD A. NAHRSTADT, VILLAGE MANAGER
FROM: KELLY HAMILL, PUBLIC WORKS DIRECTOR
DATE: February 27, 2018
SUBJECT: UPDATE ON FACILITIES ASSESSMENT AND SPACE NEEDS ANALYSIS

Facility Assessments

Northbrook Fleet Maintenance Garage
Northbrook Police Department
Northbrook Fire Station #11

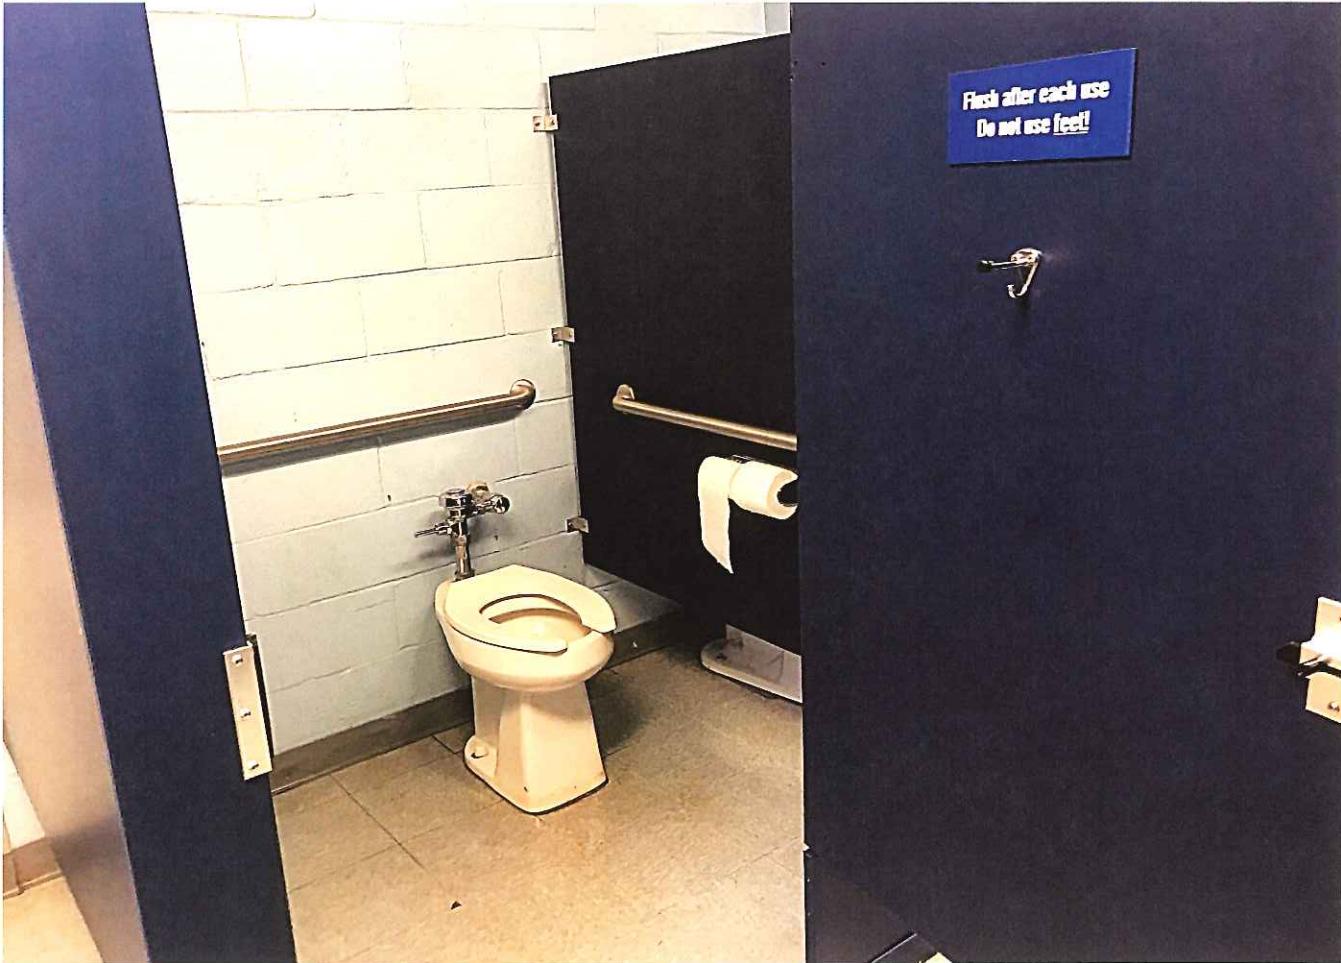
(M-7) Deteriorating plumbing fixtures

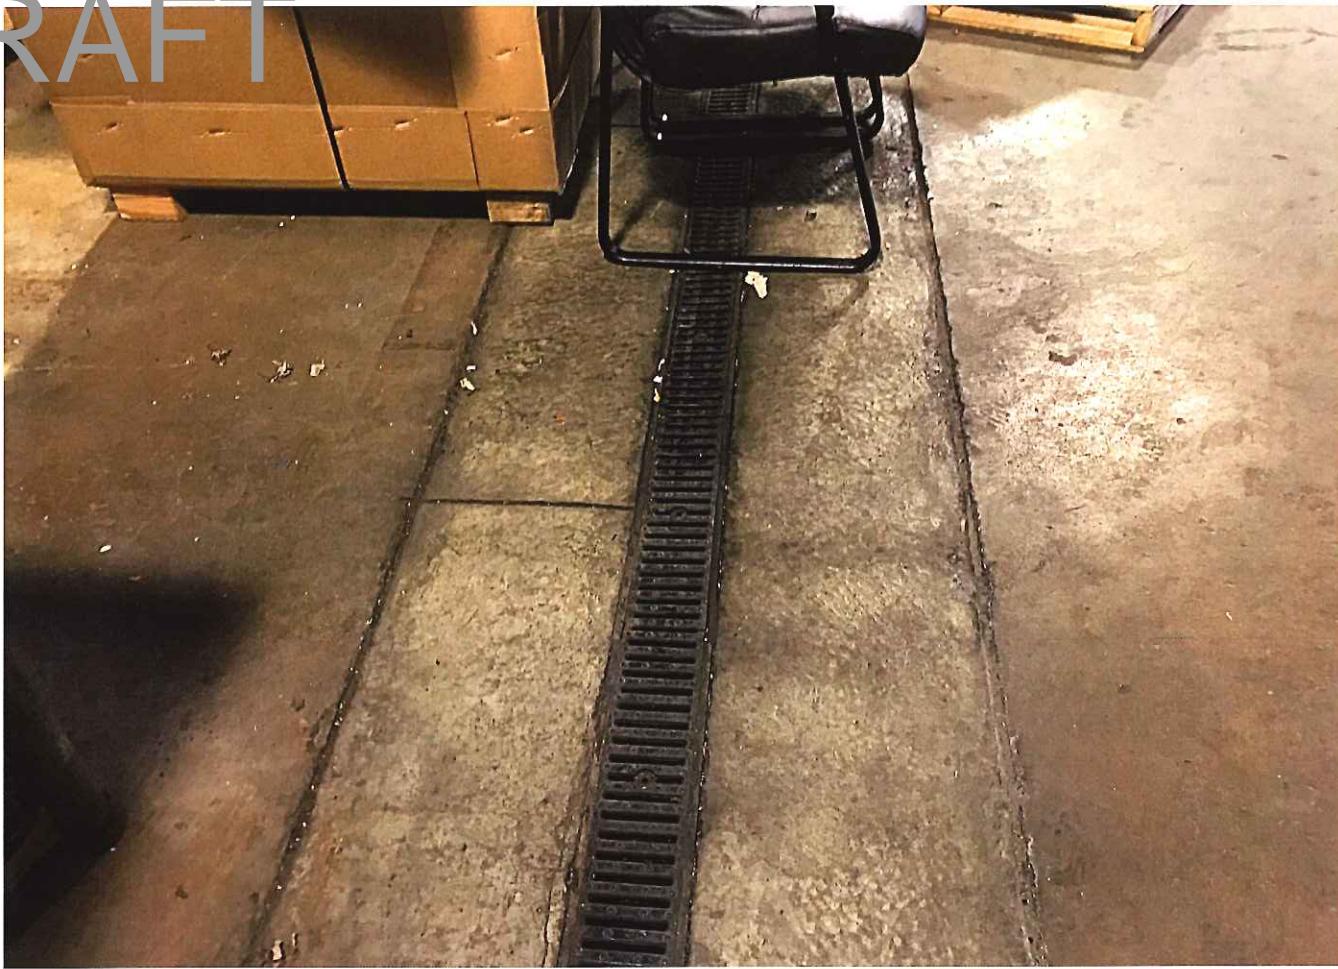
(M-9) Non-functioning trench drains

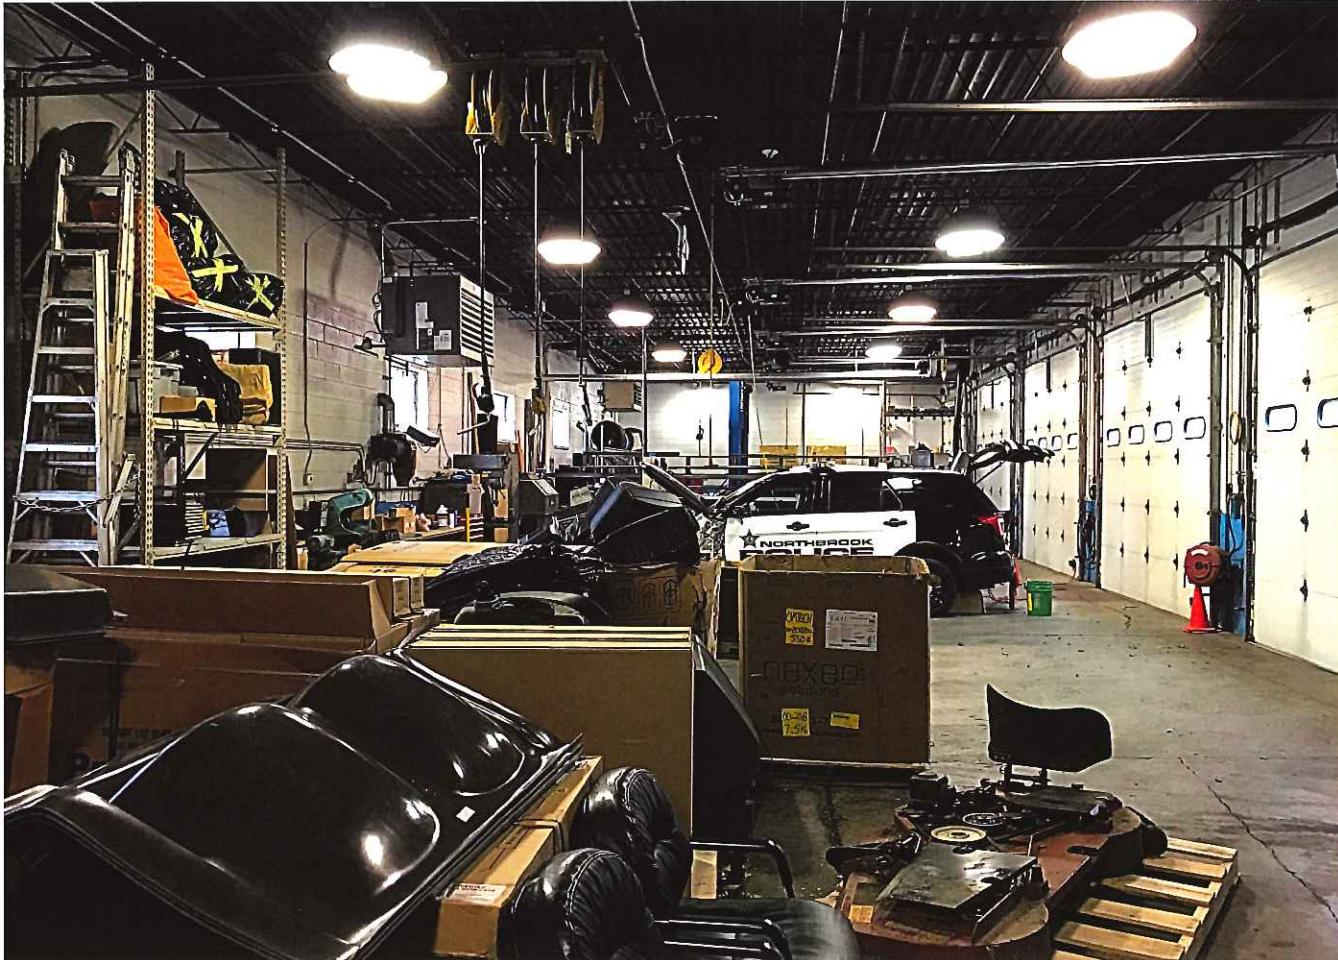
(E-5) Inefficient metal halide light fixtures

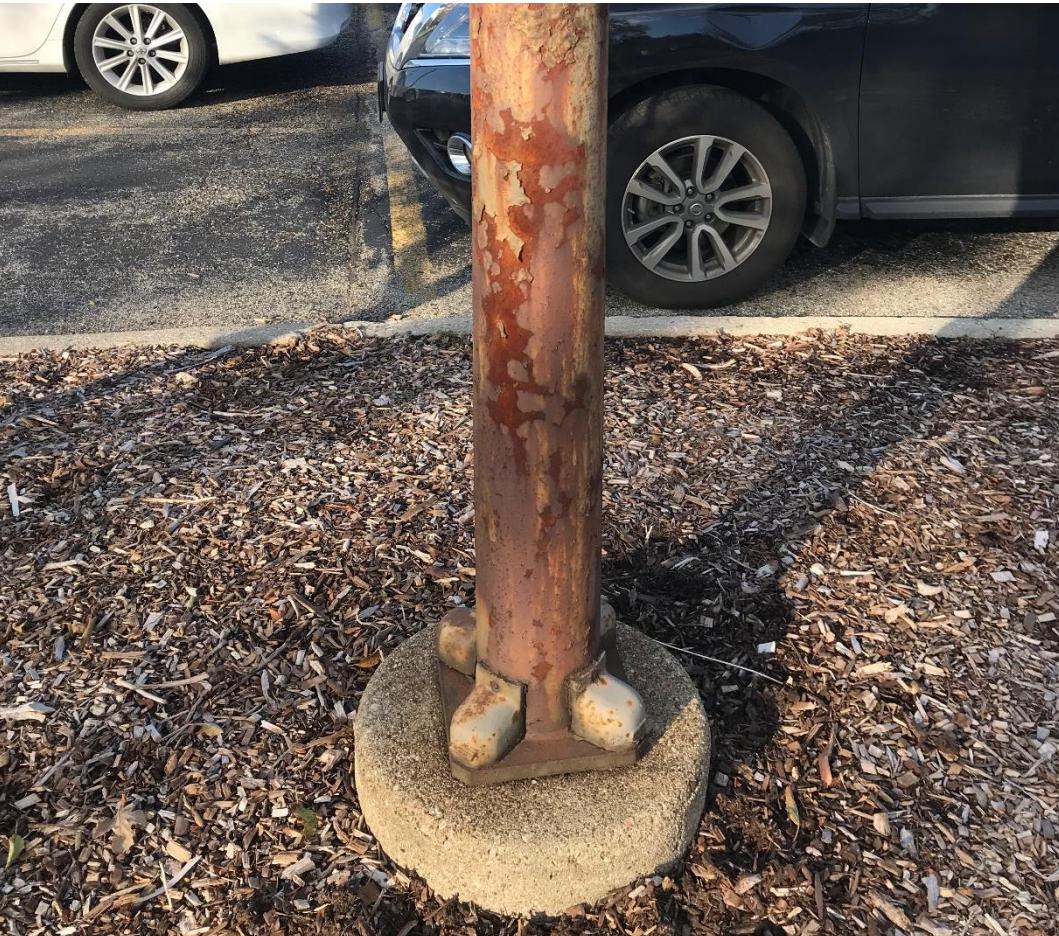
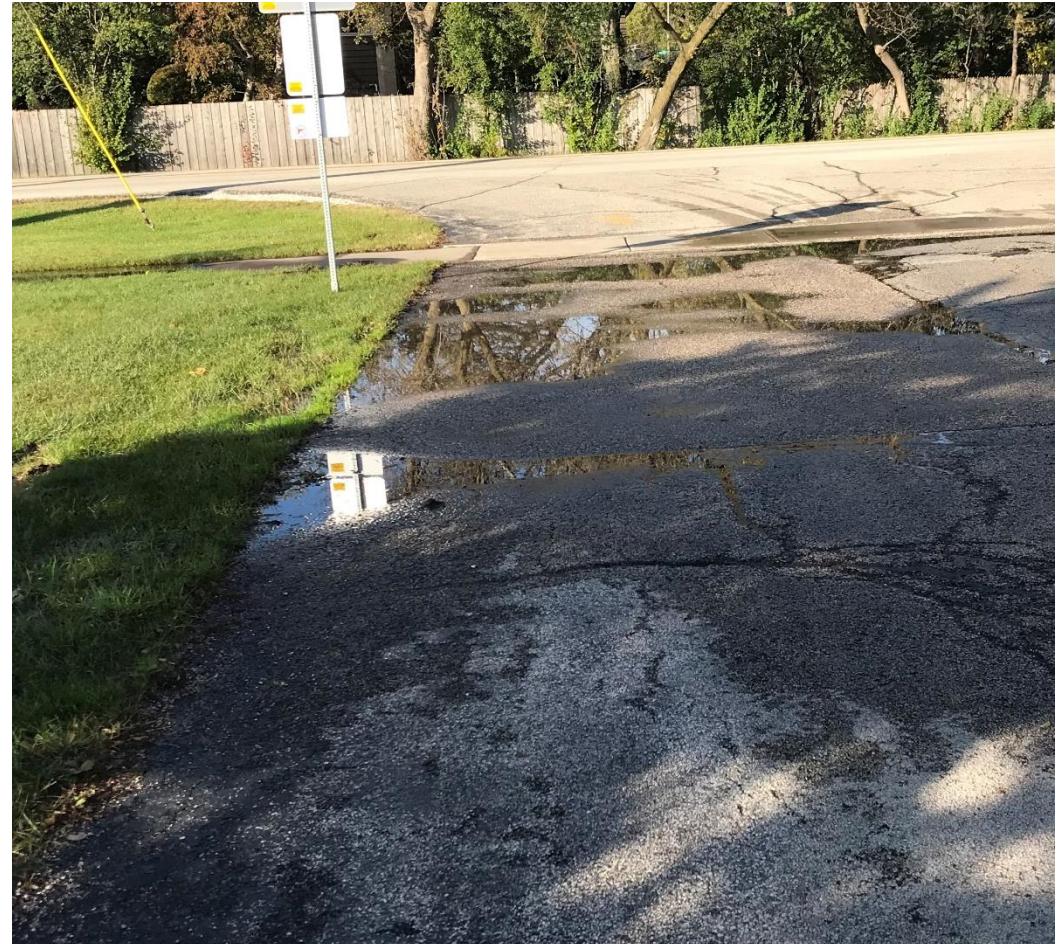
POLICE DEPARTMENT ELECTRICAL SYSTEM

- Rating of Building: B
- Projected Value of Improvements Needed: \$1,786,000
- Notable Findings:
 - Electrical Distribution System (E2)
 - Plumbing System Components (P1 and P10)
 - Windows (A1)
 - Parking Lot and Parking Lot Lighting (S4)

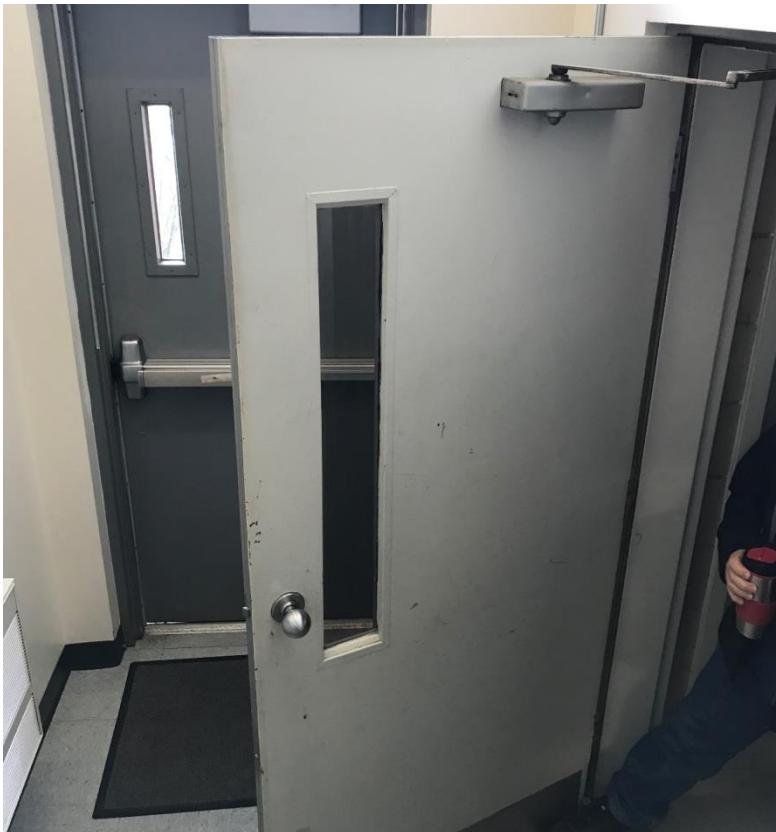
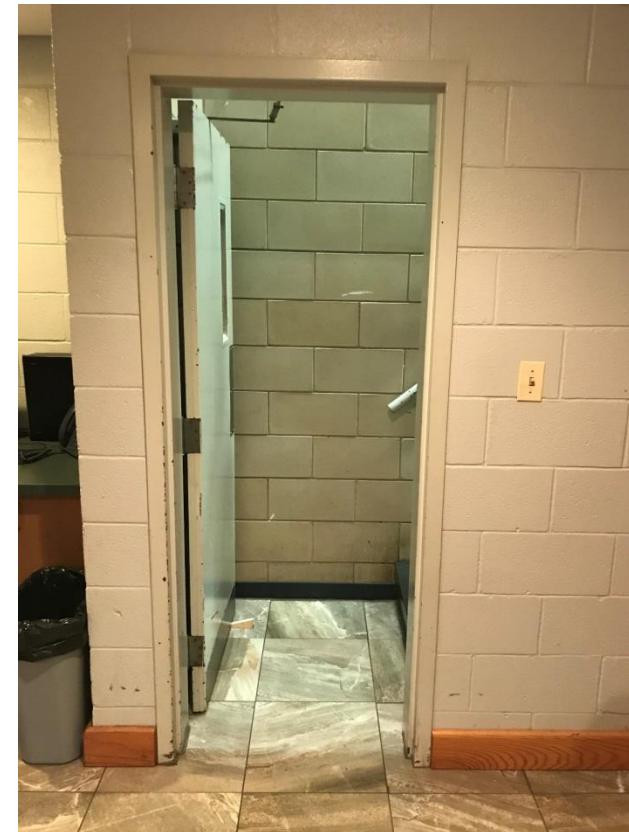
FIRE STATION II BUILDING EGRESS

- Rating of Building: C
- Projected Value of Improvements Needed: \$1,043,000
- Notable Findings:
 - Building Egress is fair to very poor throughout the operations wing (BEI-6)
 - Air conditioning system is past its useful life (M3)
 - Boiler is in good condition, however the pipes feeding the radiators themselves are failing and will require replacement (M2)

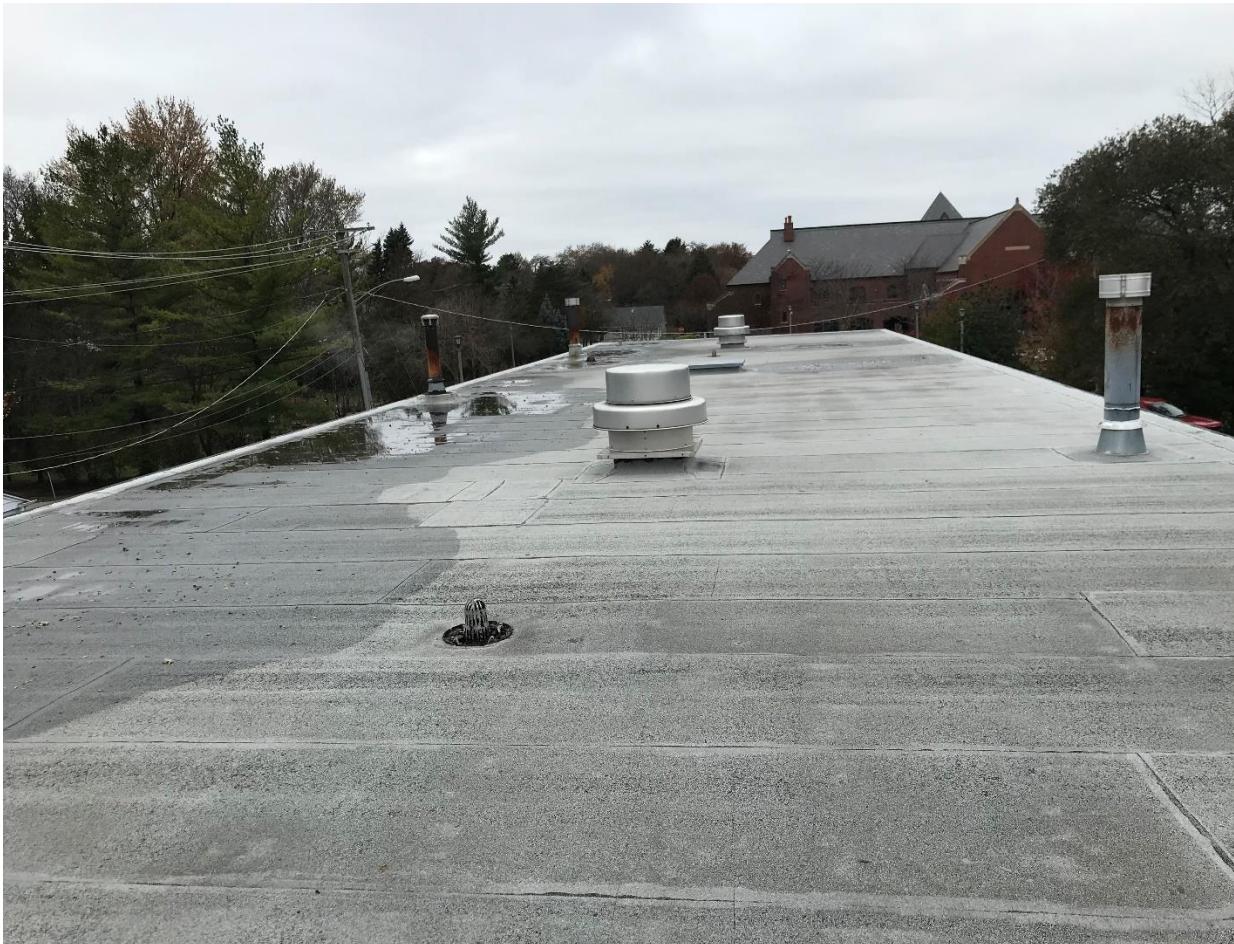
FLEET MAINTENANCE GARAGE ROOF

- Rating of Building: C
- Projected Value of Improvements Needed: \$1,129,000
- Notable Findings:
 - Roofing is approaching the end of its useful life (A4).
 - Maintenance bays are in very poor condition (A8 – A9).
