# Village of Northbrook

# MEMORANDUM

**TO:** CARA PAVLICEK, VILLAGE MANAGER  
**FROM:** KELLY HAMILL, PUBLIC WORKS DIRECTOR  
**DATE:** FEBRUARY 28, 2023  
**SUBJECT:** FACILITIES PLAN UPDATE

#### Existing Condition Analysis

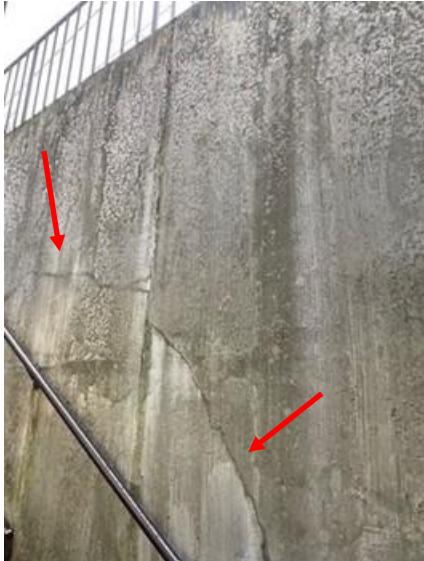
The foundation walls were in variable condition. We observed minor cracks in the EOC basement. However, we observed more significant cracks at the concrete wall adjacent to the basement stair. We also observed minor concrete cracks and spalls in the apparatus bay of the fire station, specifically at the trench drains.

*Significant concrete crack at basement stair*

We recommend that the concrete cracks at the basement stair be repaired. The cracks in the basement wall, as well as the cracks in the CMU, should be monitored for any future movement or worsening condition. We recommend crack monitors be installed and reviewed on a quarterly basis to provide a historical data set.

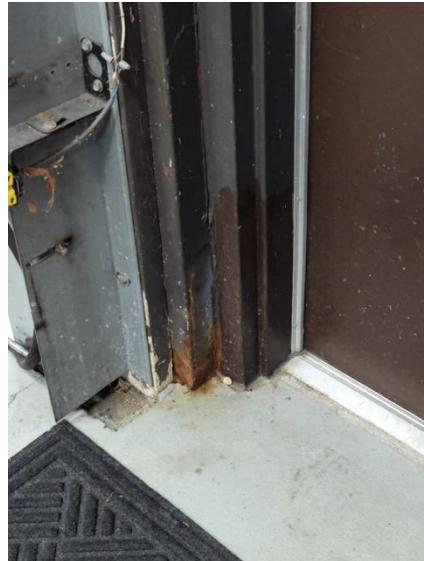
*Significant corrosion at hollow metal door and frame*

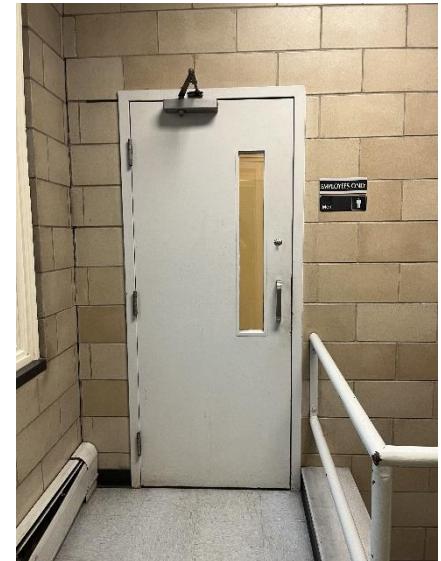
*Cracking at corner of masonry wall, improper door clearances and railing condition*

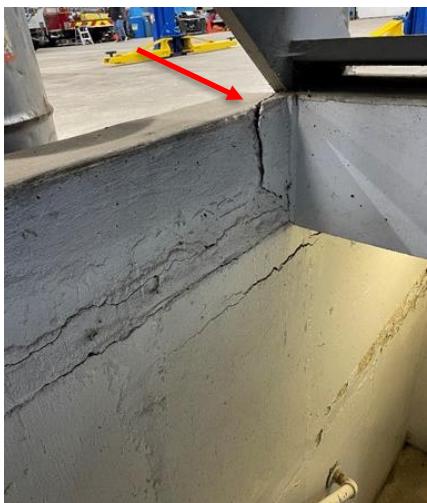
Significant concrete crack at base of mezzanine stair

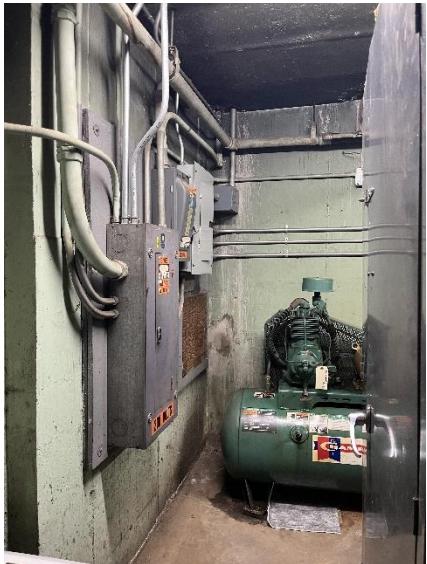
*Basement level Mechanical Room*

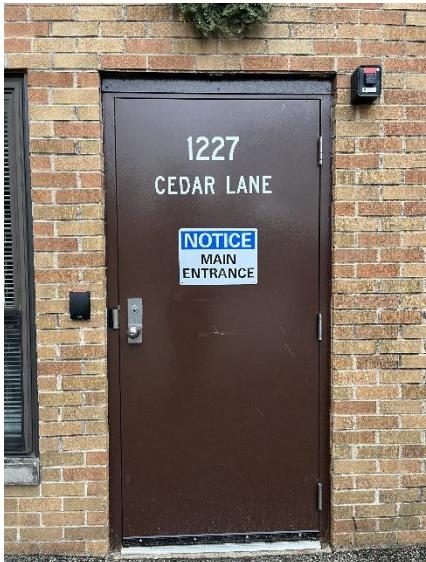
*Access control at main entry door /  
Inaccessible door hardware*

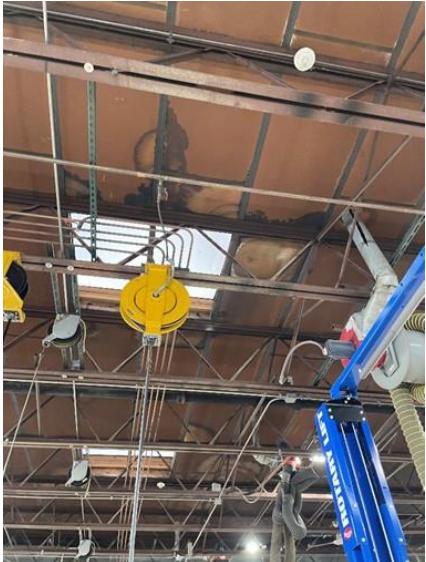
*Significant water staining at skylight*

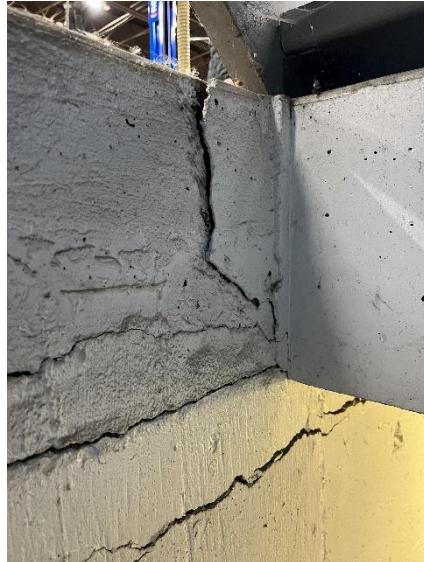
*Cracking in concrete at stair to basement*

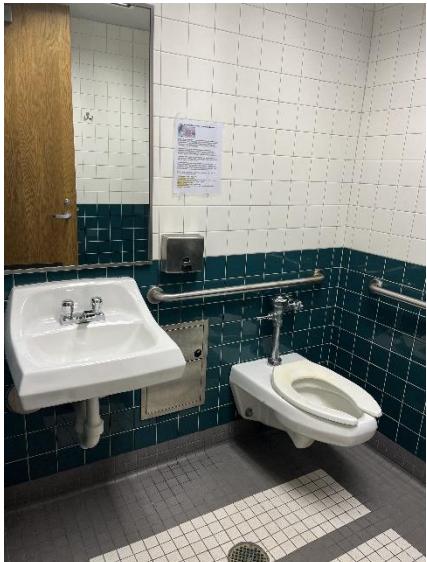
*Single user toilet room, non-compliant with current standards*

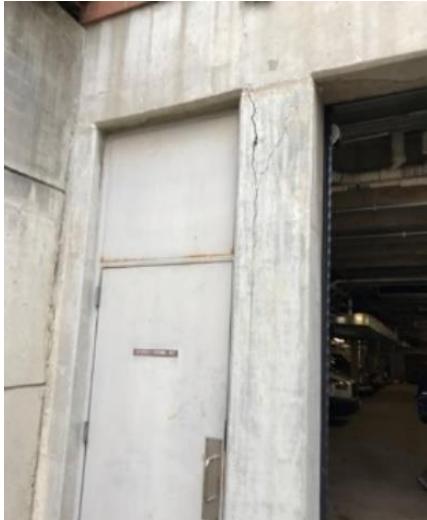
*Column cracking adjacent to garage door*

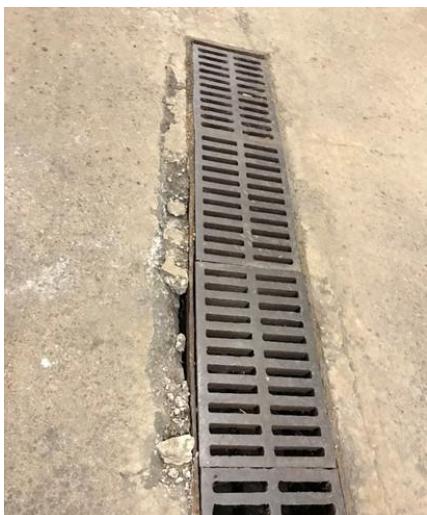
*Concrete spalling at garage trench drain*

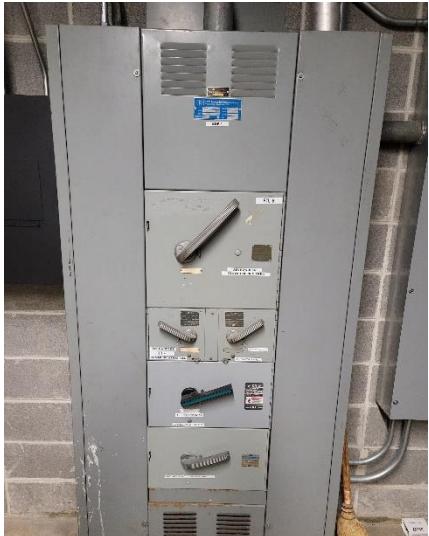
*Original electrical distribution panel*

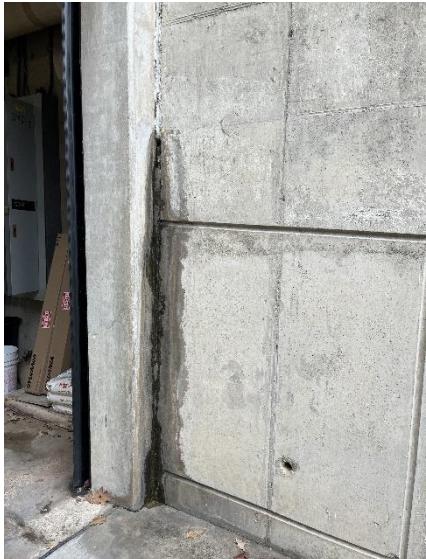
*Seepage at concrete wall near exterior entry to garage*

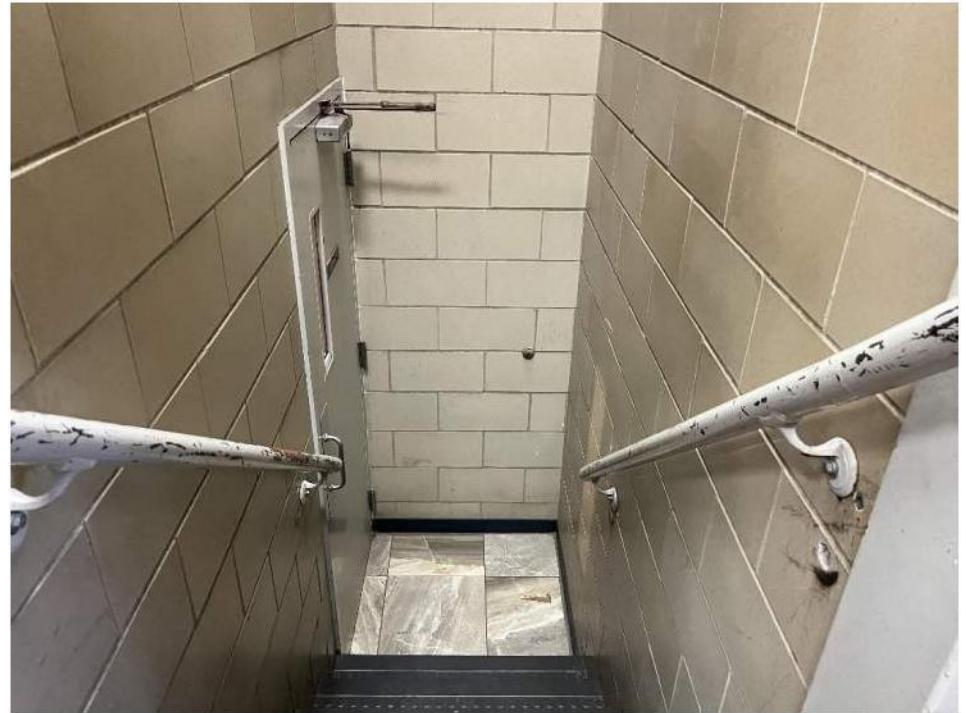
Due to the multiple levels, numerous stairways are provided within the fire station, none of which are compliant. Stairs are consistently narrow in width, severely lacking in adequate landing areas and are not equipped with handrail extensions. At some stair locations off the bay floor, an additional curb has been built up at the top of the stair to prevent water infiltration to the lower levels below. In addition to being incompliant, these also pose a safety and tripping hazard. Significant modifications would be required to make the stair areas compliant, however there is insufficient physical space available to do so.

*Non-compliant stair to lower level living quarters*

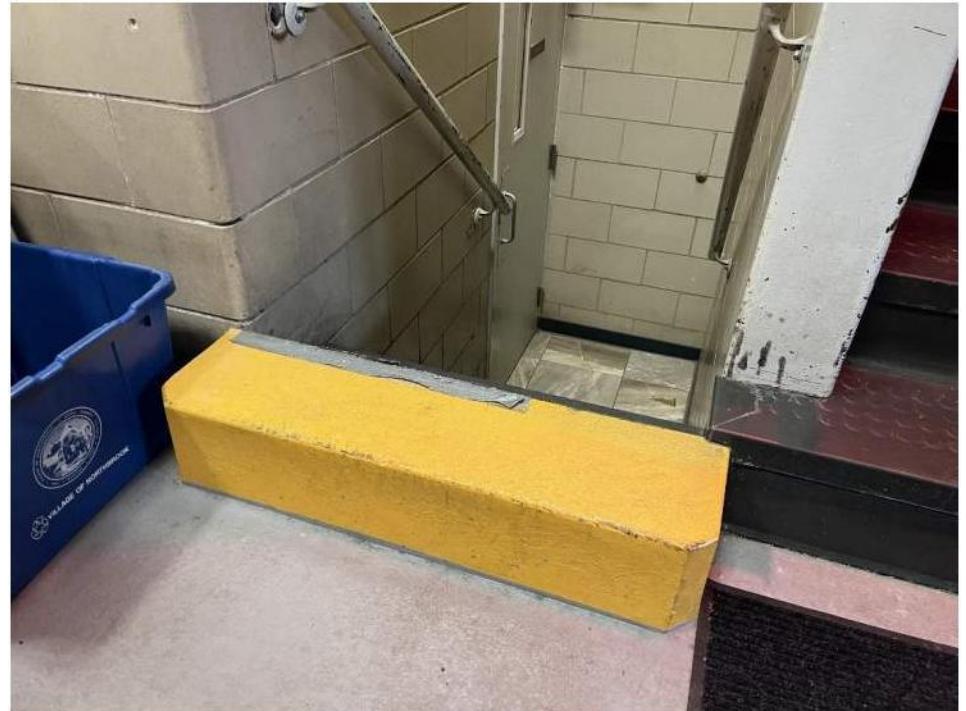
*Narrow stair with built-up curb in Apparatus Bay*

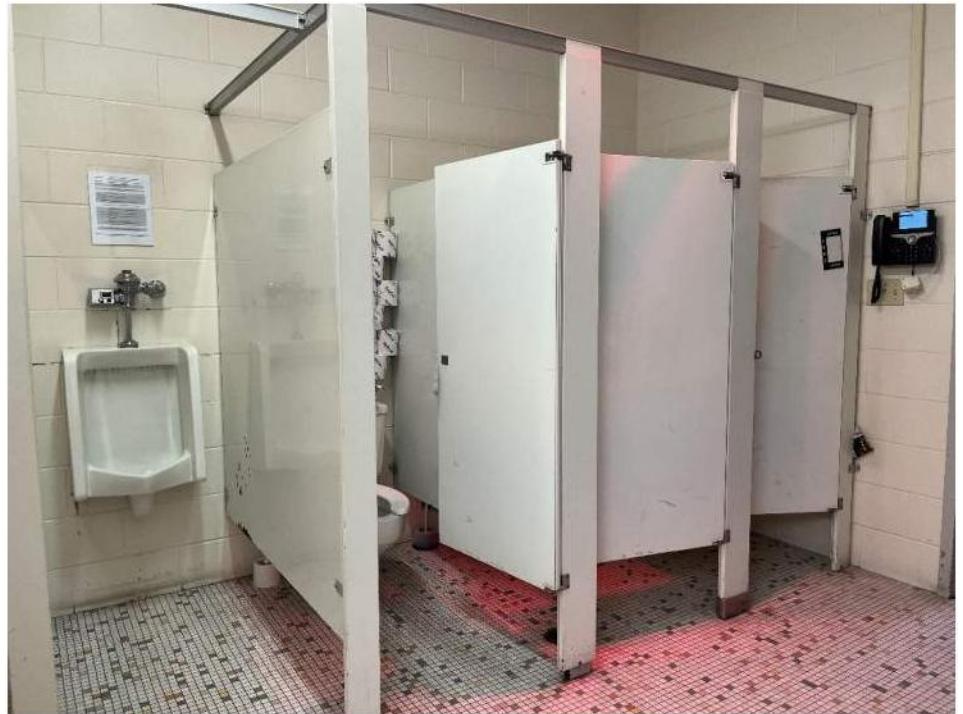
*Locker Room toilet area*

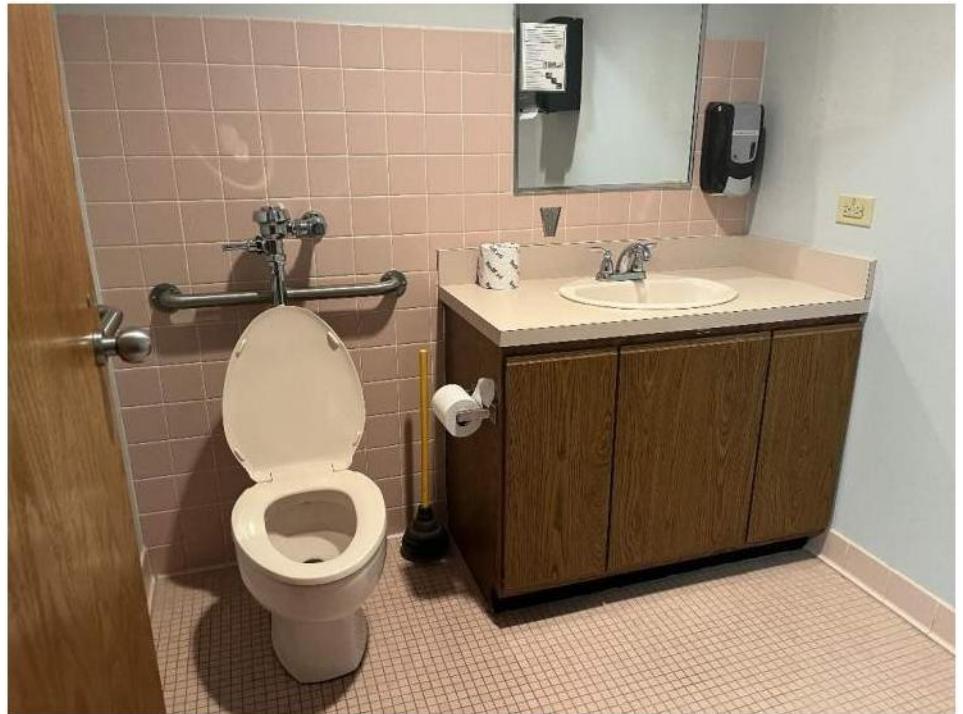
*Single user toilet room in administration wing*

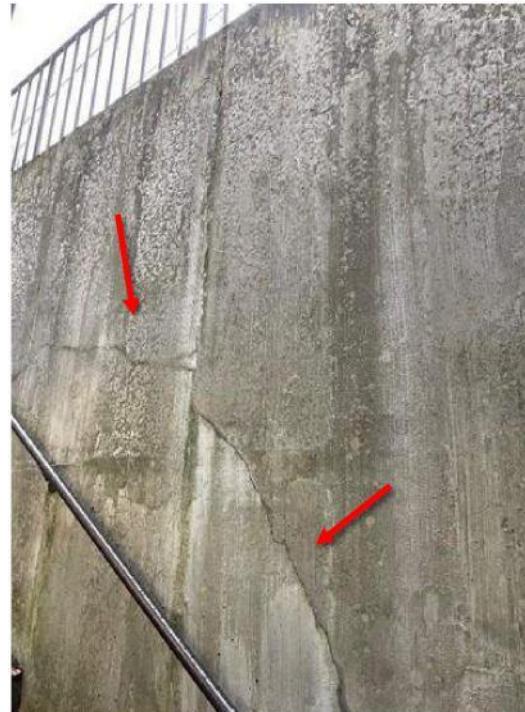
*Significant concrete crack at basement stair*

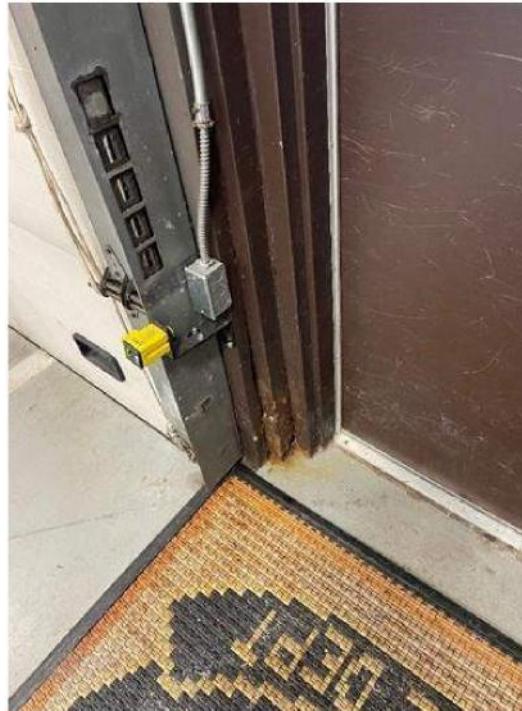
We also observed significant corrosion at the base of the steel columns in the apparatus bay.

*Significant corrosion at base of steel column in the Apparatus Bay*

It is our understanding that the steel framing in the apparatus bay has already been scheduled to be repaired and/or replaced. As the new steel will continue to be susceptible to the exterior elements and chemicals (e.g. de-icing salts), we recommend that the new steel be scraped, primed and painted with a rust inhibiting coating periodically, as part of a regular maintenance schedule in the future.

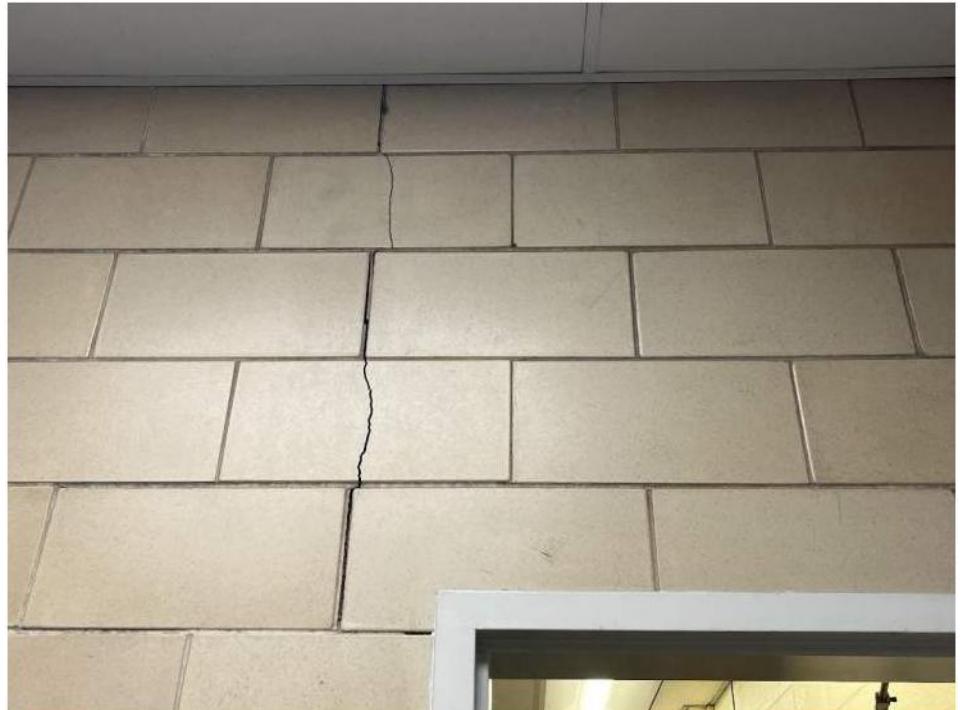
We observed minor step and thru-block cracks at both the interior and exterior masonry walls. We did not observe evidence of water infiltration at the cracks.

*Cracking at interior masonry wall*

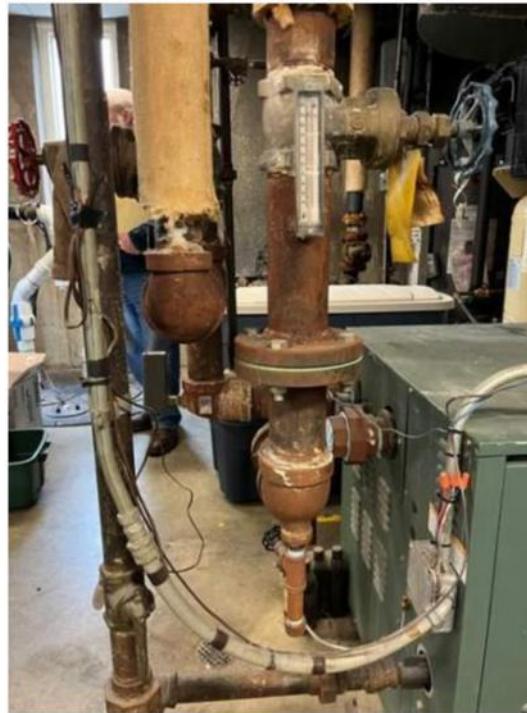
*Significant corrosion on piping*

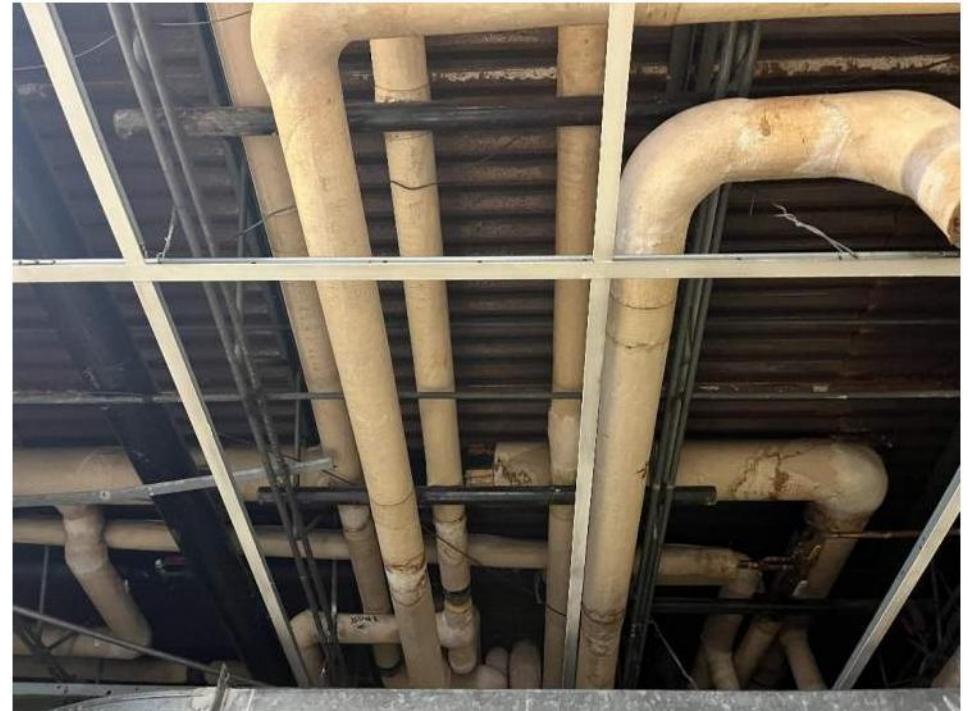
*Deteriorating pipe insulation*

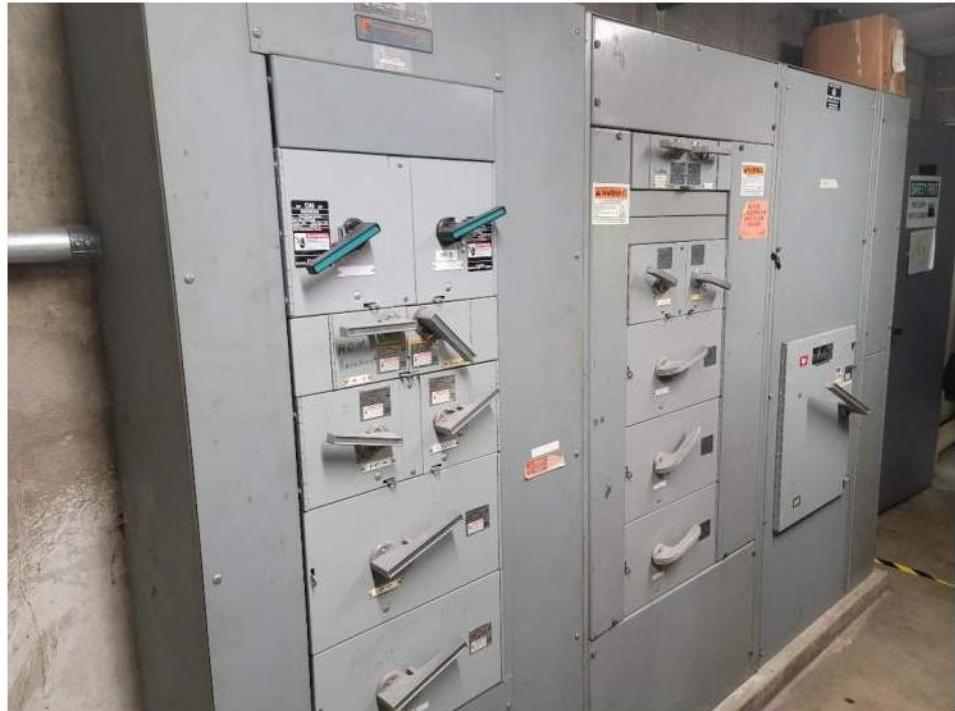
The electrical service is rated 1200 amperes at 208/120V-3Ph. The main service disconnect switch is located in the original 3-section ITE switchboard. The switchboard appears in fair condition however the 50+ year old electrical service equipment is nearing end of service life. Location of the service entrance is subject to train derailment damage. The distribution panels appear to be in fair condition. All branch panels are typical bolted circuit breaker type and appear to be anywhere from original and 50+ years of age to relatively new and in overall fair to good condition. Expansion capabilities are limited by physical breaker space and some older panels are serving as pass through wiring pull boxes. Relocation and replacement of the main electrical service entrance and associated equipment with new better protected service equipment is recommended.

*Original electrical service board*

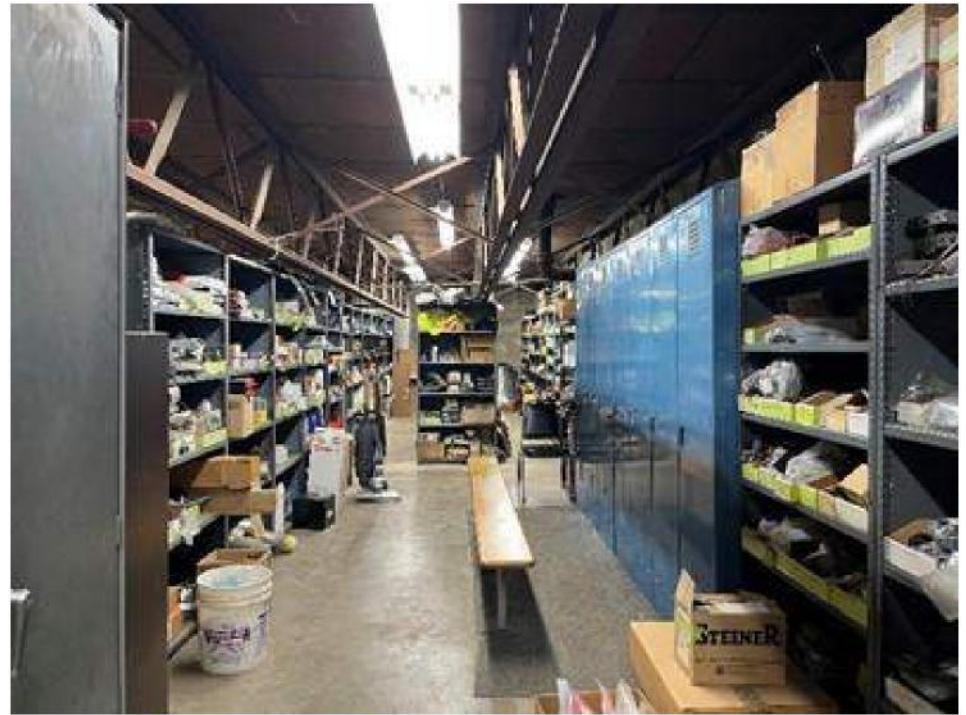
*Hazardous positioning of roof joists*

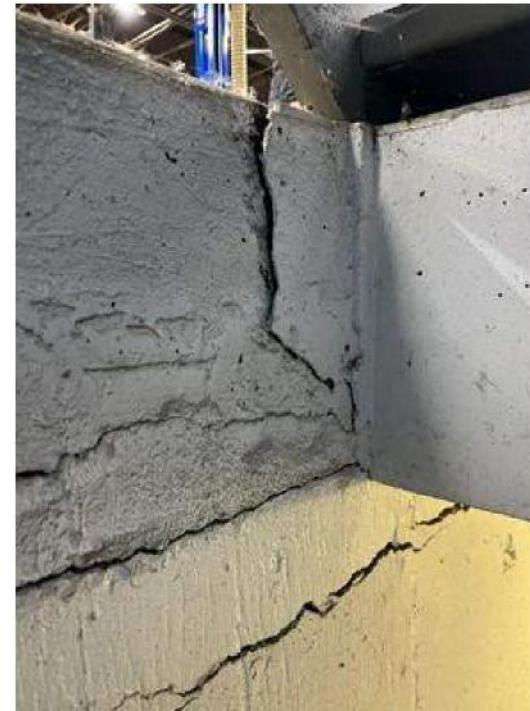
*Significant concrete cracking at stair*

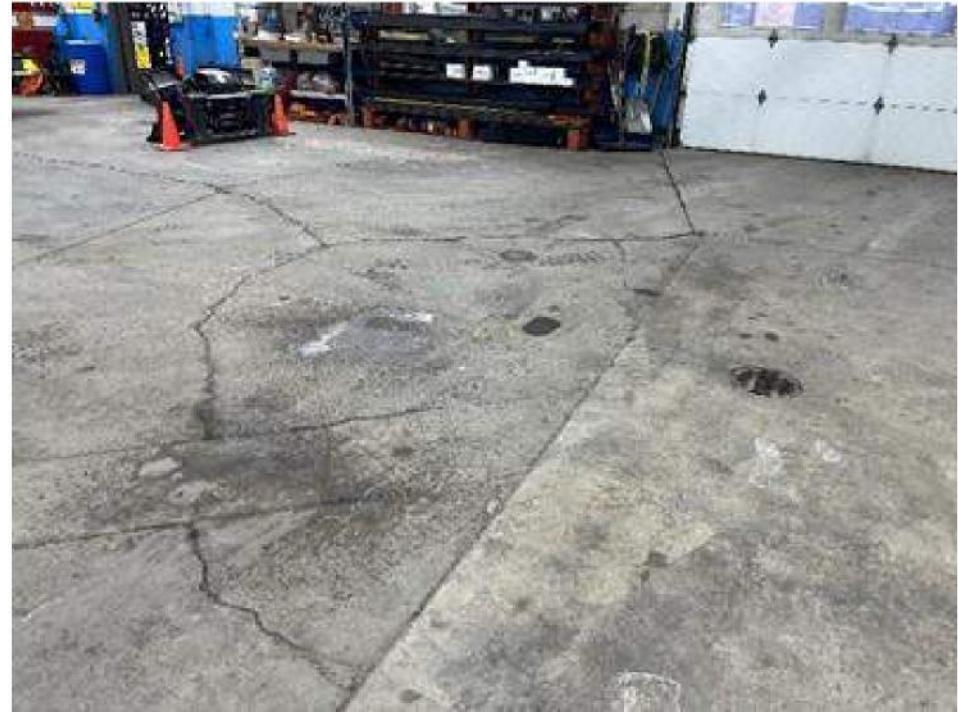
*Concrete slab on grade cracking throughout*

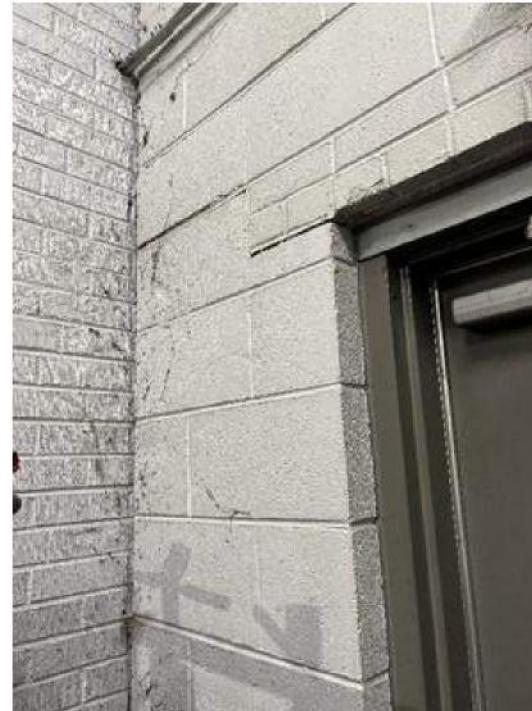
*Step cracking at interior concrete masonry*

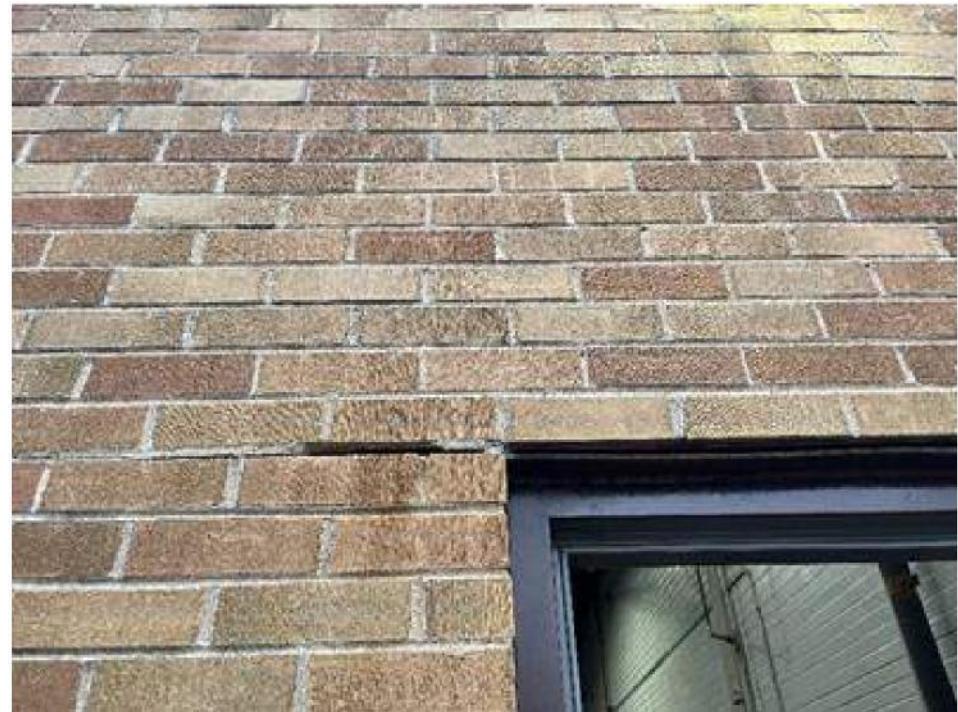
*Step cracking and brick masonry displacement*

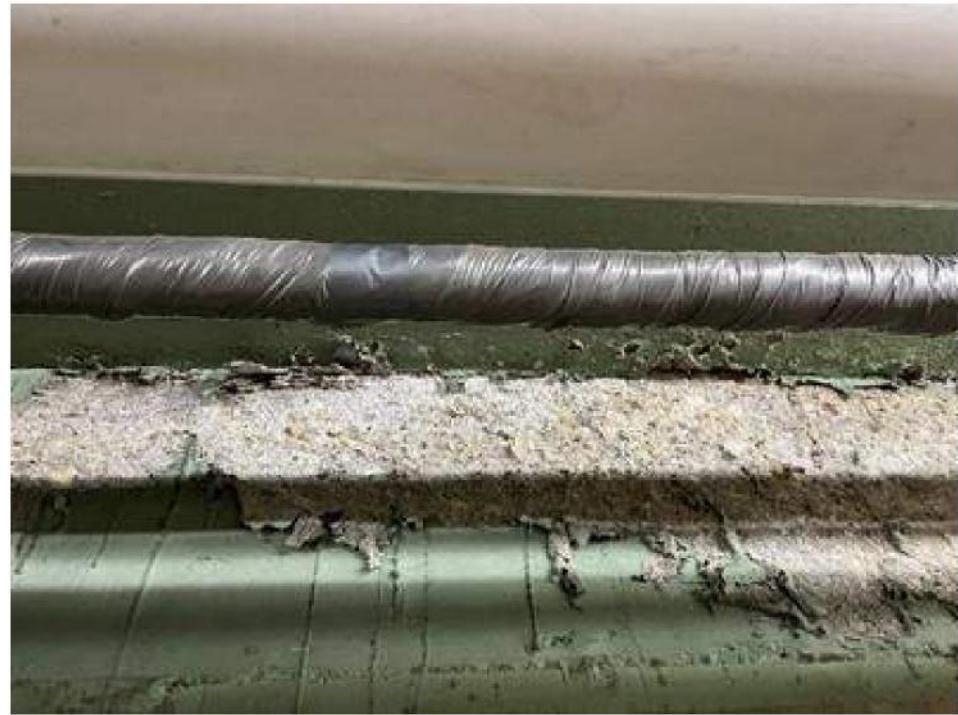
*Deterioration at basement concrete wall*

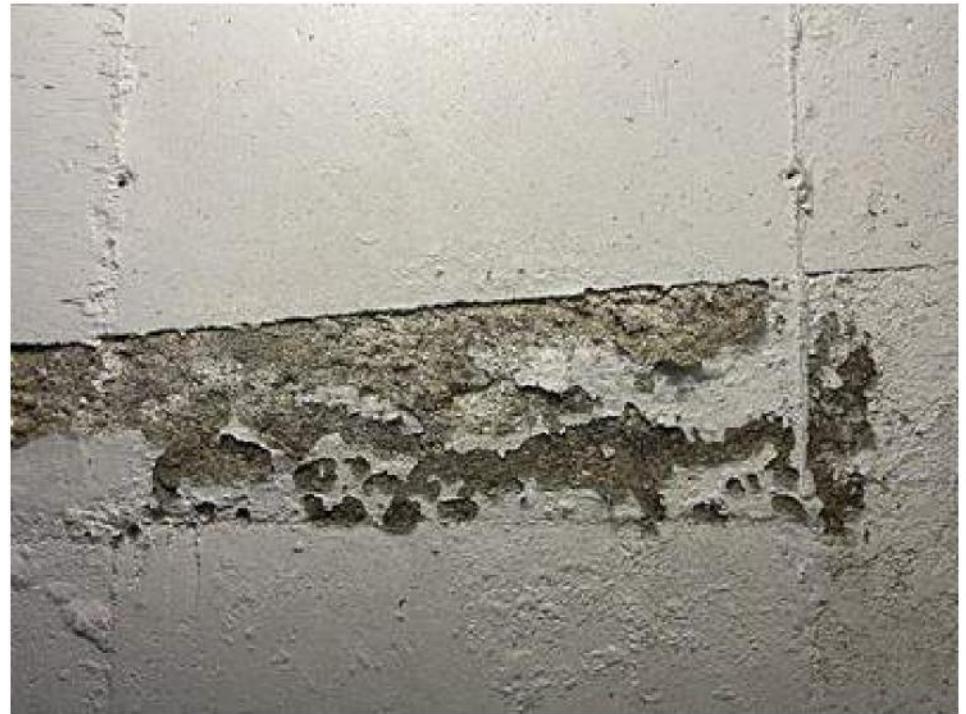
*Efflorescence at basement stair*

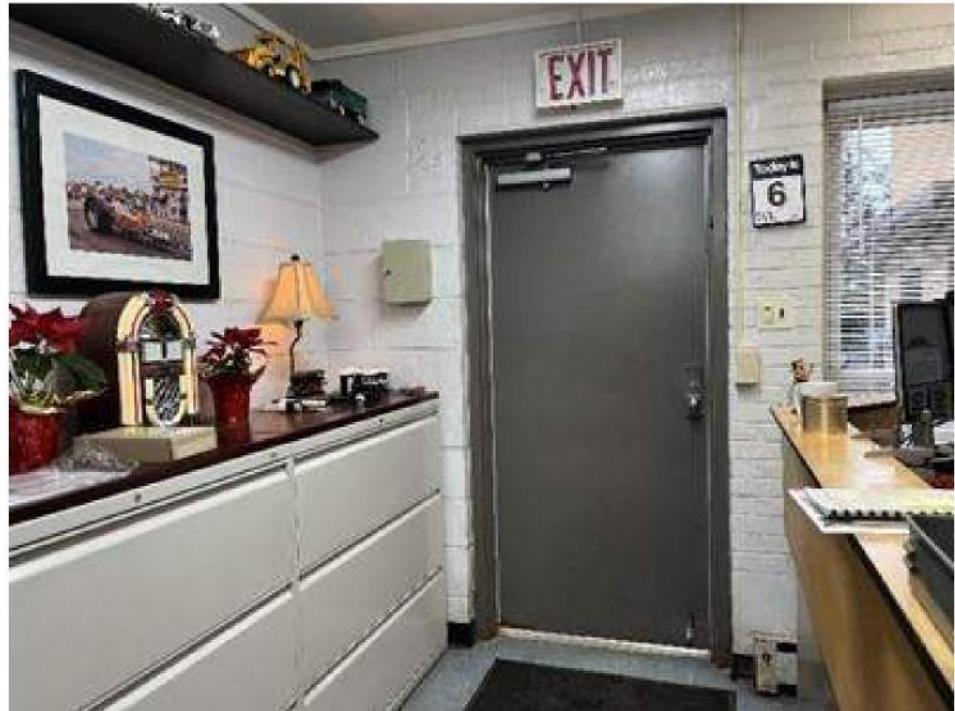
*Inadequate clearances*

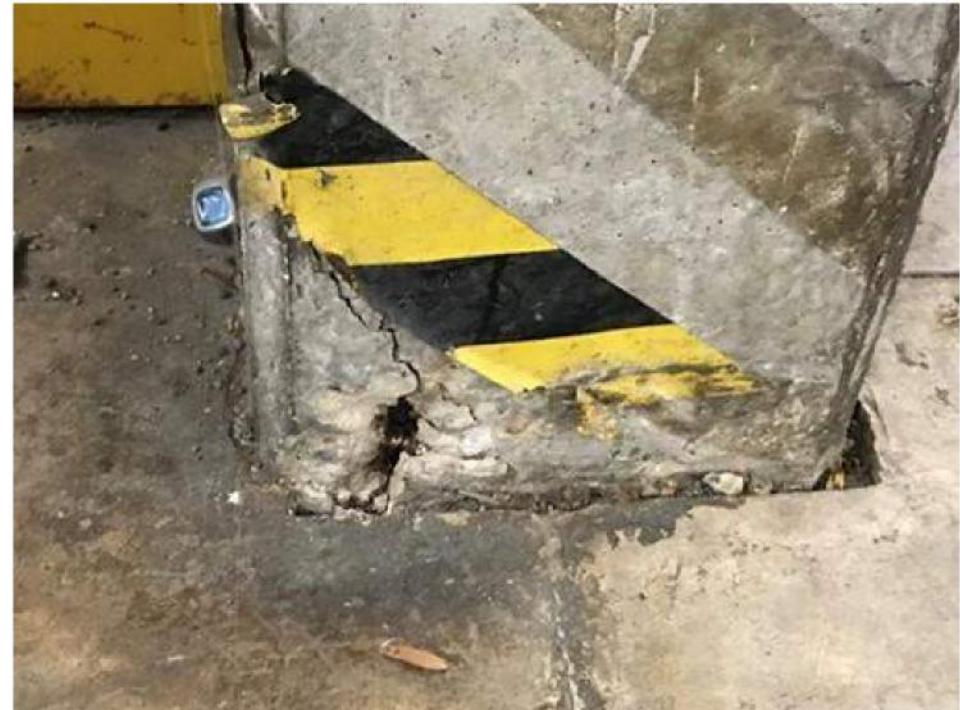
*Column cracking at garage column*

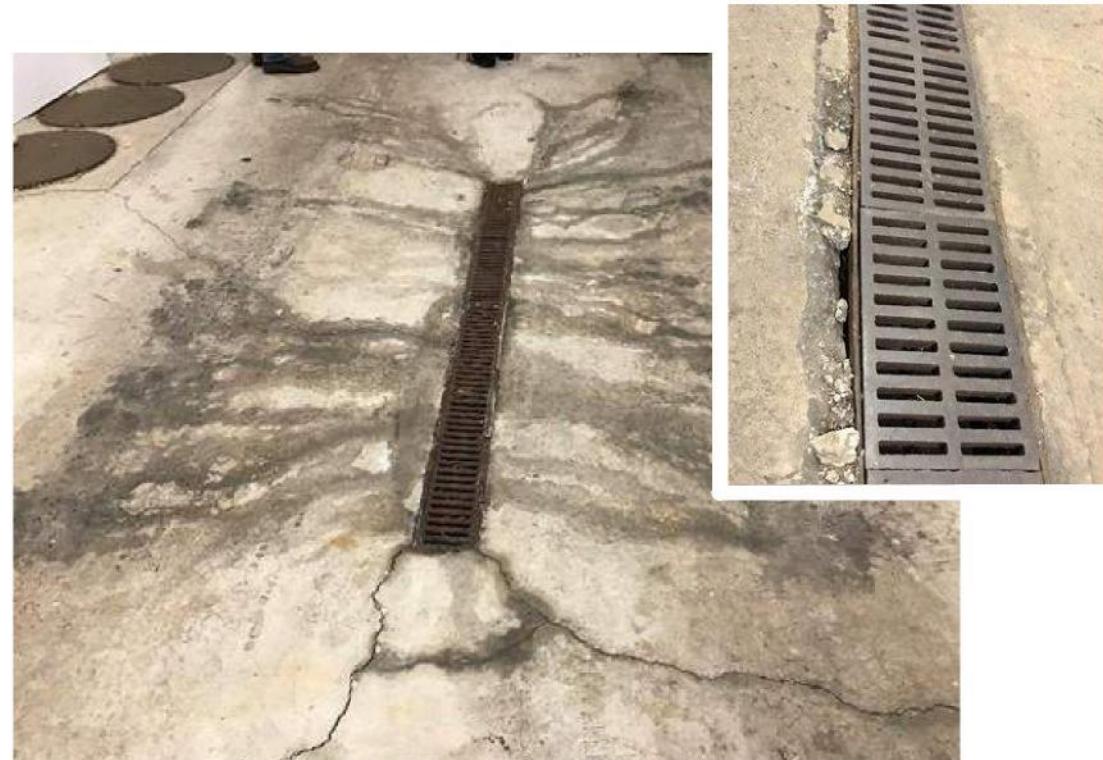
*Concrete cracking at garage trench drain*

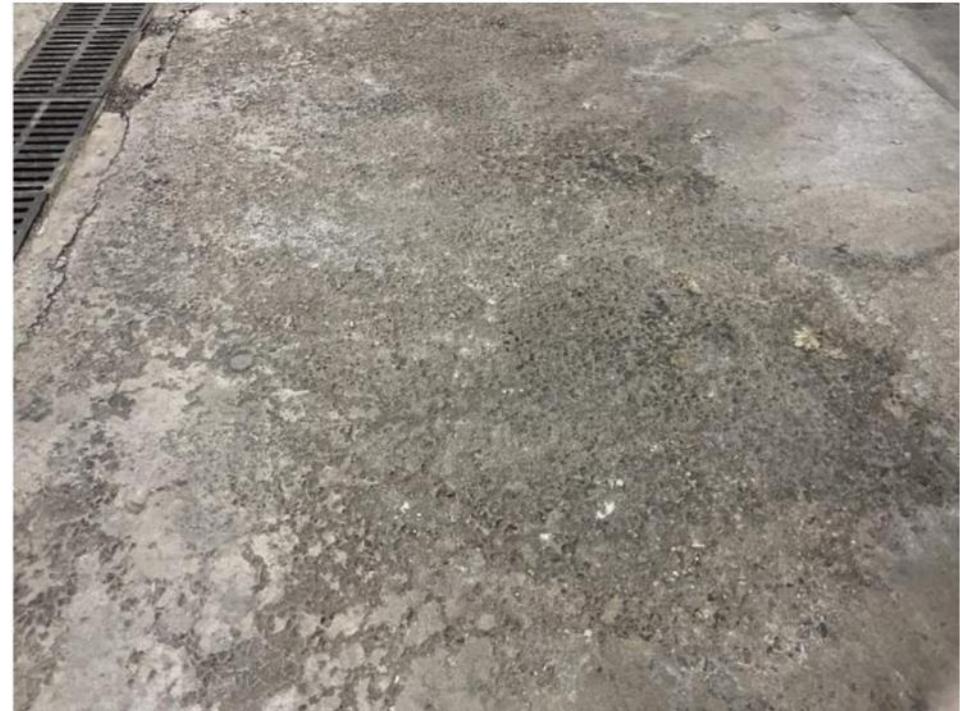
*Deterioration in surface condition of concrete in garage*

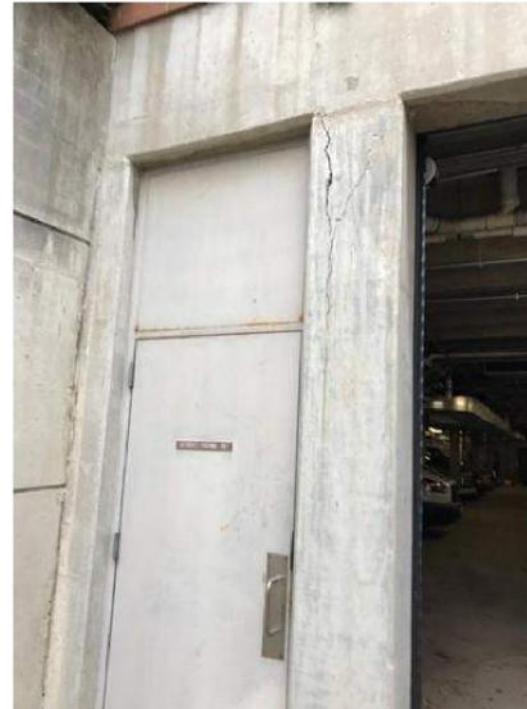
*Column cracking adjacent to garage door*

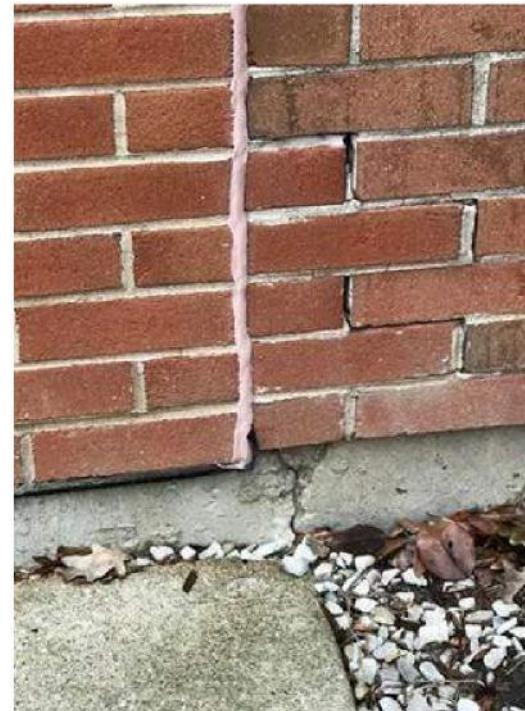
*Foundation cracking at building addition*

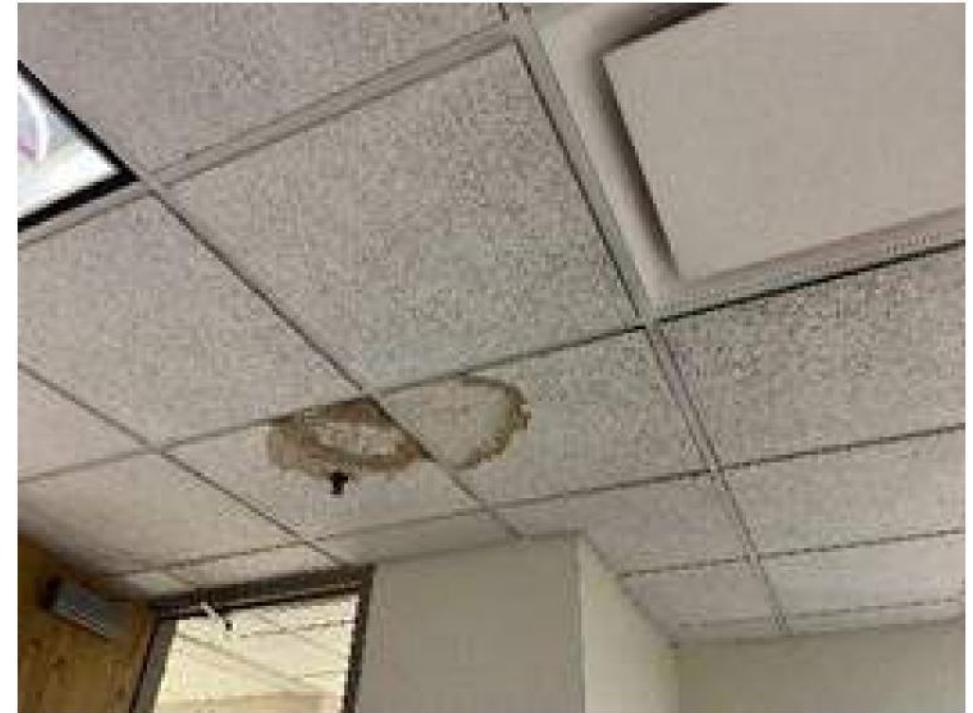
*Discolored ceiling tiles throughout*

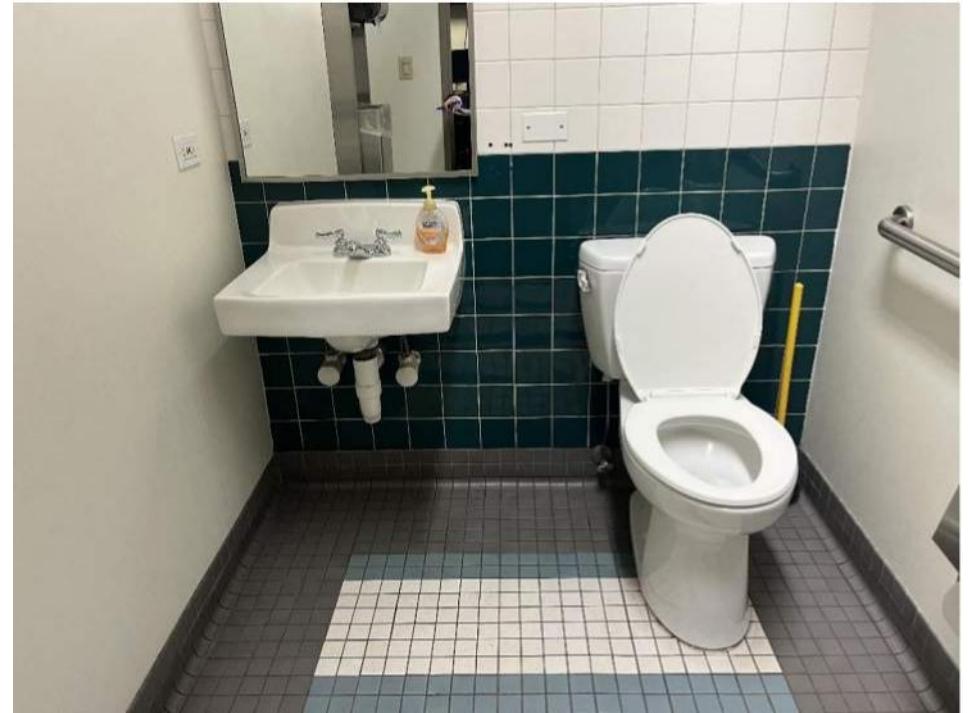
*Single user toilet room*

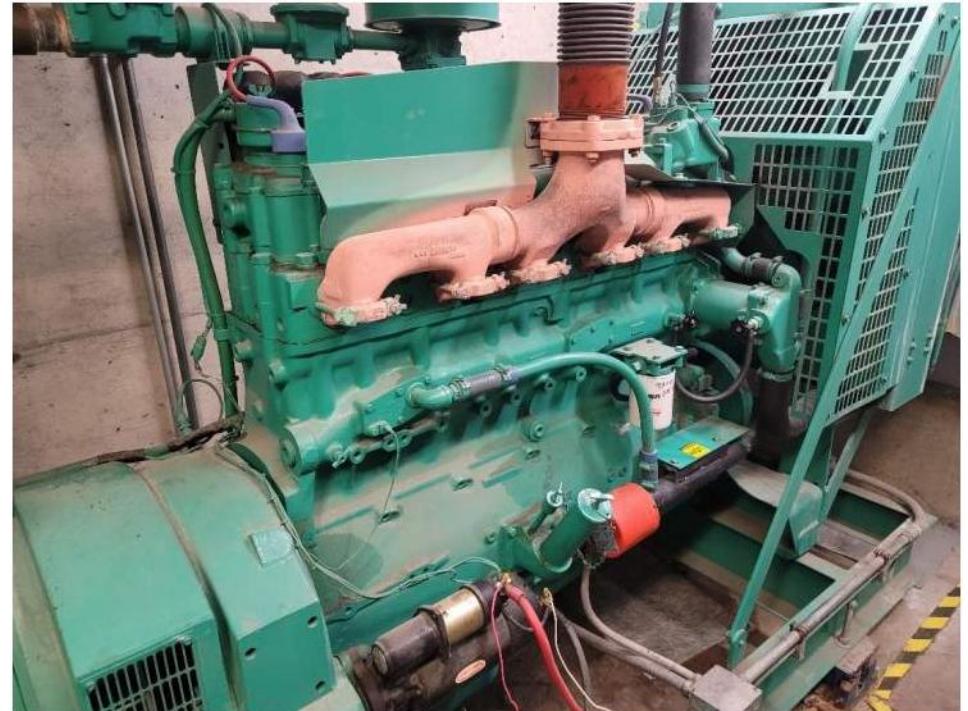
*Older generator set*
