Project 7
Curb Failure along WFNBCR
(Behind 1941 Cherry Lane)

PROJECT 7
CURB FAILURE ALONG WFNBCR
(Behind 1941 Cherry Lane)

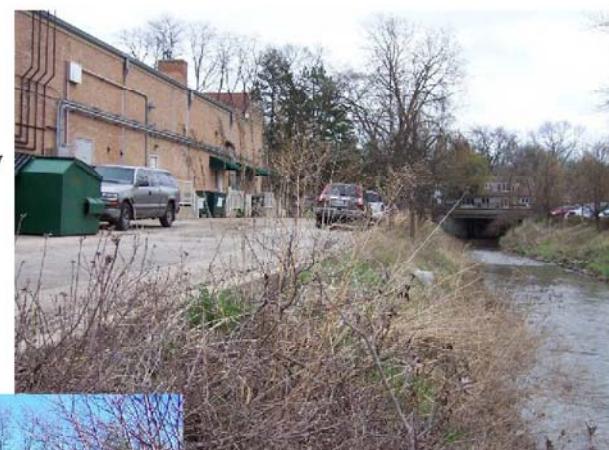
Curb Failure Looking Easterly

Curb and gutter section atop the steep bank of WFNBCR channel behind the shopping center at 1941 Cherry Lane has been settling. Contributing factors include weight of parked vehicles and weakened soil conditions due to saturation during channel flooding and spring thaws.

Pavement and channel bank slope deterioration will continue unless corrective action is taken. Major bank failure would result in restoration and permitting costs

- Remove curb and gutter and replace with extended post guardrail
- Back pitch 2' \pm paved surface slope under guard rail to proposed lateral/slotted drain
- Install pipe underdrain system to intercept ground water and minor surface runoff from proposed lateral/slotted drain
- Stabilize disturbed channel bank areas with erosion control blanket and native plantings
- Discourage truck parking in 200' \pm critical area along channel bank

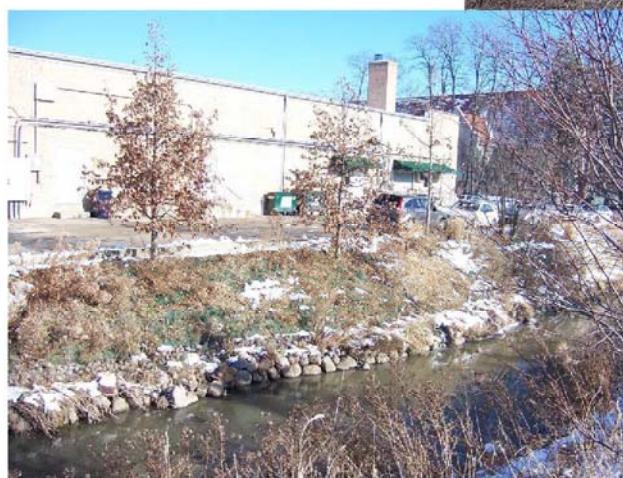
Curb Failure Looking Westerly
