PUBLIC WORKS COMMITTEE

TO: Public Works Committee
FROM: Matt Morrison, Assistant Public Works Director
DATE: January 16, 2019
SUBJECT: Tree Permit Review - 1227 Eastwood Lane

1227 EASTWOOD LANE
JANUARY 22, 2019

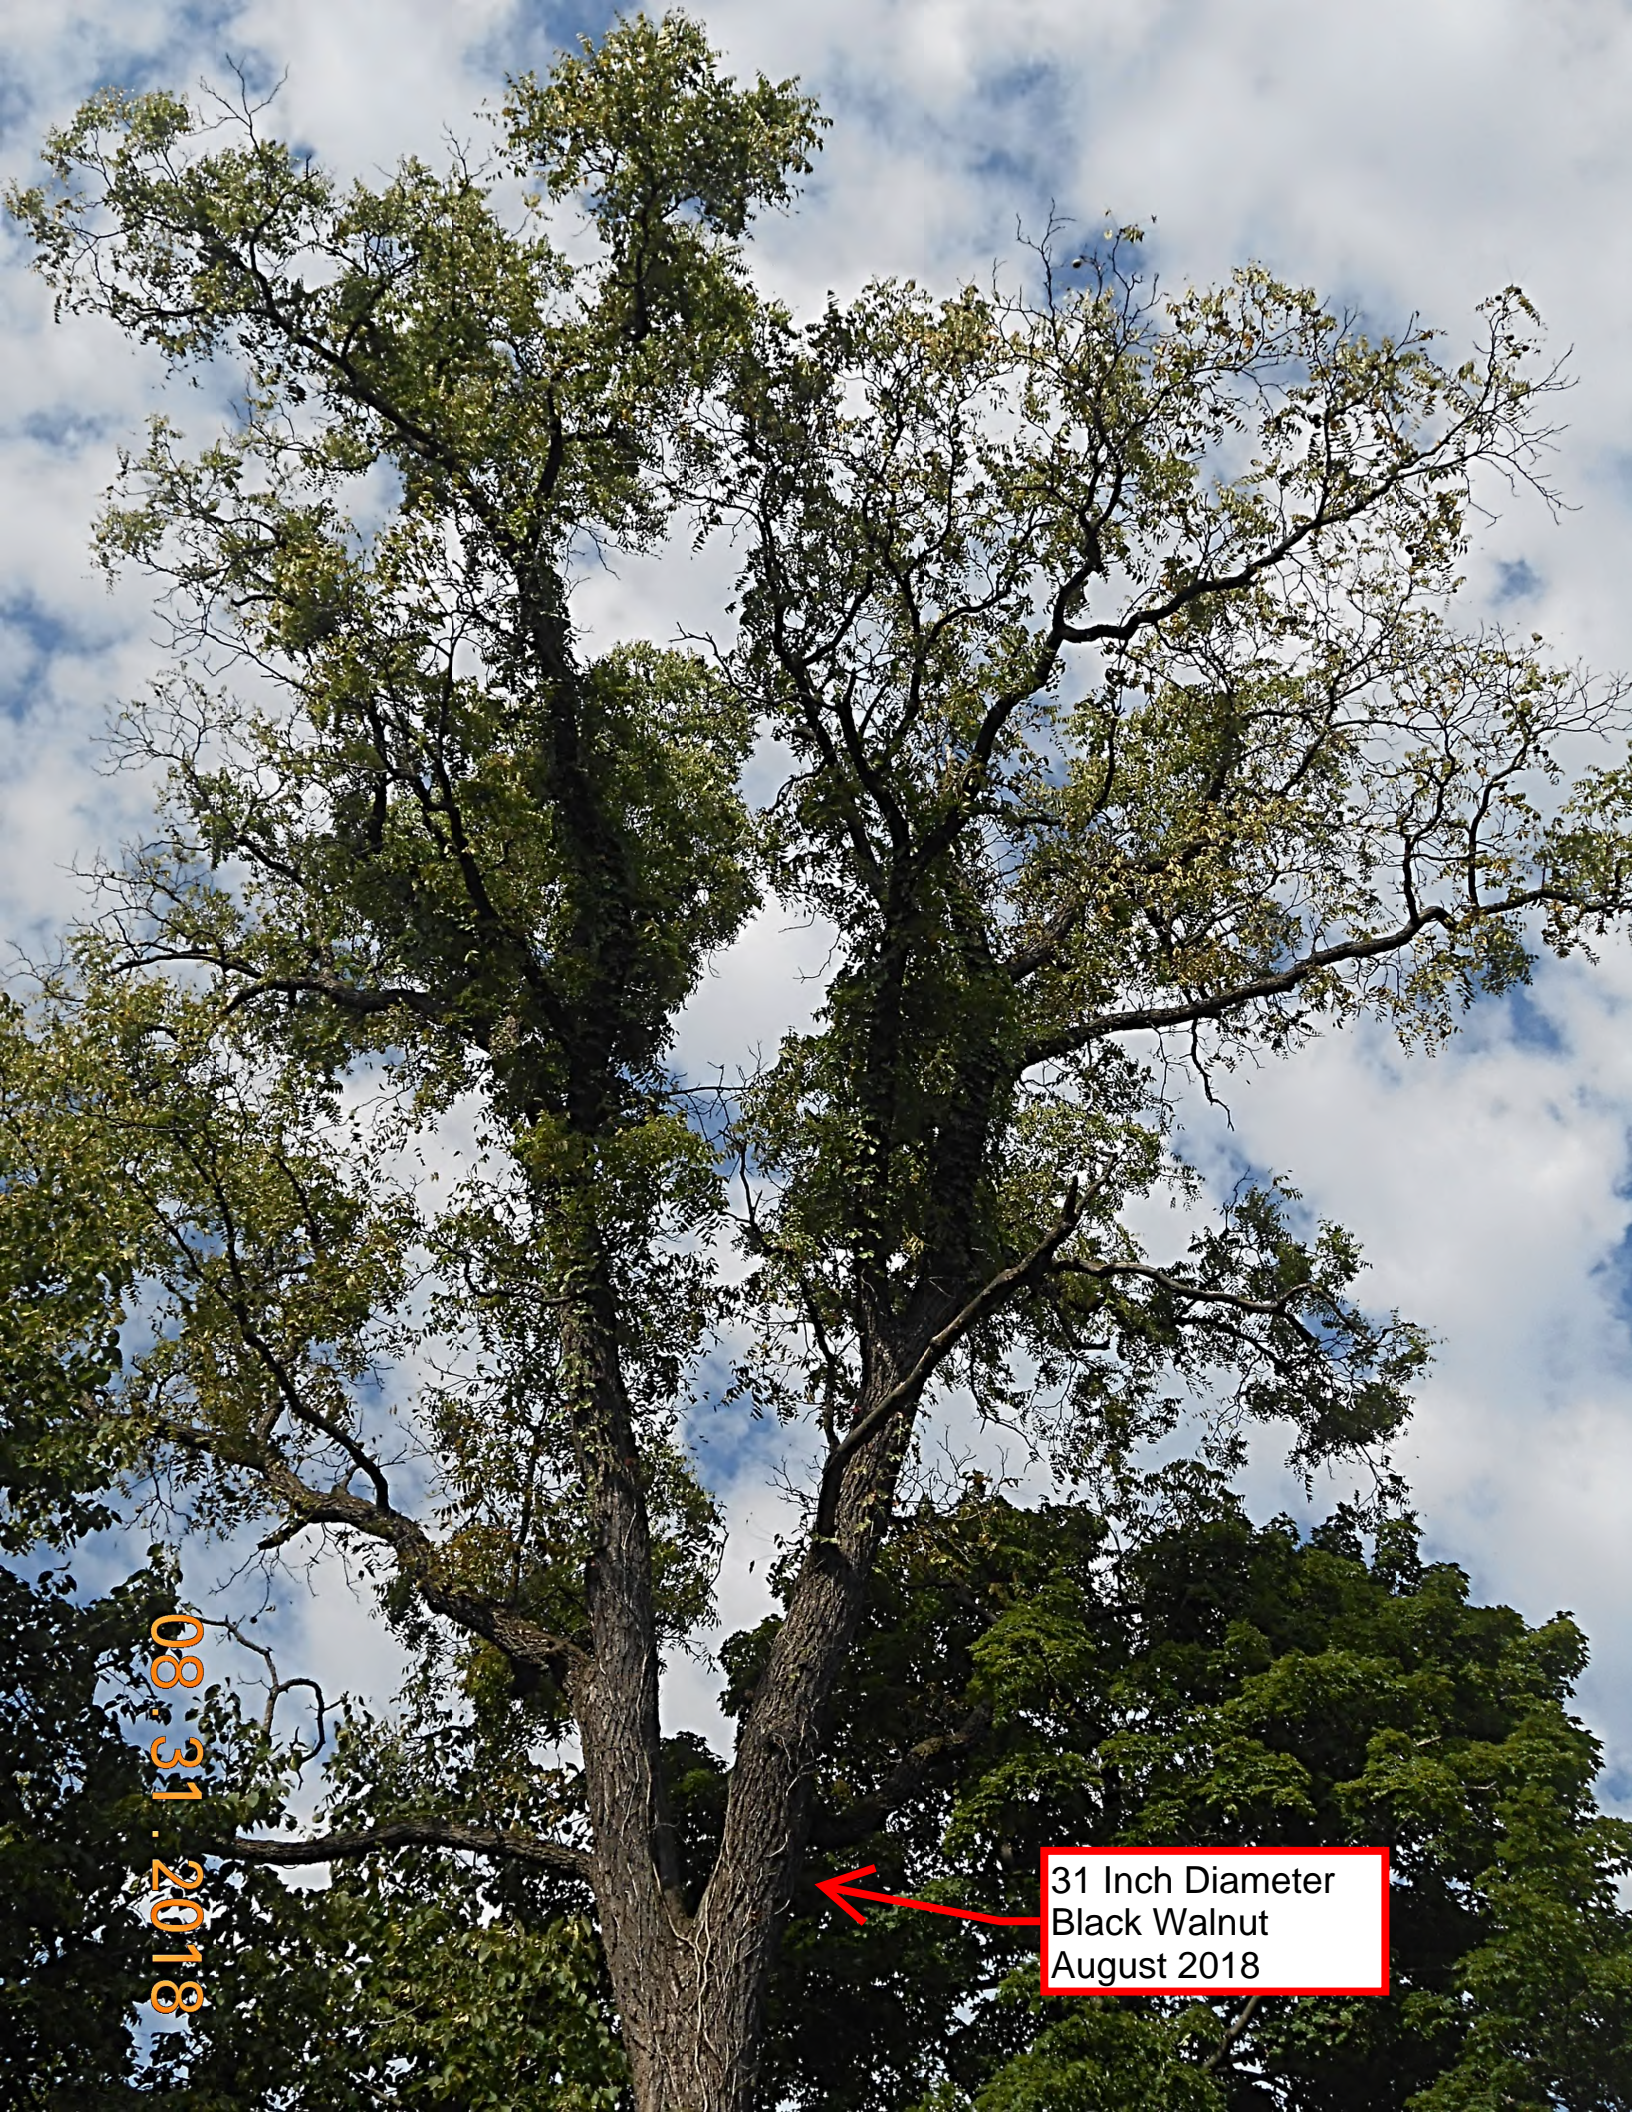
31 Inch Diameter
Black Walnut
October 2018

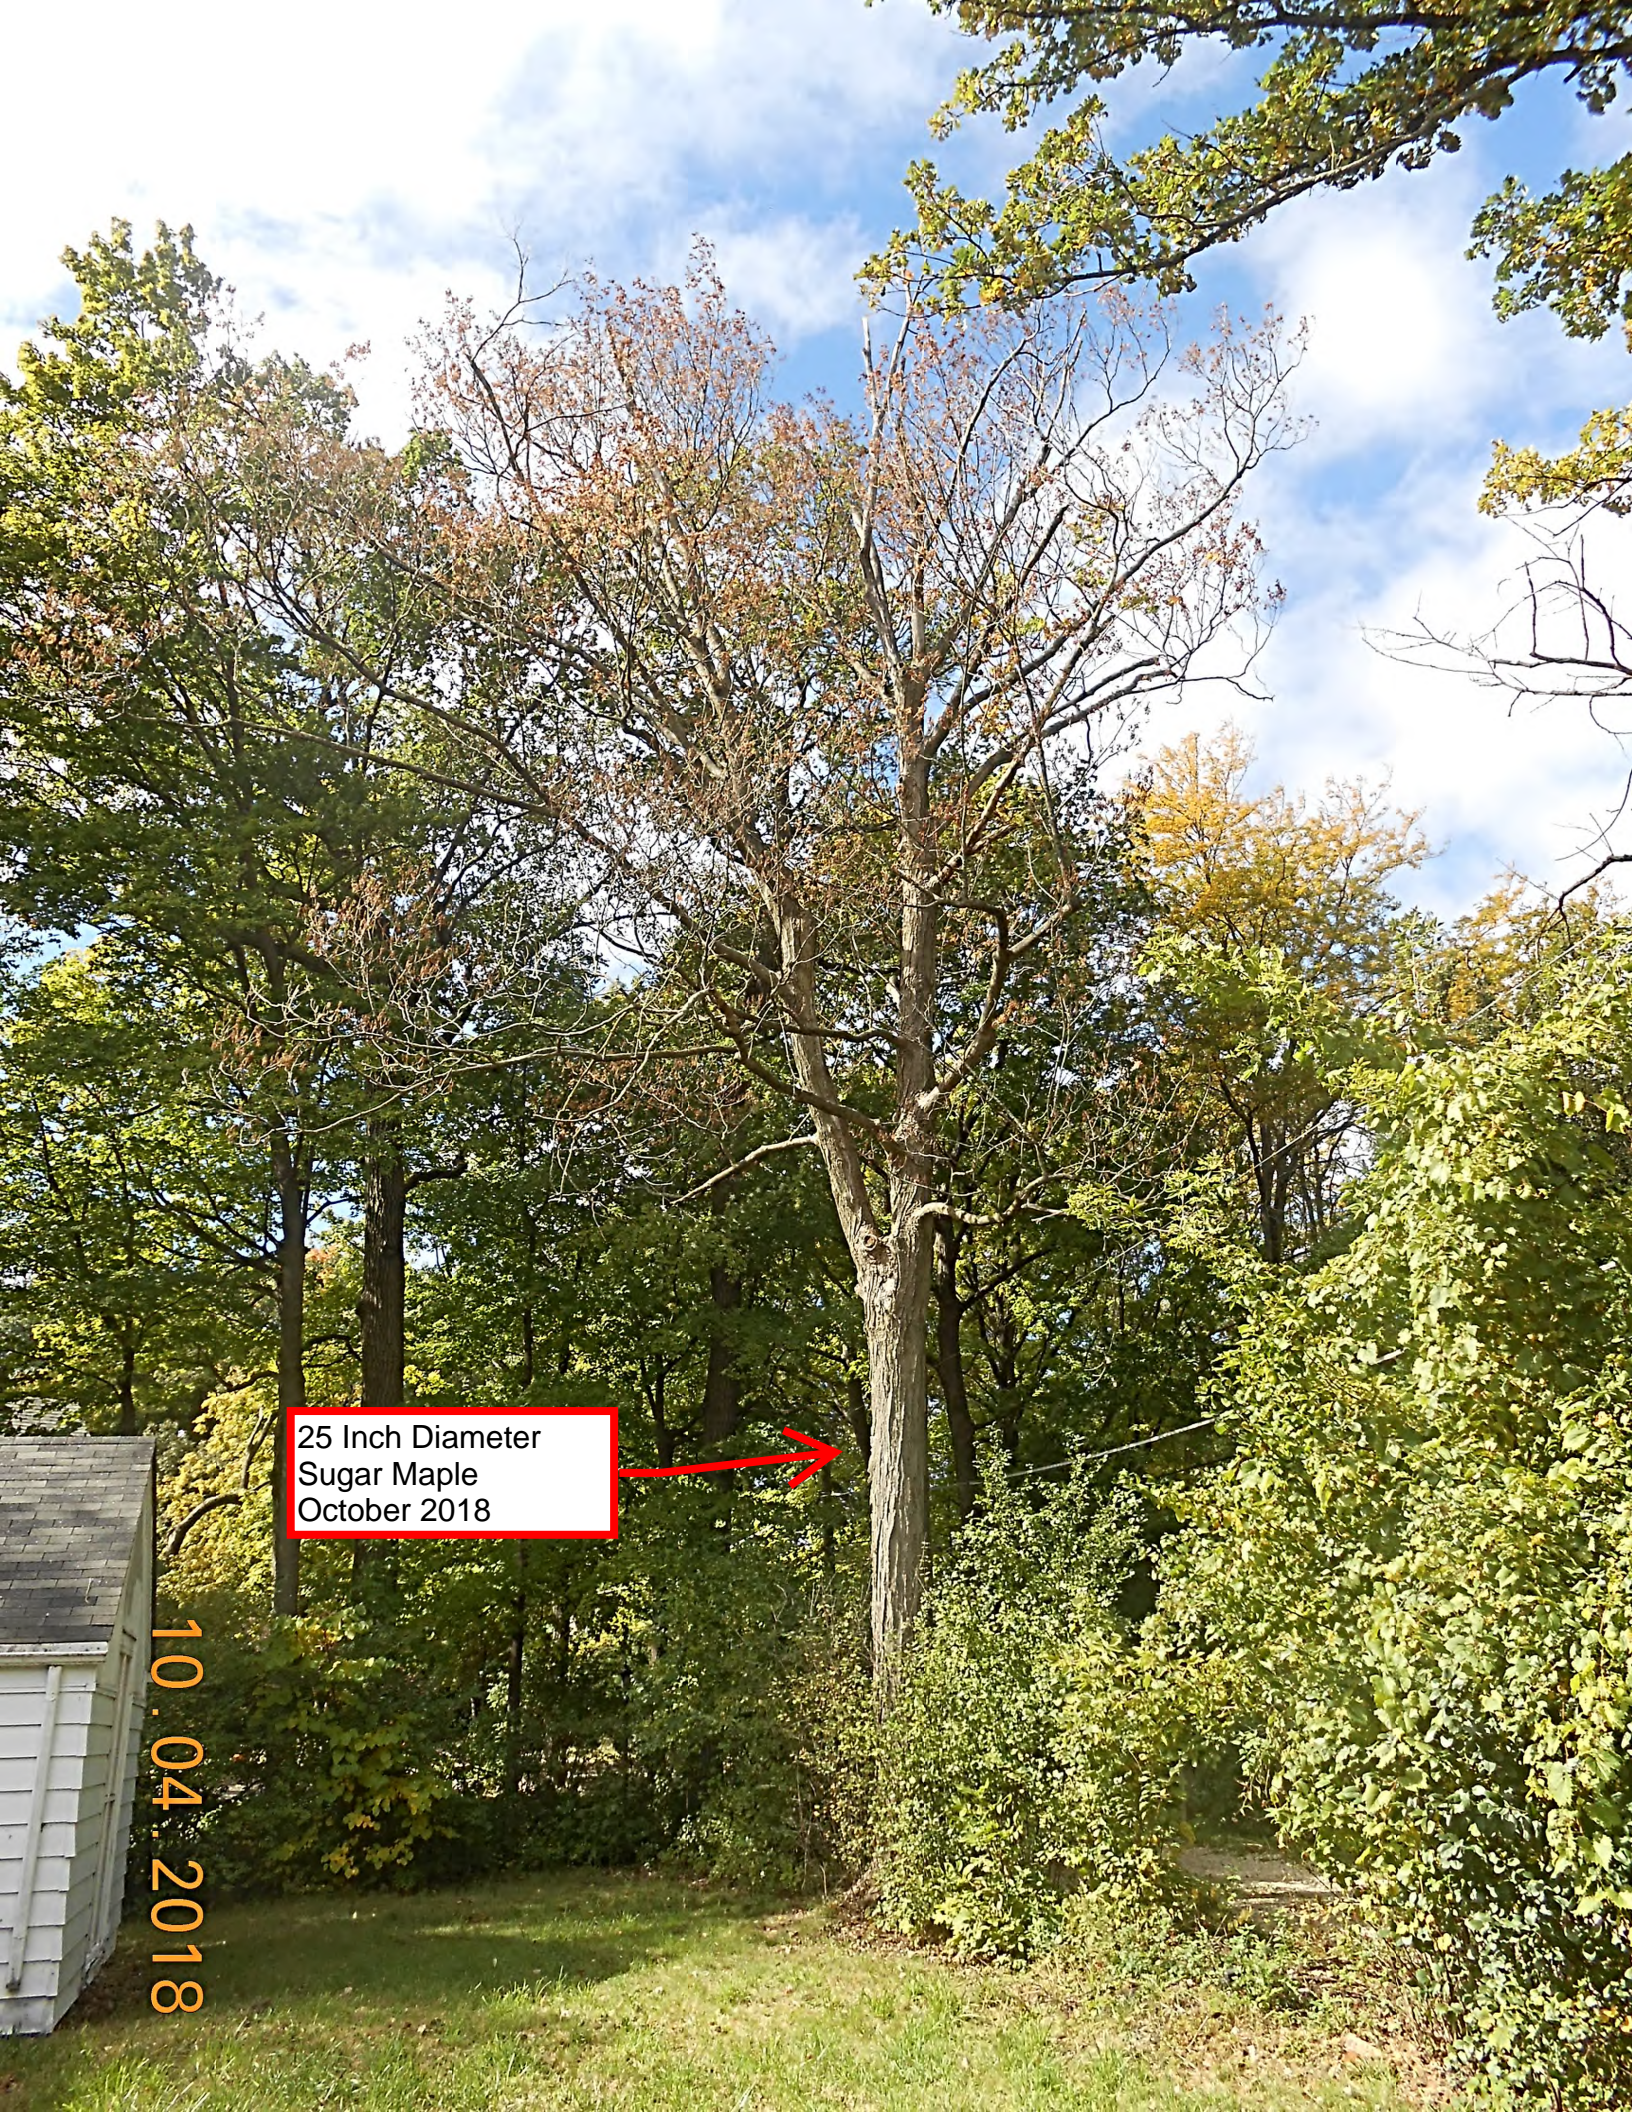
31 Inch Diameter
Black Walnut
August 2018

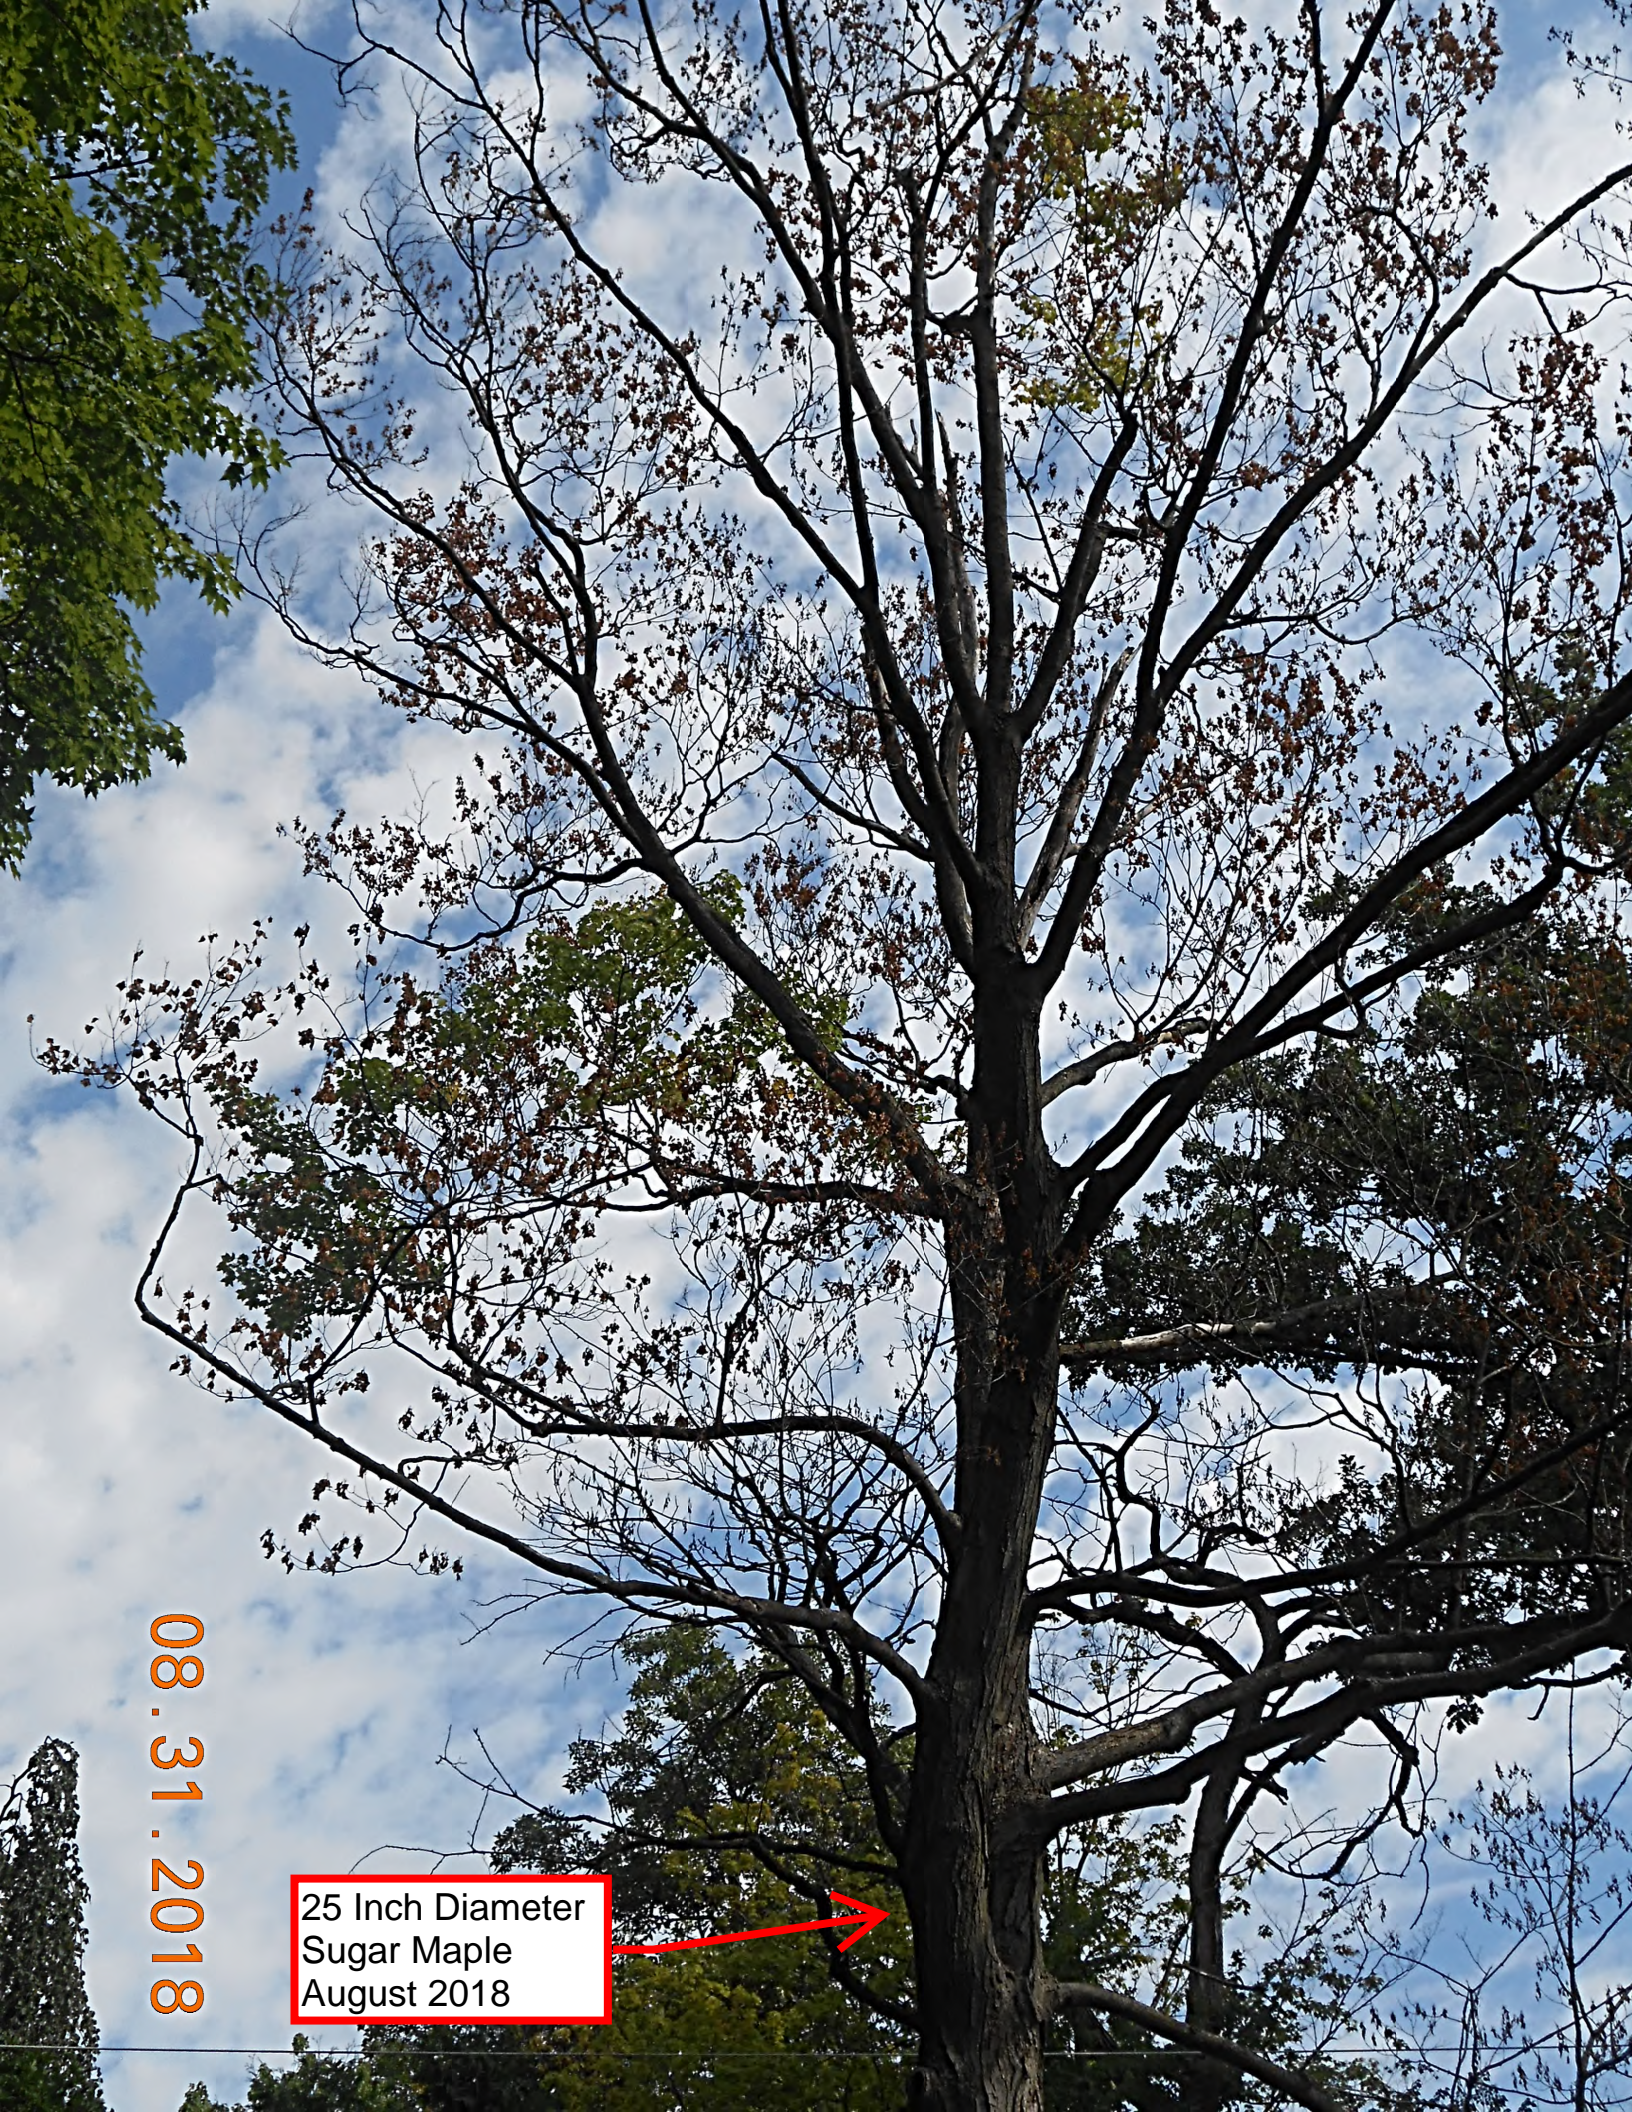
25 Inch Diameter
Sugar Maple
August 2018

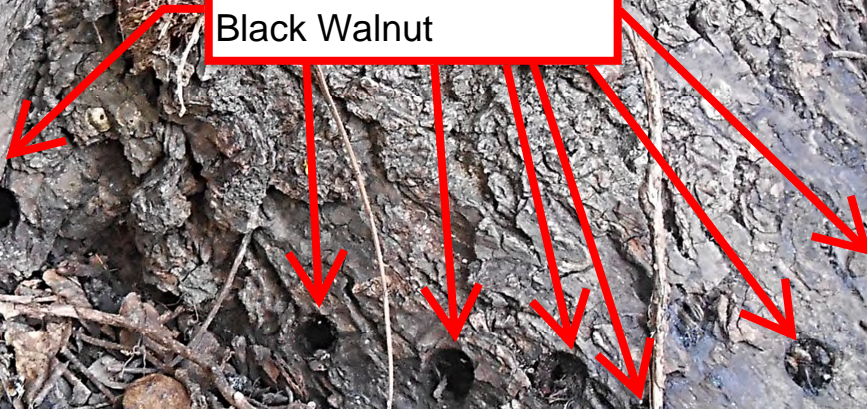
Staff also observed the holes drilled/bored in the bases of the trees that the property owner's arborist noted. These holes were similar to those on the Burr Oak that was removed from the property in the summer of 2018. Staff has observed the holes on the Black Walnut and Maple trees on a number of occasions and is troubled by them. Staff's observations noted a residue weeping from the holes with a

pungent smell. The holes are the width of a standard #2 pencil, and a depth of approximately 1.5". In reviewing the holes that have appeared on the Black Walnut, Sugar Maple and the Burr Oak that was removed from the property last summer, staff is not aware of a boring insect that creates holes of that diameter and depth in trees, leaves a residue on the tree, or that attacks all three species of trees.

Holes Drilled/Bored
Black Walnut

Staff recommends that the Public Works Committee recommend removal of the landmark trees as they are in conflict with the proposed new home and will decline to a point of dying or becoming a hazard as a result of the holes drilled/bored into the base of the trees. Given the nature of the holes drilled/bored into the trees and the residue weeping from them, staff recommends that the full fees of \$8,400 be assessed and not reduced by replanting on the property. Consistent with other landmark and tree removals considered by the Public Works Committee, staff recommends that a condition of tree removals be that the wood from the trees be reused for a purpose other than firewood, mulch, or wood chips and preferably be used in the construction of the new home. Lastly, that the property owner and their contractor should be required to take aggressive measures to preserve all other trees on this and neighboring properties.

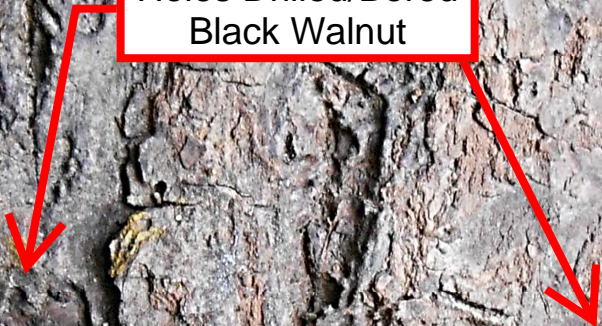
Holes Drilled/Bored
Black Walnut

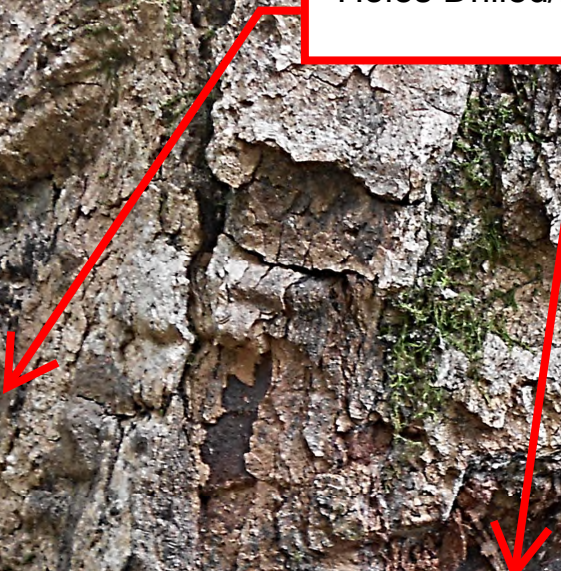
Holes Drilled/Bored and Weeping Residue
Sugar Maple

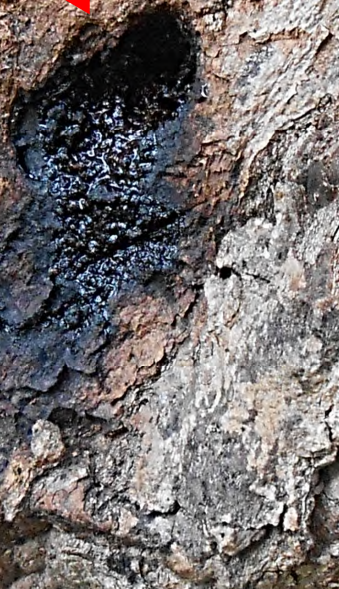
Residue Weeping from Drilled/Bored Hole
Sugar Maple

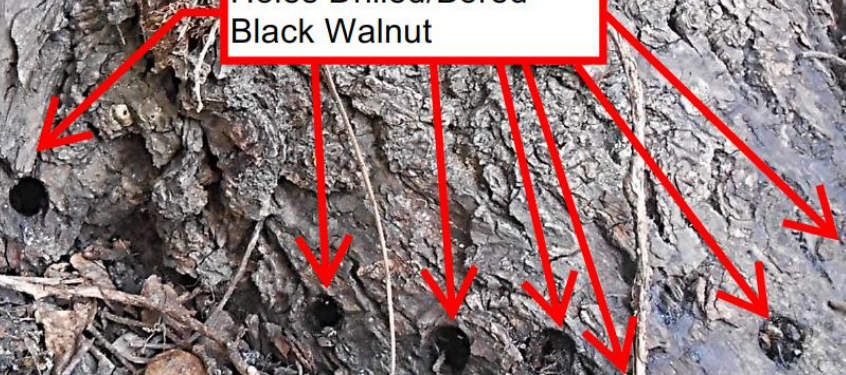
- The property owner's arborist and have staff have observed holes drilled or bored into the base of the Black Walnut and Sugar Maple.
- Similar holes were observed on the base of the Burr Oak removed in the summer of 2018.
- Staff has observed residue weeping from the holes with a pungent smell, holes of a diameter the width of a standard #2 pencil, and a depth of approximately 1.5" deep.
- Staff is not aware of any insect that bores holes of the size or depth witnessed and attacks the three species on the property.

Holes Drilled/Bored
Black Walnut

- Authorize the removal of the landmark Black Walnut and Sugar Maple.
- If the landmark tree removals are approved, staff recommends the following conditions:
 - \$150 per inch DBH for the landmark trees be assessed for the 56 inches of trees being removed.
 - Given the nature of the holes drilled/bored into the base of the tree, staff recommends that the fee for these trees not be eligible for reduction by replanting of trees on the property.
 - The wood from the tree must be milled for a purpose other than firewood, mulch, or wood chips and preferably be used in the construction of the new home.
 - The builder and homeowner must take aggressive measures to preserve all other heritage and landmark trees on the property and those located on adjacent properties
 - The property owner will be subject to any conditions associated with tree permits for the removal of additional trees.

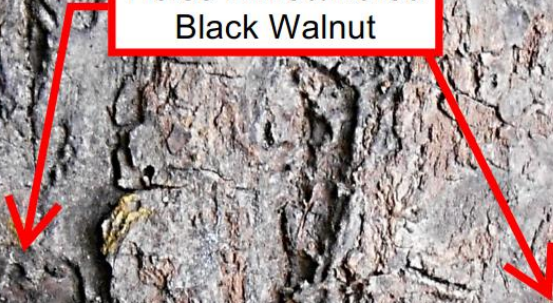
Holes Drilled/Bored
Black Walnut

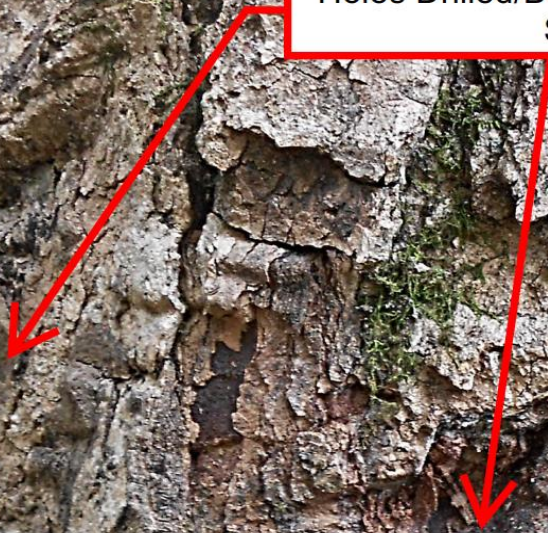
Holes Drilled/Bored and Weeping Residue
Sugar Maple
