# Village of Northbrook

## PUBLIC WORKS COMMITTEE

**TO:** Public Works Committee  
**FROM:** Matt Morrison, Assistant Public Works Director  
**DATE:** January 16, 2019  
**SUBJECT:** Tree Permit Review - 1227 Eastwood Lane

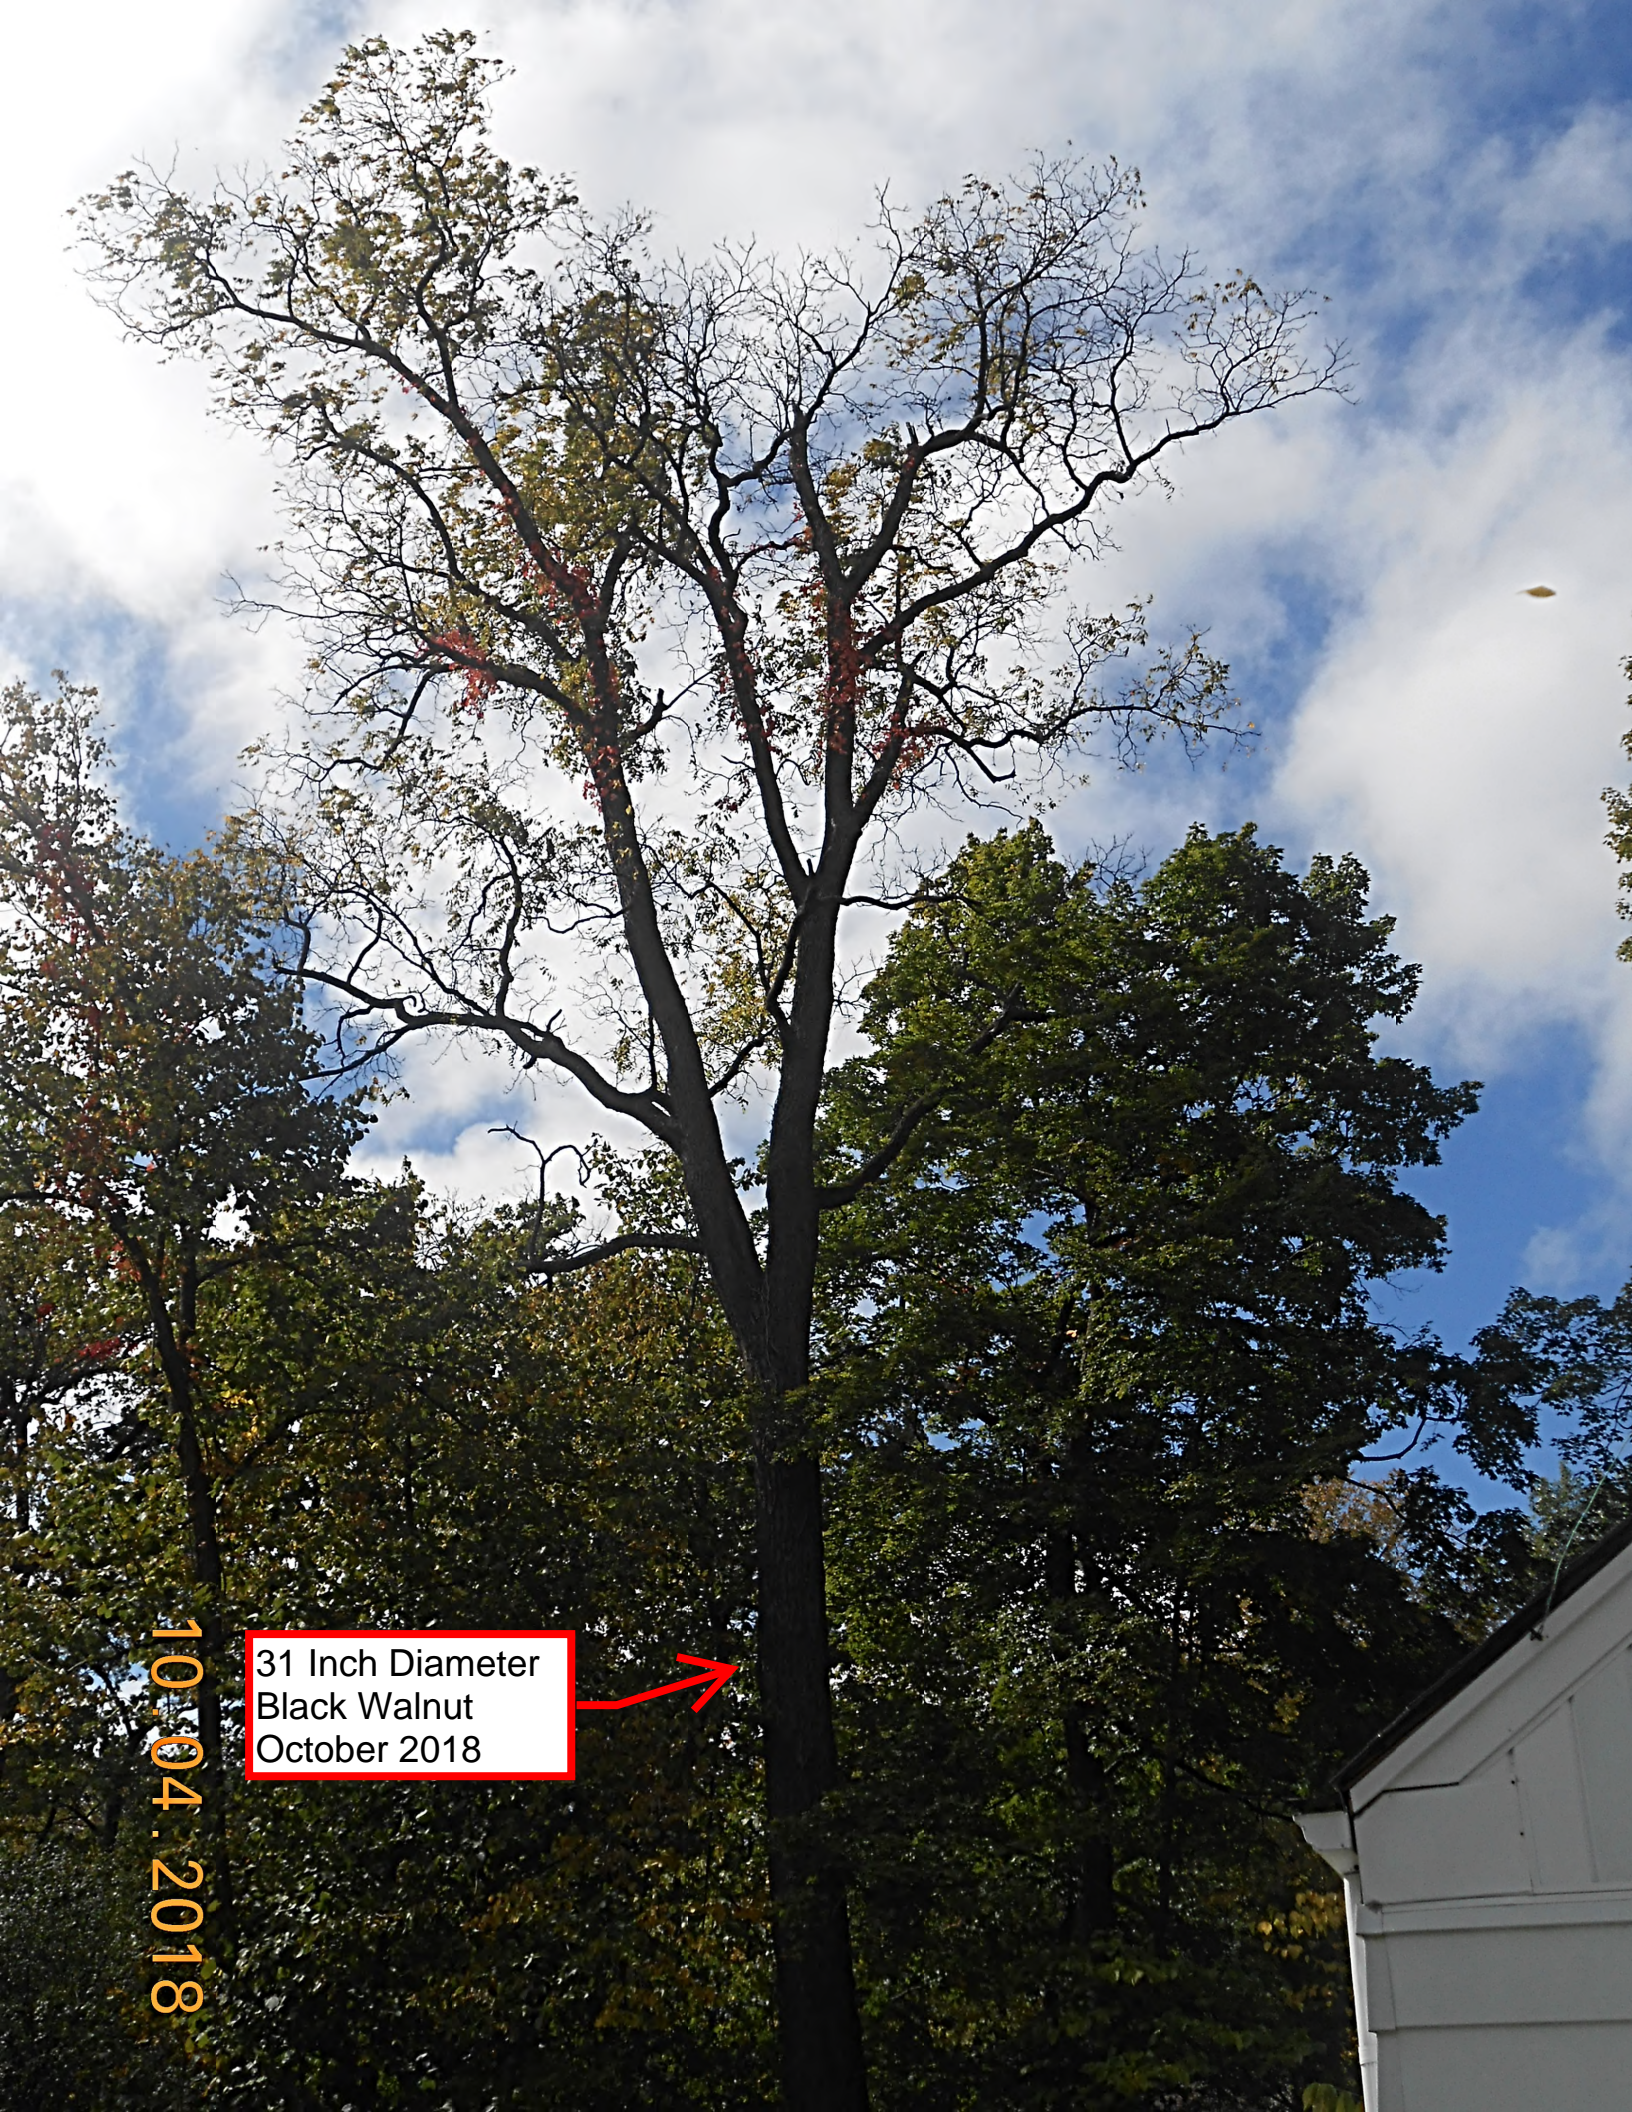
31 Inch Diameter  
Black Walnut  
October 2018

TRUNK APPEARS IN GOOD CONDITION  
VERY GOOD CANDIDATE FOR BOARD LUMBER

LOWER TRUNK & BASE HOLES WERE FOUND  
(NOT MANY) FURTHER ANALYSIS WOULD  
BE REQUIRED TO DETERMINE ORIGIN  
OF HOLES (INJECTION OR INSECTS)

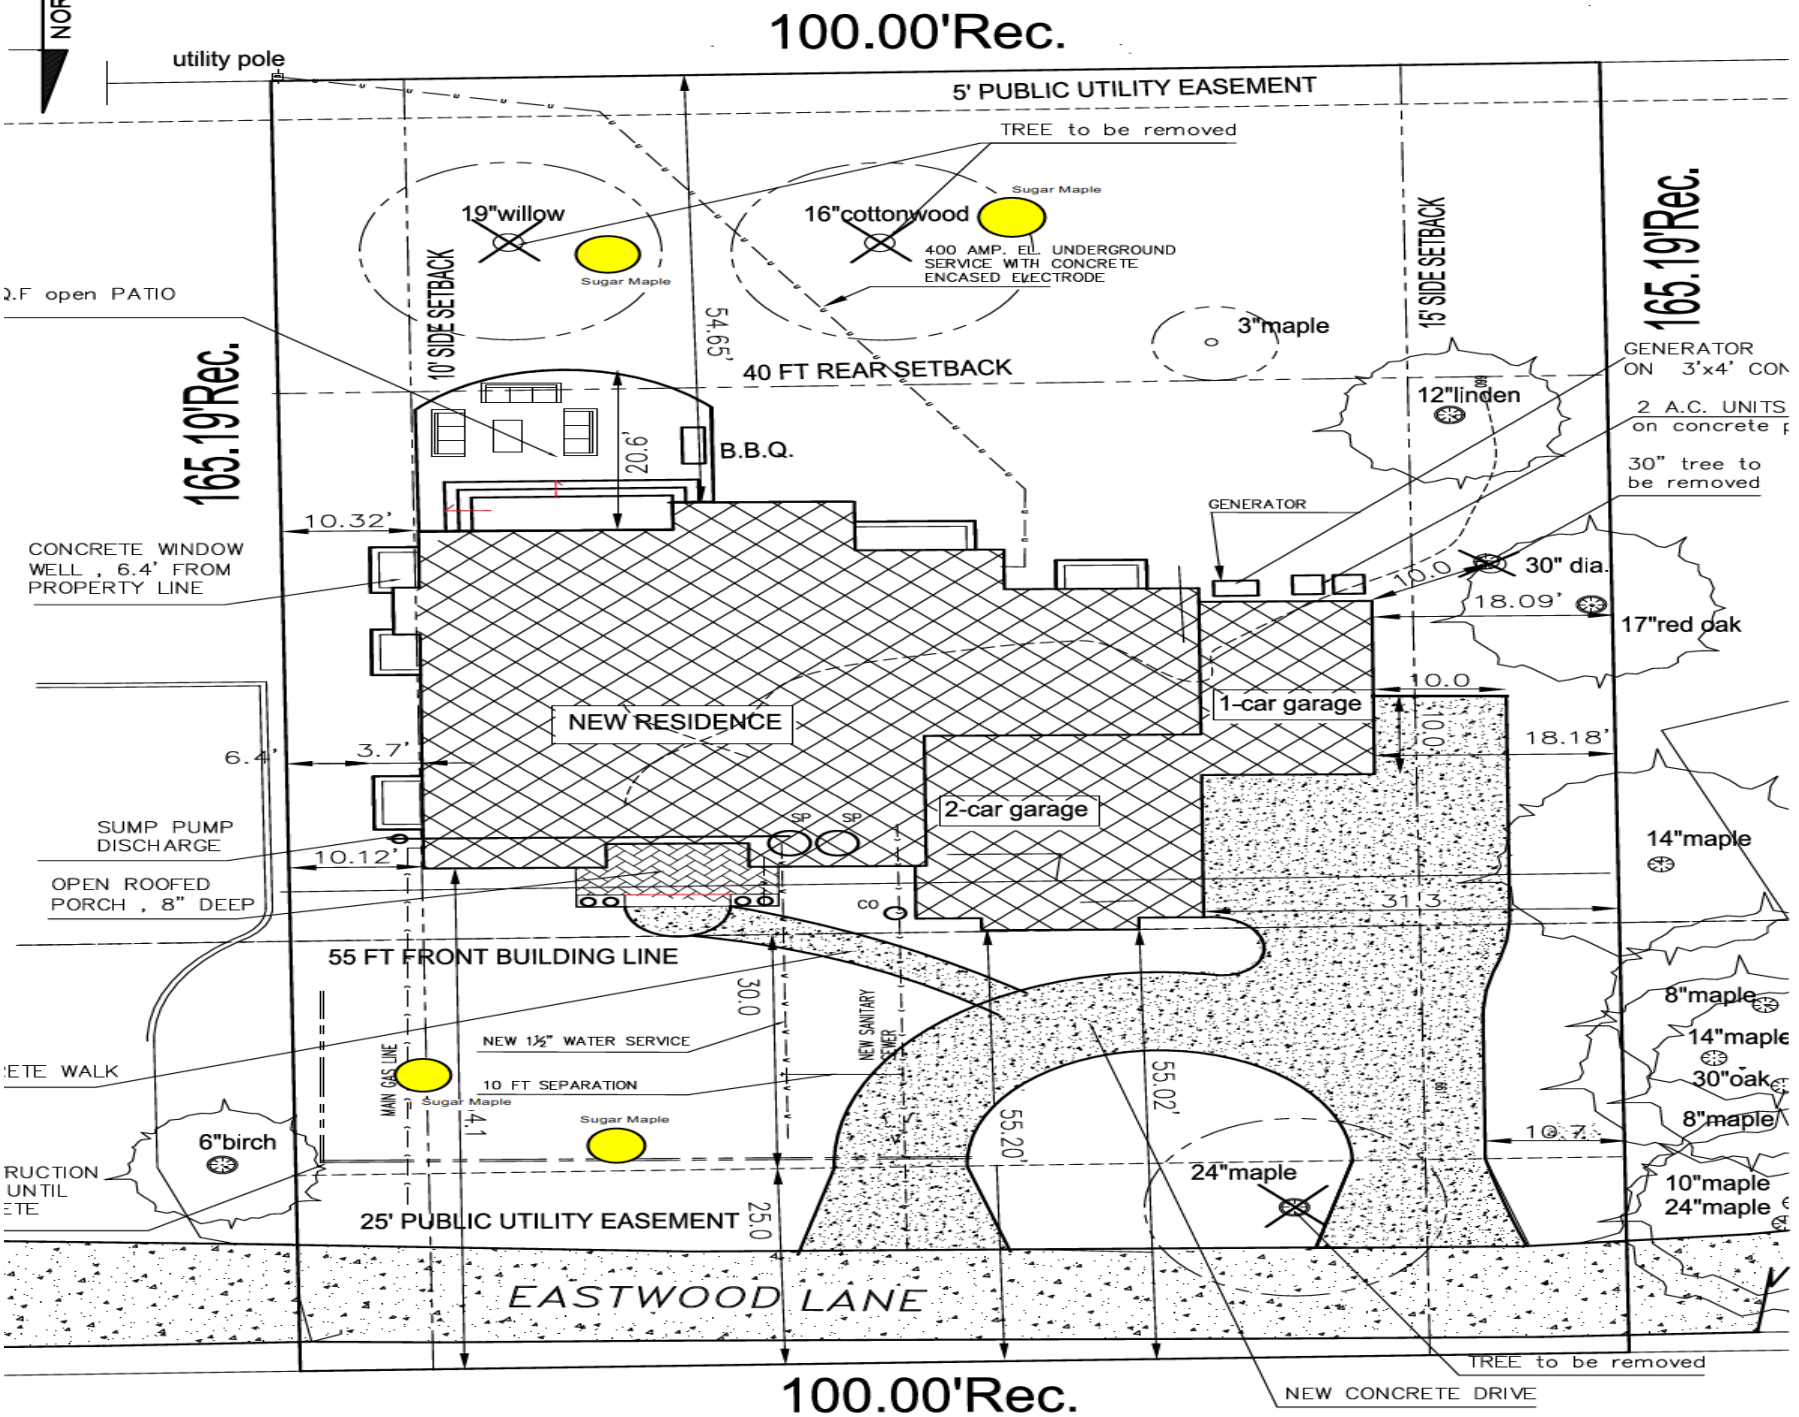
- Staff does not disagree with the property owner's arborists ratings of the trees.
- The Black Walnut is in conflict with the construction of the new home's garage while the Sugar Maple is in conflict with the proposed circular driveway.
- The property owner has indicated they intend to replant 12 inches of trees on the property.

- Authorize the removal of the landmark Black Walnut and Sugar Maple.
- If the landmark tree removals are approved, staff recommends the following conditions:
  - \$150 per inch DBH for the landmark trees be assessed for the 56 inches of trees being removed.
  - Given the nature of the holes drilled/bored into the base of the tree, staff recommends that the fee for these trees not be eligible for reduction by replanting of trees on the property.
  - The wood from the tree must be milled for a purpose other than firewood, mulch, or wood chips and preferably be used in the construction of the new home.
  - The builder and homeowner must take aggressive measures to preserve all other heritage and landmark trees on the property and those located on adjacent properties
  - The property owner will be subject to any conditions associated with tree permits for the removal of additional trees.
