Environmental Land Use Control

**1657 SHERMER ROAD
NORTHBROOK, ILLINOIS**

**OCTOBER 26, 2010
PROJECT #2010 – 4109 IAQ**

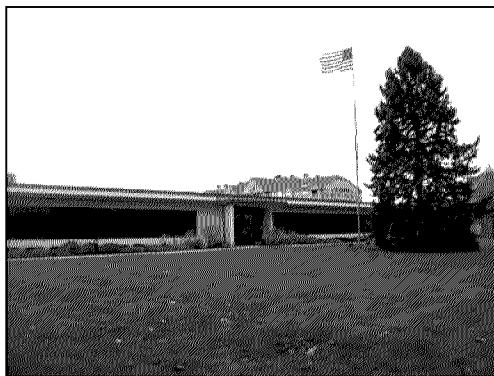
Photograph 1

The Northbrook Grainger facility is a single-story steel-framed, brick building that was constructed in 1947 (Photograph 1). Additions to the building were constructed in 1959, 1972, and 2006. The most recent renovation activities consisted of converting approximately 47,000 square feet of warehouse space into an office area. The total square footage of the Grainger facility is approximately 182,093 square feet, with the office area comprising approximately 86,949 square feet and the warehouse comprising 95,144 square feet.

Hygieneering did not observe any obvious structural problems, or evidence of moisture infiltration inside or outside of the building. There was no evidence of significant roof leaks or moisture problems in the building (refer to the Building Interior Visual Assessment Section of the report for a detailed description).

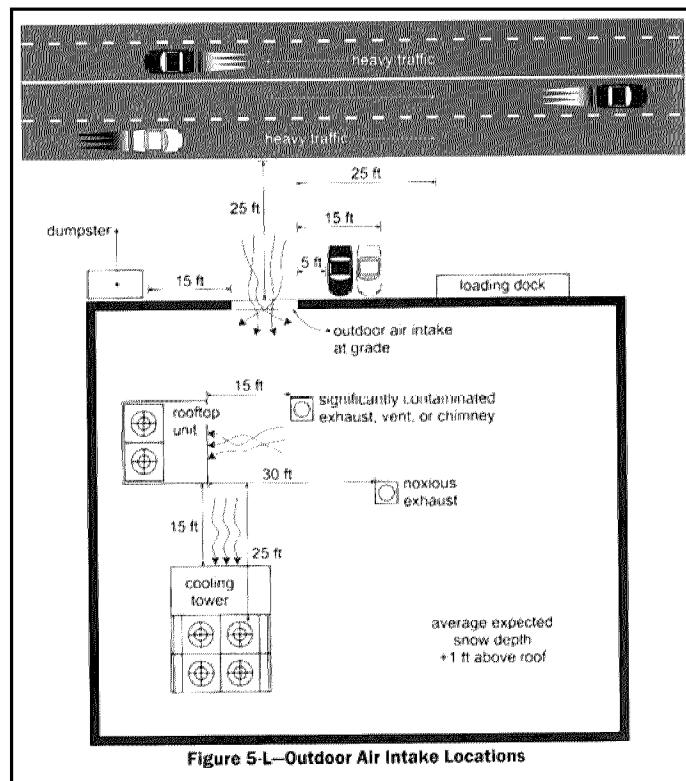
A review of the exterior of the building was conducted with respect to the guidelines set forth in ASHRAE 62.1-2004 for potential exterior contaminant sources as shown below in Figure 1. This figure reviews the acceptable distances for various pollutant sources from the air intakes.

Figure 1 – (taken from ASHRAE 62.1-2004 User Manual)

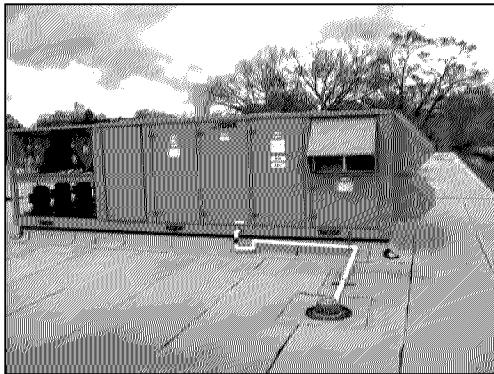
Photograph 4

RTU-1's air intake location was free of potential pollutant sources (Photograph 4). The pest screen was in place and intact (Photograph 5). The unit's dampers were clean with no significant dust/dirt accumulation (Photograph 6). The unit's pleated filters were lightly loaded (Photograph 7). The unit's cooling coils and condensate pan were clean with no significant dust/dirt buildup and no bioaccumulation was noted (Photographs 8 and 9, respectively). The condensate drain line was intact and well connected to the exterior drainpipe. The condensate drain line is attached to an extension PVC pipe, which drains into a roof drain. The roof drain was free from debris buildup. The supply fan was also in good condition with no significant dirt accumulation.

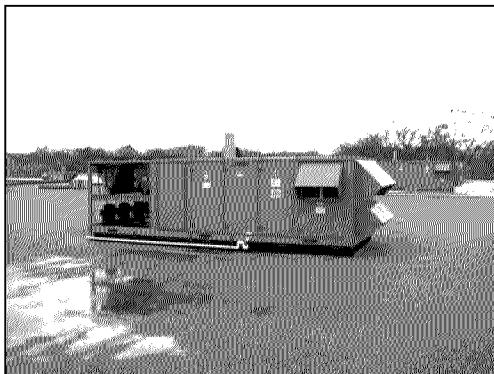
Photograph 10

RTU-3's air intake location was free of potential pollutant sources (Photograph 10). The pest screen was in place and intact (Photograph 11). The unit's dampers were clean with no significant dust/dirt accumulation. The unit's pleated filters were lightly loaded (Photograph 12). The unit's cooling coils and condensate pan were clean with no significant dust/dirt buildup and no bioaccumulation was noted (Photographs 13). The condensate drain line was intact and well connected to the exterior drainpipe. The condensate drain line is attached to an extension PVC pipe, which drains into a roof drain (Photograph 14). The roof drain was free from debris buildup. The supply fan was also in good condition with no significant dirt accumulation (Photograph 15).

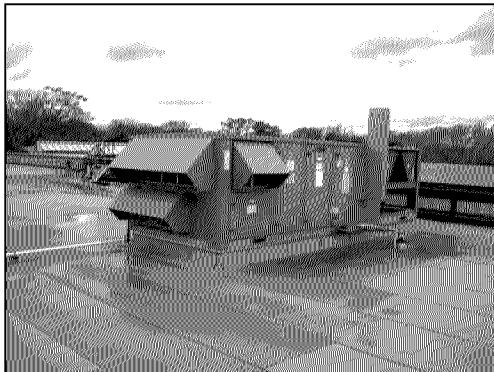
Photograph 16

RTU-5's air intake location was free of potential pollutant sources (Photograph 16). The pest screen was in place and intact. The unit's dampers were clean with no significant dust/dirt accumulation. The unit's pleated filters were lightly loaded (Photograph 17). The unit's cooling coils and condensate pan were clean with no significant dust/dirt buildup and no bioaccumulation was noted (Photographs 18 and 19, respectively). The condensate drain line was intact and well connected to the exterior drainpipe. The condensate drain line is attached to an extension PVC pipe, which drains into a roof drain (Photograph 20). The roof drain was free from debris buildup. The supply fan was also in good condition with no significant dirt accumulation.

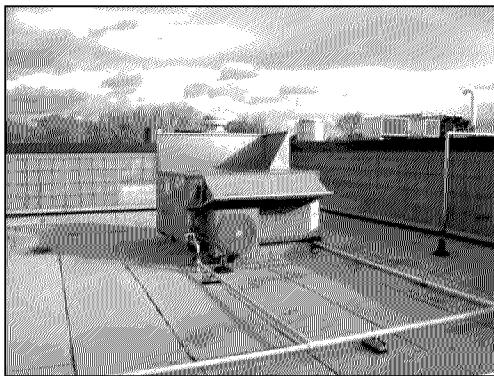
Photograph 21

RTU-7's air intake location was free of potential pollutant sources (Photograph 21). The pest screen was in place and intact. The unit's dampers were clean with no significant dust/dirt accumulation. The unit's pleated filters were lightly loaded and appeared to have minor water staining present (Photograph 22). The unit's cooling coils and condensate pan were clean with no significant dust/dirt buildup and no bioaccumulation was noted (Photographs 23). The condensate drain line was not properly connected to the extension PVC pipe and appeared to have leaf build-up present within the drain (Photograph 24). The condensate drain line is attached to an extension PVC pipe, which drains into a roof drain. The roof drain was free from debris buildup. The supply fan was not accessible during the time of the assessment.

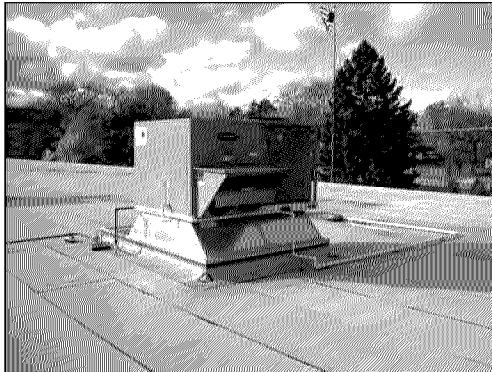
Photograph 25

RTU-8's air intake location was free of potential pollutant sources (Photograph 25). The pest screen was in place and intact. The unit's dampers were clean with no significant dust/dirt accumulation. The unit's box filters were lightly loaded (Photograph 26). The unit's cooling coils and condensate pan were clean with no significant dust/dirt buildup and no bioaccumulation was noted (Photographs 27). The condensate drain line was intact and well connected to the exterior drainpipe. The condensate drain line is attached to an extension PVC pipe, which drains into a roof drain (Photograph 28). The roof drain was free from debris buildup. The supply fan was inaccessible during the time of the assessment.

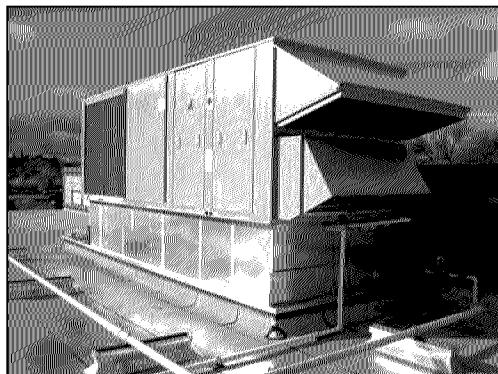
Photograph 29

RTU-11's air intake location was free of potential pollutant sources (Photograph 29). The pest screen was in place and intact (Photograph 30). The unit's dampers were clean with no significant dust/dirt accumulation. The unit's pleated filters were lightly loaded (Photograph 31). The unit's cooling coils and condensate pan were clean with no significant dust/dirt buildup and no bioaccumulation was noted (Photographs 32 and 33, respectively). The condensate drain line was intact and well connected to the exterior drainpipe. The condensate drain line is attached to an extension PVC pipe, which drains into a roof drain (Photograph 34). The roof drain was free from debris buildup. The supply fan was also in good condition with no significant dirt accumulation.

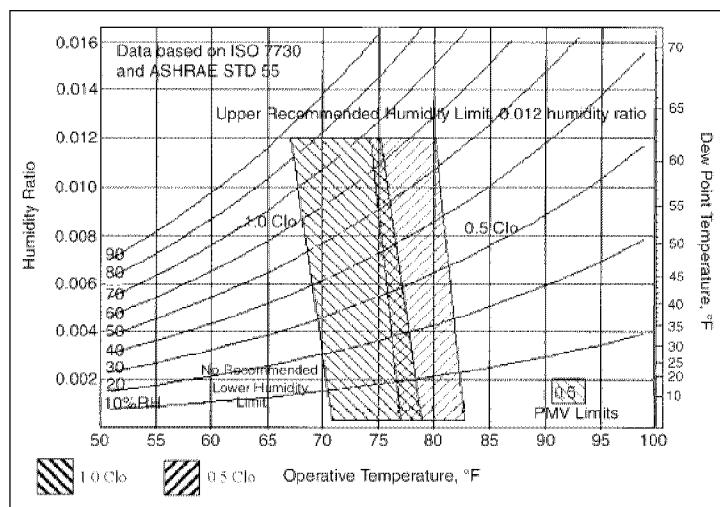
Indoor air temperature and relative humidity are physical conditions important to occupant comfort. ASHRAE Standard 55-2004, Thermal Environmental Conditions for Human Occupancy, provides a graphical method for determining 80% occupant acceptability of temperature and relative humidity in a typical indoor environment (Figure 2). Temperature and relative humidity ranges for typical indoor environments are based on several factors including clothing coverage and activity levels of the occupants. The attached graph is based on typical office activity levels.

Figure 2: Acceptable range of operative temperature and humidity for typical indoor environments

Ambient temperatures and relative humidity levels within the office areas ranged from 71.5 to 73.5°F and 37.2 to 53.0%, respectively. The readings fall within the acceptable range of operable temperature and humidity levels in the ASHRAE Standard 55-2004.

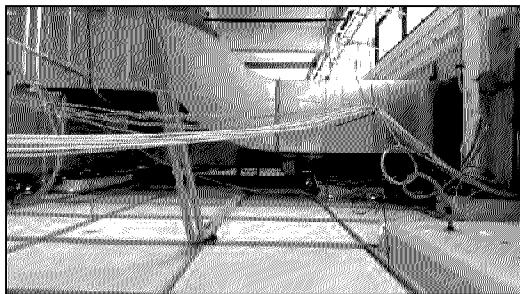
In the old office area, the portion of the ceiling impacted by the recent roof leak was visually inspected. There were no signs of water stained ceiling tile or mold growth. Hygieneering visibly inspection the area above the ceiling tiles (Photograph 1) and no mold growth or signs of water damage building materials were noted. The water damaged drywall that composes the underside of the roof decking was recently replaced. There were no signs of water stains, water damage, or mold growth to any of the drywall roof decking in the area of the recent water infiltration (Photograph 2). None of the accessible ceiling tile or drywall roof decking had elevated moisture levels when assessed with the thermal imaging camera. The roof deck was too high to probe with a moisture meter.

Photograph 1 – Above ceiling tiles near roof leak

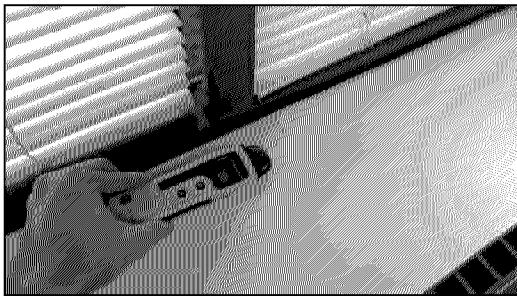
Moisture issues within buildings can cause mold growth to occur. A moisture survey of the accessible walls, carpeting, ceilings, and drywall roof decking within the areas of concern was performed using a FLIR thermal imaging camera and a GE SurveyMaster Protimeter. Elevated levels of moisture were observed to the majority of window sills of the south and west perimeters of the old office area (Photograph 7). In the southeast portion of the old office area, the drywall wall and carpeting below the window were wet (Photograph 8).

Photograph 7 – Elevated moisture levels on old office window sills

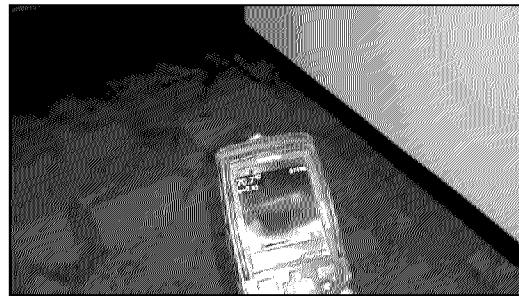
Photograph 8 – Elevated moisture on carpet and drywall wall in old office

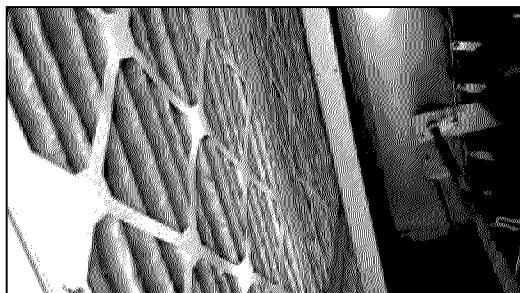
This unit supplies the north side of the new office area. The filters appeared lightly loaded (Photograph 9). The cooling coils appear to be free of significant dust (Photograph 10). The condensate pans were free of debris and rust.

Photograph 9 - RTU-1

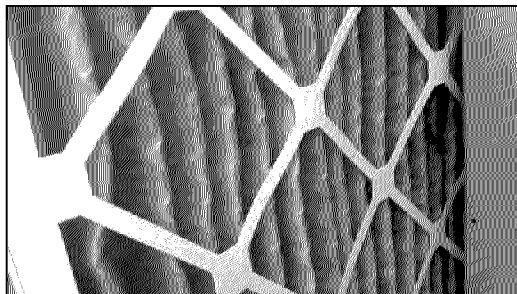
This unit supplies the south side of the new office area. The filters appeared lightly loaded (Photograph 11). The cooling coils appear to be free of significant dust (Photograph 12). The condensate pans were free of debris and rust.

Photograph 11 - RTU-4

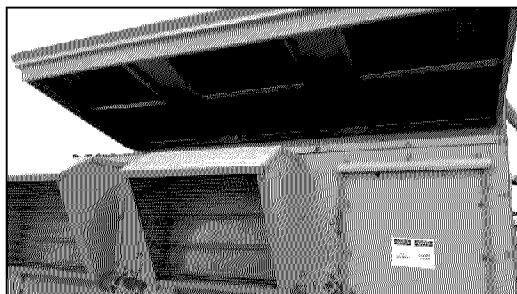
This unit supplies the old office area. Pest screens were present and properly fitted (Photograph 13). The filters appeared lightly loaded (Photograph 14). The cooling coils appear to be free of significant dust (Photograph 15). The condensate pans were free of debris and rust. The condensate drain line was free of debris and unobstructed (Photograph 16).

Photograph 13 – Pest screens in place

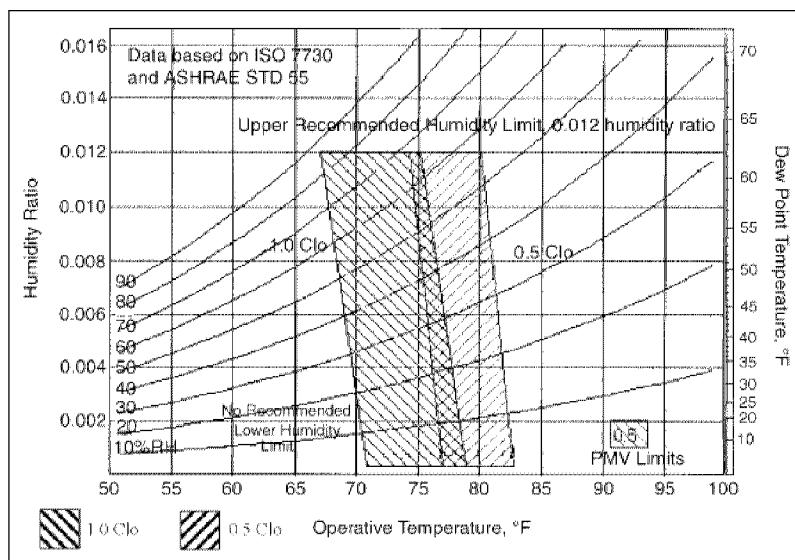
graphical method for determining 80% occupant acceptability of temperature and relative humidity in a typical indoor environment (See Figure 1). Temperature and relative humidity ranges for typical indoor environments are based on several factors including clothing coverage and activity levels of the occupants. This standard only applies to areas occupied for a minimum of fifteen minutes and does not apply to areas such as lobbies, stairwells or corridors. The attached thermal comfort graph is based on typical office activity levels.

Figure 1 Thermal Comfort Graph:
Acceptable range of operative temperature and humidity for typical indoor environments

Ambient temperatures and relative humidity ranged from 70.6-74.0°F and 67.6-79.5%. The relative humidity readings are elevated compared to the acceptable range of operable temperature and humidity levels in the ASHRAE Standard 55-2004. It was reported to by Grainger, that the temperature of the cooling coils had been raised due to cold temperature complaints. The high humidity condition may create an environment conducive for mold growth.
