PHASE I ENVIRONMENTAL SITE ASSESSMENT
W.W. Grainger, Inc. Property
1657 Shermer Road
Northbrook, Illinois

March 1, 2018
File No. 81.0220267.07

PREPARED FOR:
Village of Northbrook
1225 Cedar Lane
Northbrook, Illinois

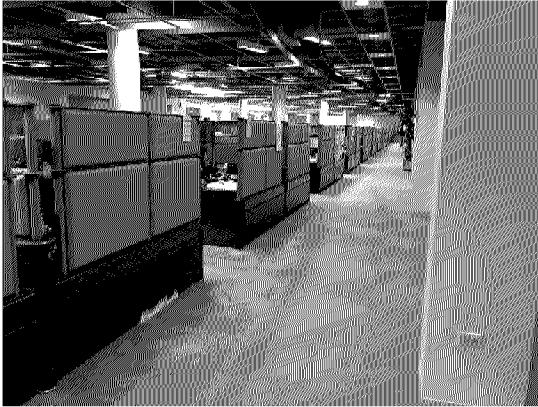
Client Name:	Site Location:	Project No.
Village of Northbrook	1657 Shermer Road, Northbrook, IL	81.0220267.07
Photo 13 Office space	Photo 14 Multi-purpose room on north end of building, former north dock area

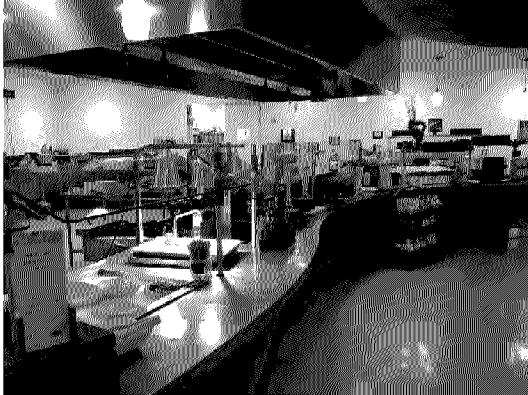
Photo 15 Cafeteria/kitchen	Photo 16 View of floor drain and grease trap in kitchen

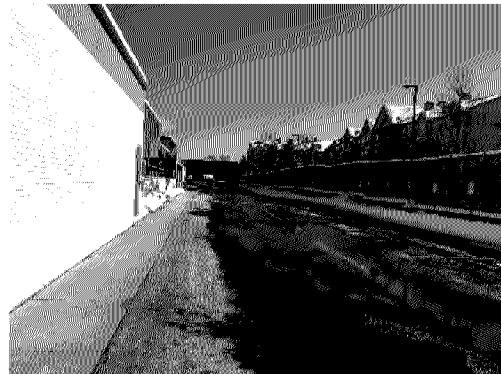
Client Name:	Site Location:	Project No.
Village of Northbrook	1657 Shermer Road, Northbrook, IL	81.0220267.07
Photo 17 South side of building, looking east at dock area		Photo 18 Parking lot on west side of building

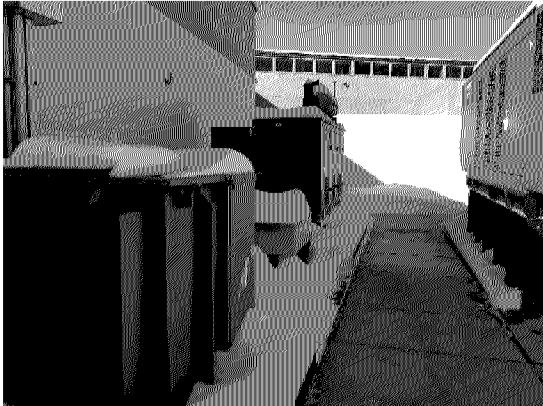
Photo 19 Generators and transformer at northeast corner of building		Photo 20 Transformer at northeast corner of building
