PUBLIC WORKS COMMITTEE

TO: Public Works Committee
FROM: Matt Morrison, Assistant Public Works Director
DATE: January 16, 2019
SUBJECT: Tree Permit Review - 1227 Eastwood Lane

1227 EASTWOOD LANE
JANUARY 22, 2019

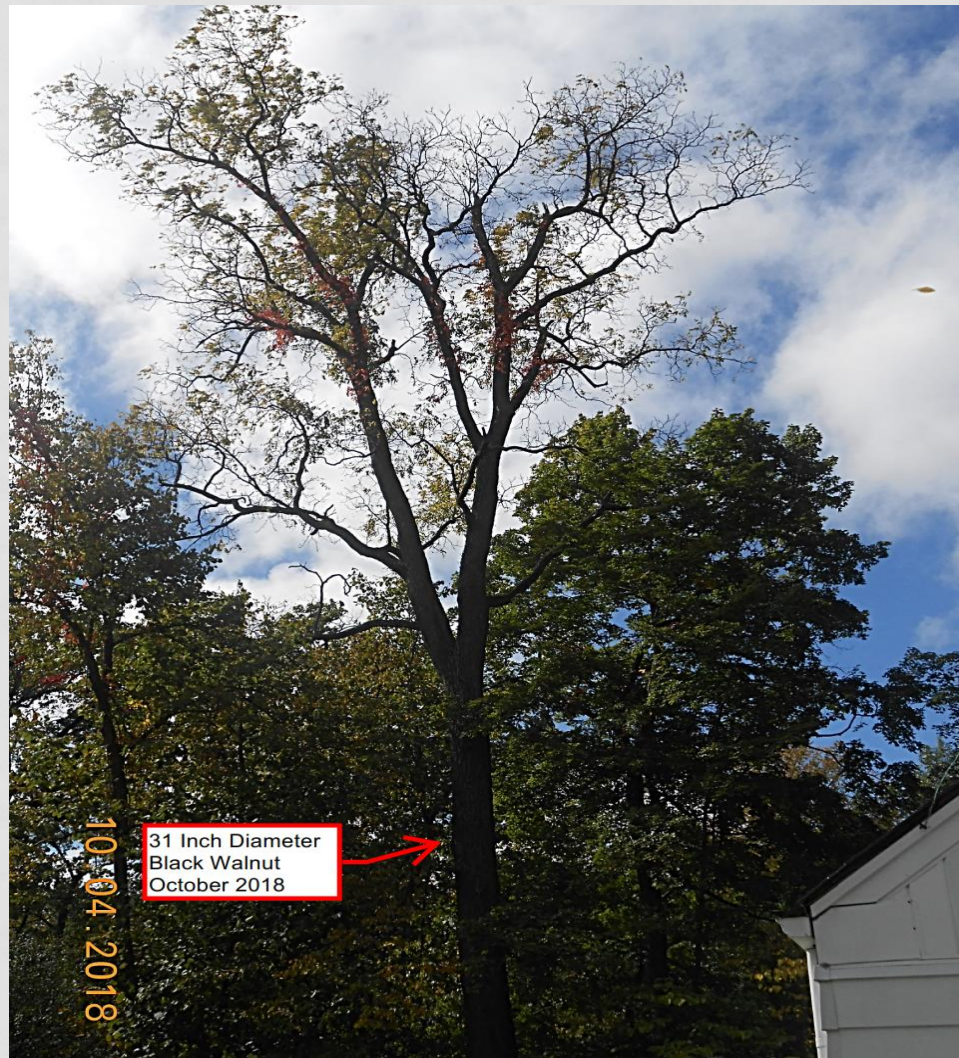
LOWER TRUNK & BASE HOLES WERE FOUND (NOT MANY) FURTHER ANALYSIS WOULD BE REQUIRED TO DETERMINE ORIGINS OF HOLES (INJECTION OR INSECTS)

31 Inch Diameter
Black Walnut
October 2018

- The property owner's arborist and have staff have observed holes drilled or bored into the base of the Black Walnut and Sugar Maple.
- Similar holes were observed on the base of the Burr Oak removed in the summer of 2018.
- Staff has observed residue weeping from the holes with a pungent smell, holes of a diameter the width of a standard #2 pencil, and a depth of approximately 1.5" deep.
- Staff is not aware of any insect that bores holes of the size or depth witnessed and attacks the three species on the property.

- Authorize the removal of the landmark Black Walnut and Sugar Maple.
- If the landmark tree removals are approved, staff recommends the following conditions:
 - \$150 per inch DBH for the landmark trees be assessed for the 56 inches of trees being removed.
 - Given the nature of the holes drilled/bored into the base of the tree, staff recommends that the fee for these trees not be eligible for reduction by replanting of trees on the property.
 - The wood from the tree must be milled for a purpose other than firewood, mulch, or wood chips and preferably be used in the construction of the new home.
 - The builder and homeowner must take aggressive measures to preserve all other heritage and landmark trees on the property and those located on adjacent properties
 - The property owner will be subject to any conditions associated with tree permits for the removal of additional trees.

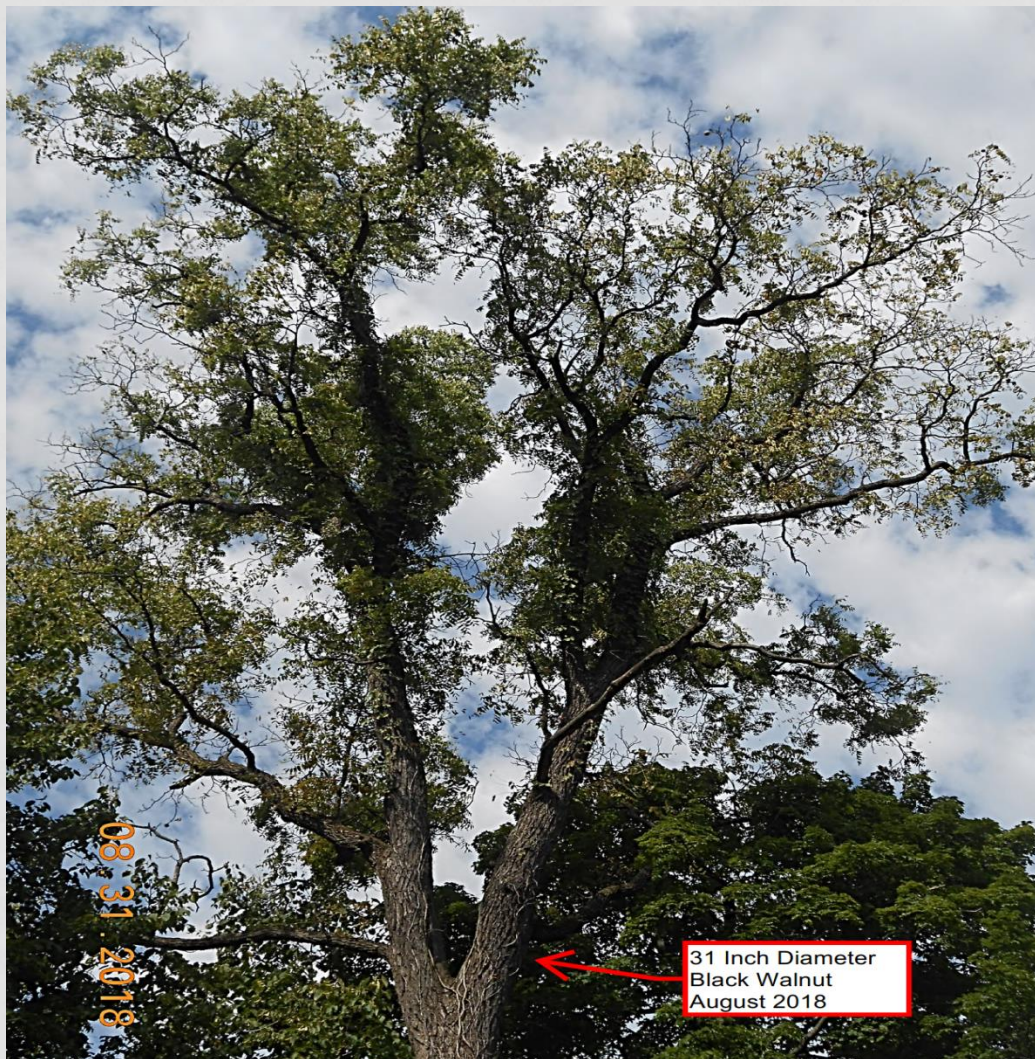
CROWN IS THINNER THAN WHEN I OBSERVED IT IN SUMMER (I DID NOT FULLY INSPECT IT IN SUMMER)

TRUNK APPEARS IN GOOD CONDITION
VERY GOOD CANDIDATE FOR BOARD LUMBER

31 Inch Diameter
Black Walnut
August 2018

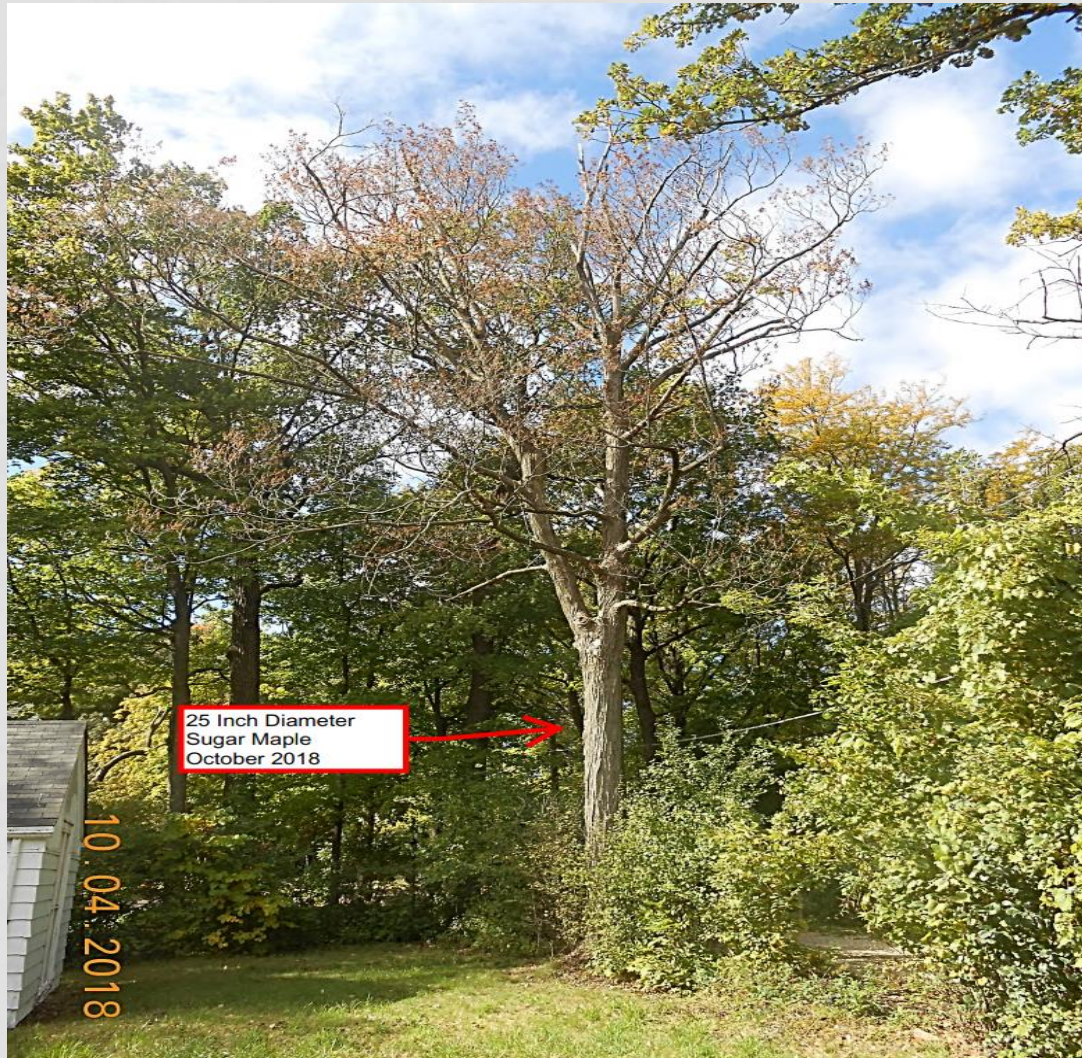
* HOLES AT BASE OF TRUNK I CANNOT DETERMINE WHETHER THEY ARE MAN MADE OR CAUSED BY INSECTS (NO FRASS) CANKER FOUND AT BASE (NOT ATTACHED)

25 Inch Diameter
Sugar Maple
October 2018

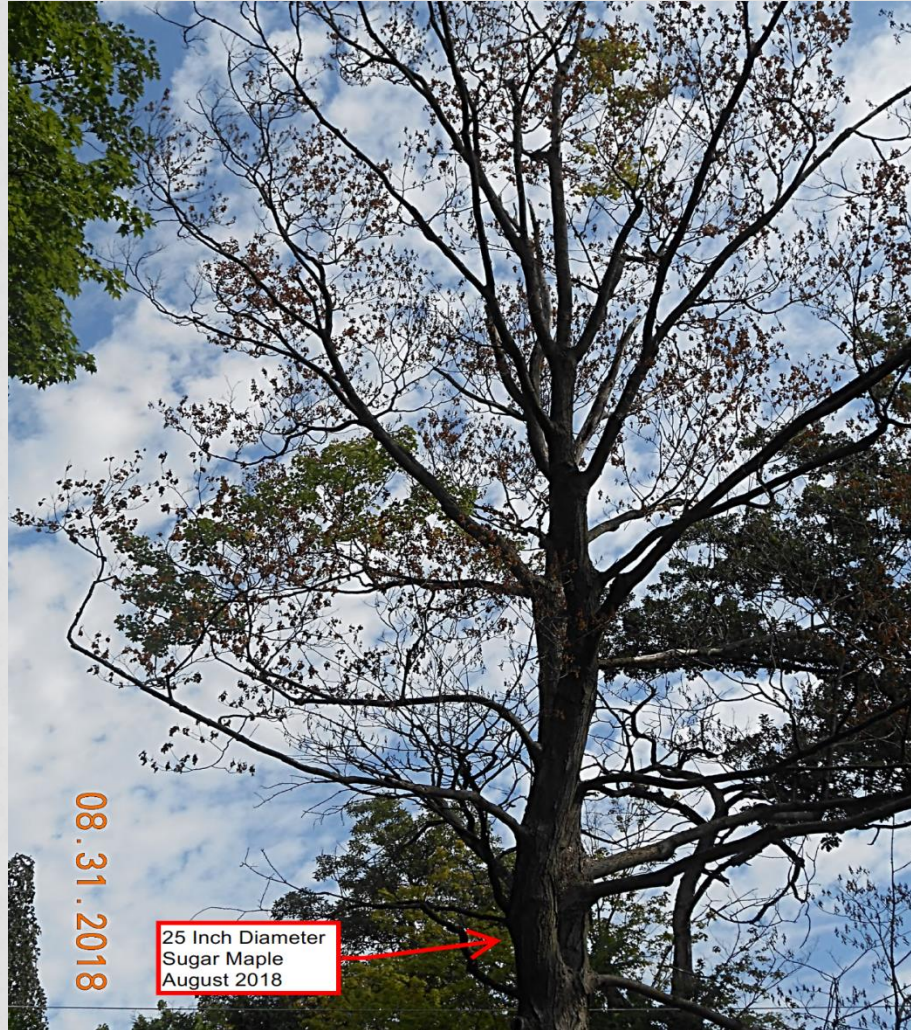
WEAK CROWN NUMEROUS BROKEN BRANCHES ON GROUND

25 Inch Diameter
Sugar Maple
August 2018
