# Village of Northbrook

## PUBLIC WORKS COMMITTEE

**TO:** Public Works Committee  
**FROM:** Matt Morrison, Assistant Public Works Director  
**DATE:** January 16, 2019  
**SUBJECT:** Tree Permit Review - 1227 Eastwood Lane

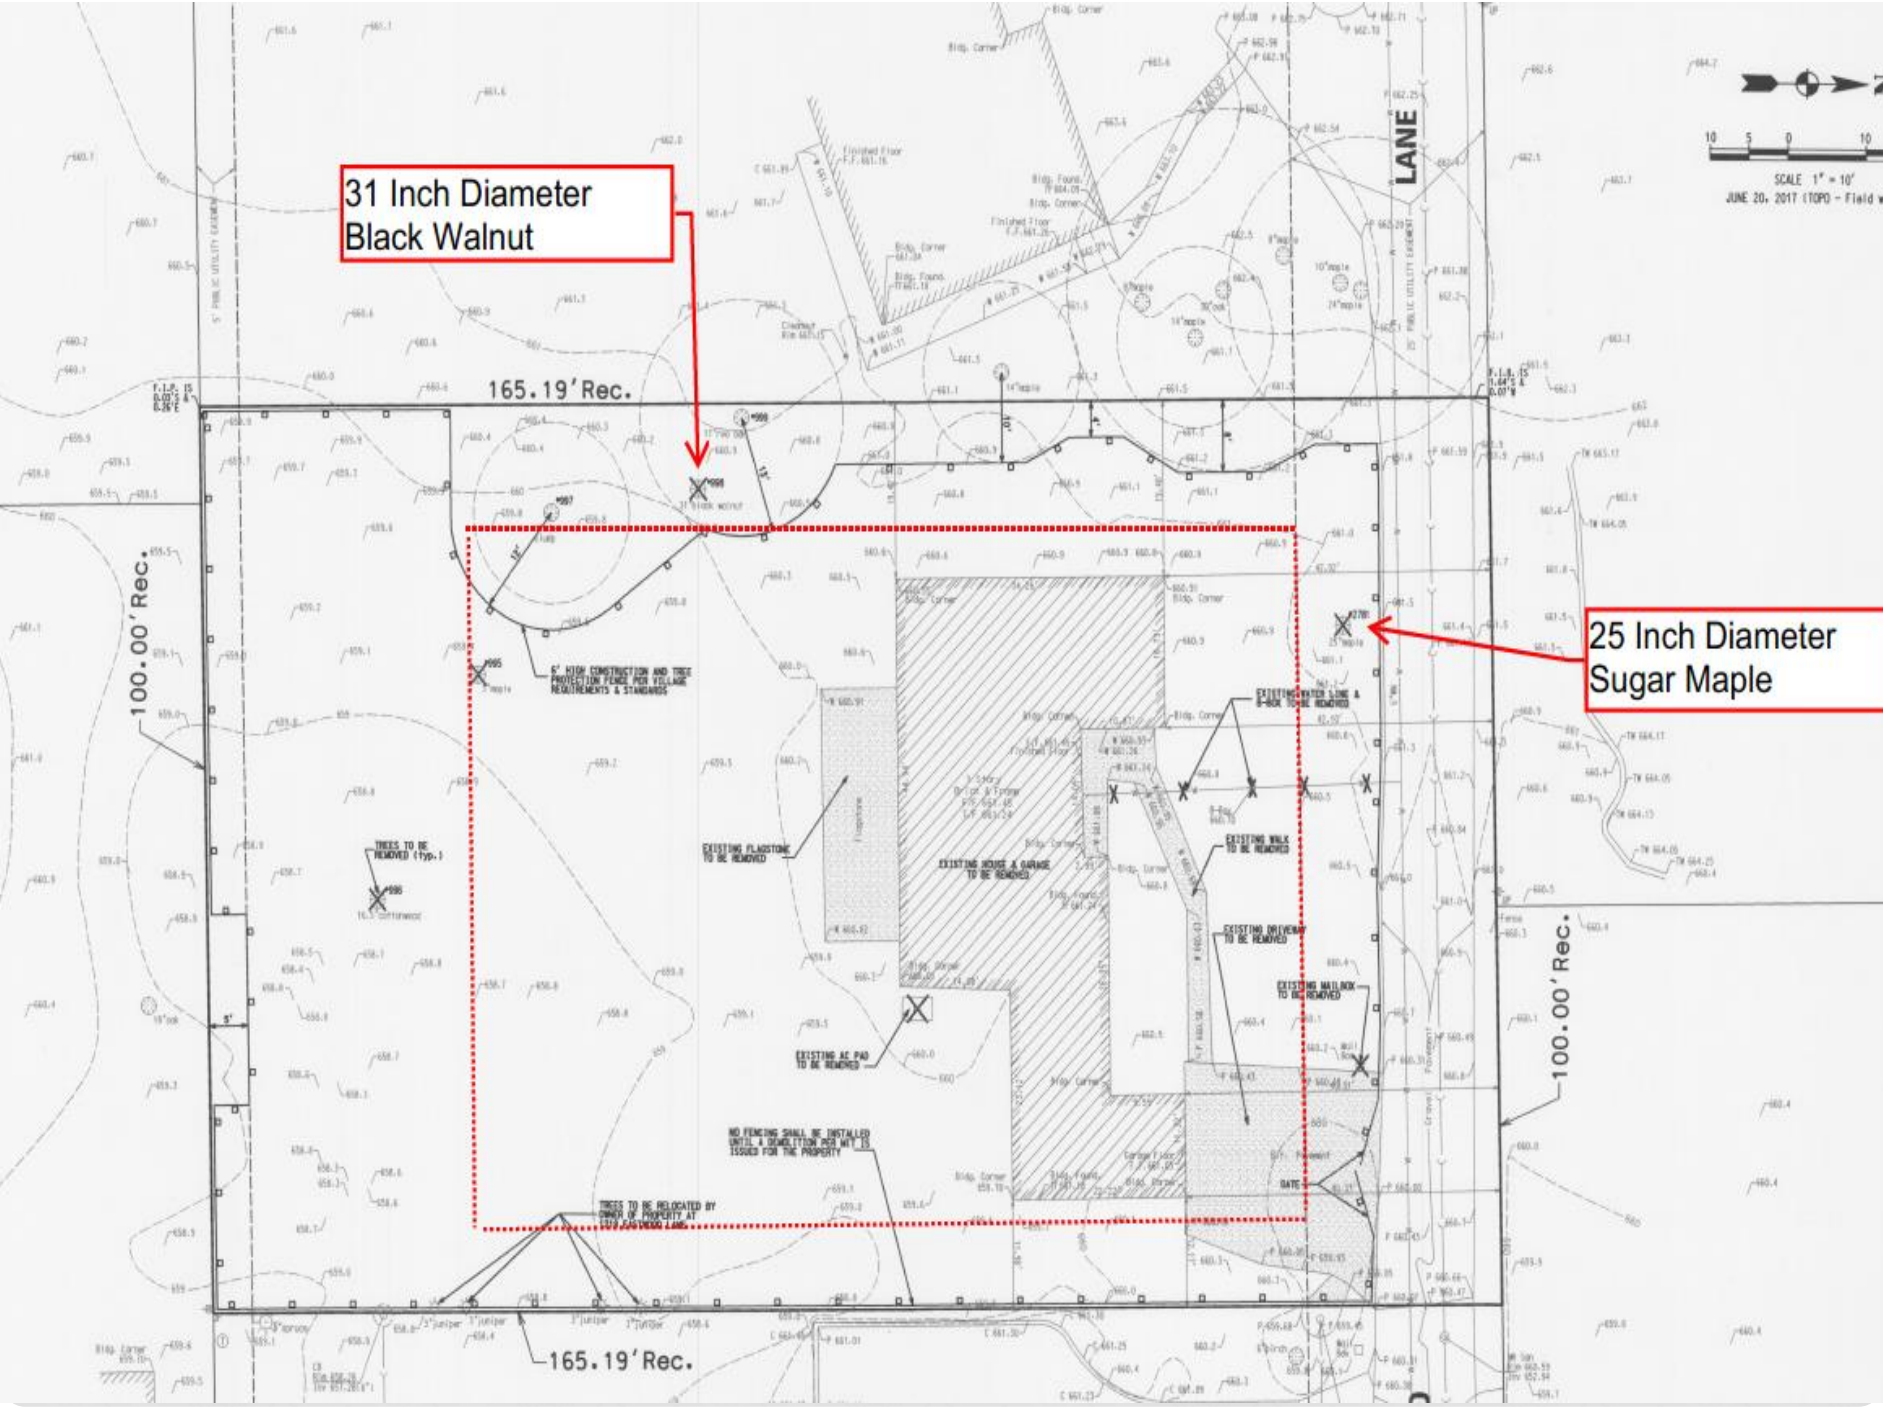
**31 Inch Diameter  
Black Walnut**

**25 Inch Diameter  
Sugar Maple**

- Staff does not disagree with the property owner's arborists ratings of the trees.
- The Black Walnut is in conflict with the construction of the new home's garage while the Sugar Maple is in conflict with the proposed circular driveway.
- The property owner has indicated they intend to replant 12 inches of trees on the property.

- Authorize the removal of the landmark Black Walnut and Sugar Maple.
- If the landmark tree removals are approved, staff recommends the following conditions:
  - \$150 per inch DBH for the landmark trees be assessed for the 56 inches of trees being removed.
  - Given the nature of the holes drilled/bored into the base of the tree, staff recommends that the fee for these trees not be eligible for reduction by replanting of trees on the property.
  - The wood from the tree must be milled for a purpose other than firewood, mulch, or wood chips and preferably be used in the construction of the new home.
  - The builder and homeowner must take aggressive measures to preserve all other heritage and landmark trees on the property and those located on adjacent properties
  - The property owner will be subject to any conditions associated with tree permits for the removal of additional trees.

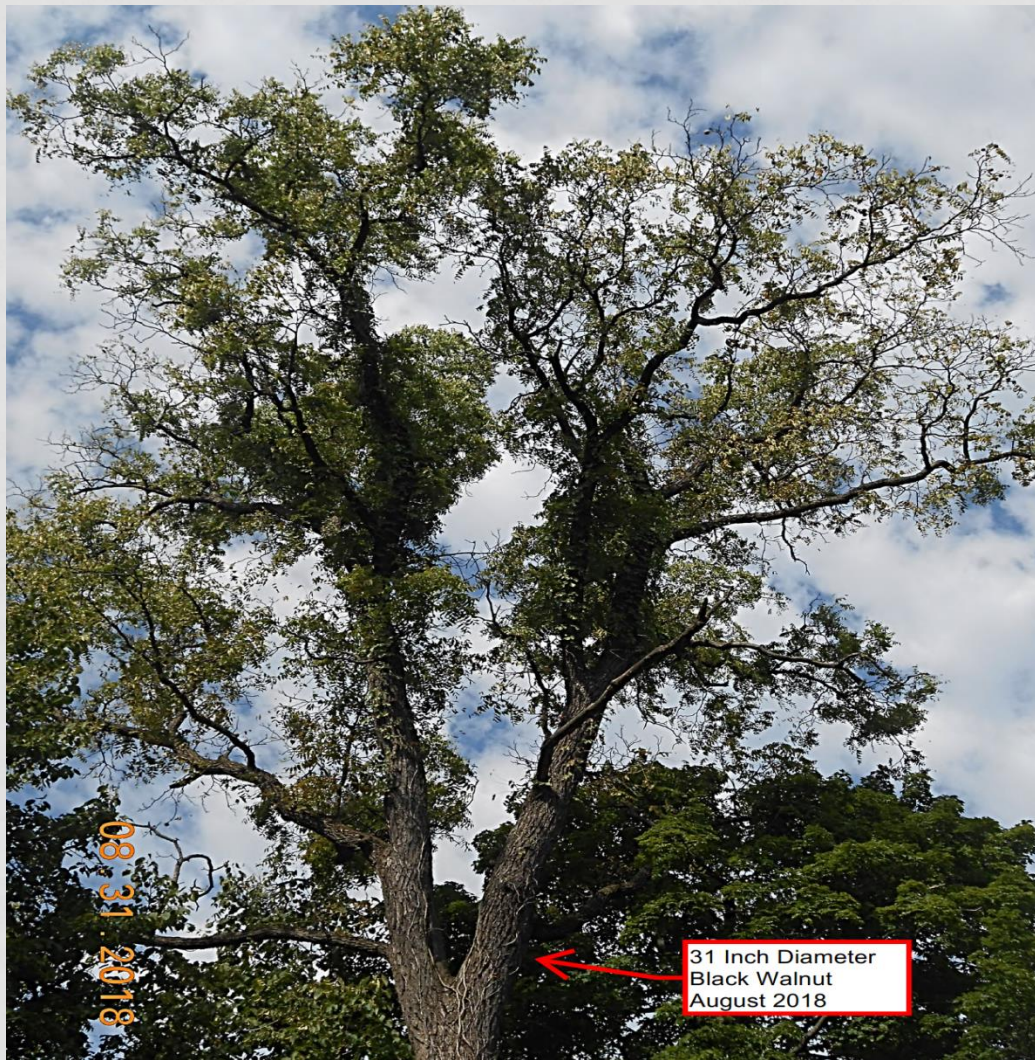
31 Inch Diameter  
Black Walnut  
August 2018

CROWN IS THINNER THAN WHEN I  
OBSERVED IT IN SUMMER (I DID NOT FULLY  
INSPECT IT IN SUMMER)
