Village of Northbrook

TO: RICHARD A. NAHRSTADT, VILLAGE MANAGER
FROM: KELLY HAMILL, PUBLIC WORKS DIRECTOR
DATE: February 27, 2018
SUBJECT: UPDATE ON FACILITIES ASSESSMENT AND SPACE NEEDS ANALYSIS

Facility Assessments

Northbrook Fleet Maintenance Garage
Northbrook Police Department
Northbrook Fire Station #11

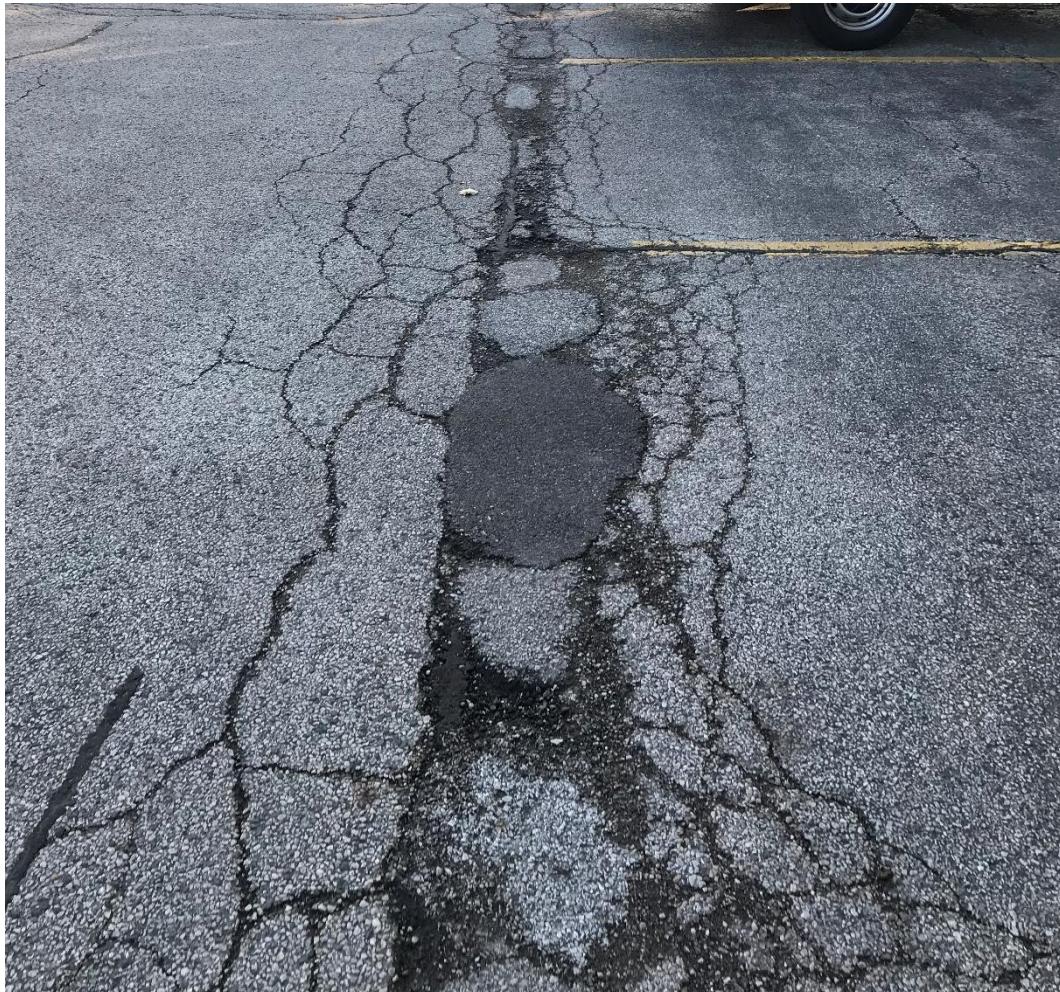
POLICE DEPARTMENT PARKING LOTS

- Rating of Building: B
- Projected Value of Improvements Needed: \$1,786,000
- Notable Findings:
 - Electrical Distribution System (E2)
 - Plumbing System Components (P1 and P10)
 - Windows (A1)
 - Parking Lot and Parking Lot Lighting (S4)

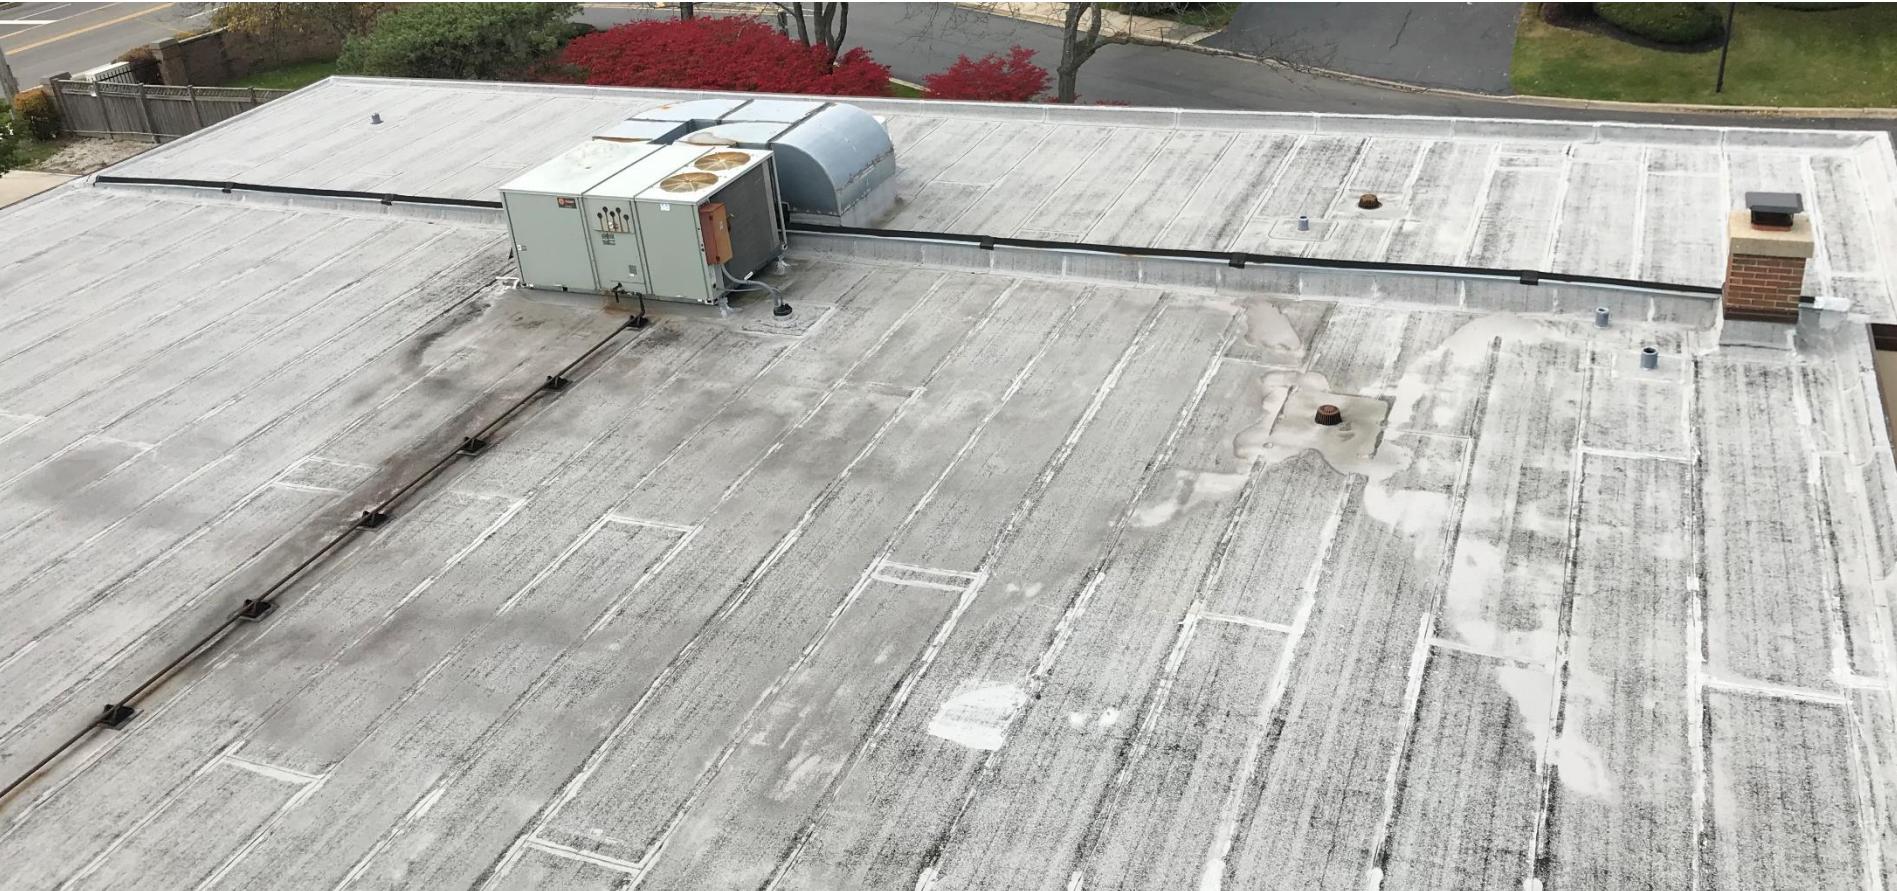
FIRE STATION II AIR CONDITIONING UNITS/ROOF

- Rating of Building: C
- Projected Value of Improvements Needed: \$1,043,000
- Notable Findings:
 - Building Egress is fair to very poor throughout the operations wing (BEI-6)
 - Air conditioning system is past its useful life (M3)
 - Boiler is in good condition, however the pipes feeding the radiators themselves are failing and will require replacement (M2)
