# Village of Northbrook

# MEMORANDUM

**TO:** CARA PAVLICEK, VILLAGE MANAGER  
**FROM:** KELLY HAMILL, PUBLIC WORKS DIRECTOR  
**DATE:** FEBRUARY 28, 2023  
**SUBJECT:** FACILITIES PLAN UPDATE

#### Existing Condition Analysis

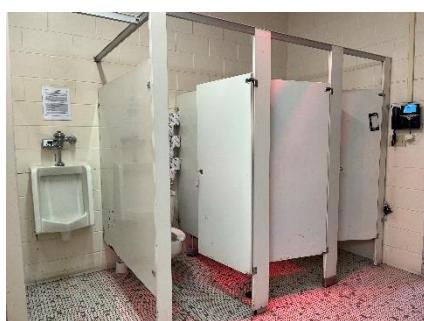
*Inadequate bathroom facilities for women*

Per the original building design, a single toilet/shower and locker room area was incorporated, and the station is currently lacking in separate, dedicated facilities for each gender. Insufficient maneuvering clearances are provided in all of these areas and both the toilet and shower areas are lacking an accessible stall. The remainder of the single user toilet facilities within the fire station are cramped and need to be brought into compliance with code.

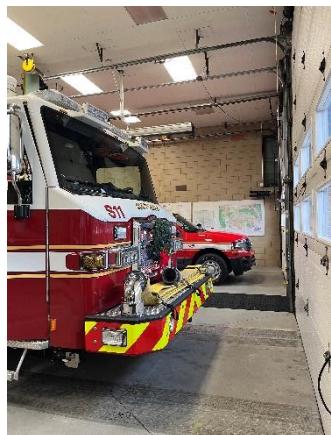
*Apparatus Bay circulation*

- The support areas for Station 11 are insufficient in size to meet the current needs. They are also dysfunctional being located on two different levels and at opposite sides of the Apparatus Bays.
- The apparatus bays have inadequate circulation space around the vehicles for personnel movement.
- All the fire operations are located either a half floor above or below the apparatus bays which inhibits response time. These spaces are also split by the apparatus bays in the middle.
- The stairs are too narrow for proper movement with equipment and gear. All functions require use of stairs for their access.

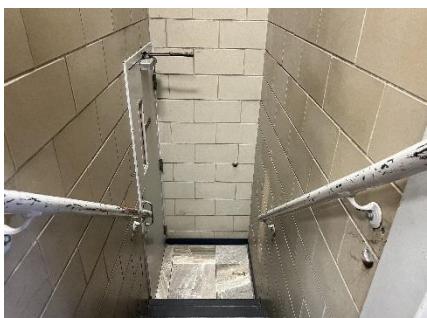
*Non-compliant stair to lower level living quarters*

Due to the multiple levels, numerous stairways are provided within the fire station, none of which are compliant. Stairs are consistently narrow in width, severely lacking in adequate landing areas and are not equipped with handrail extensions. At some stair locations off the bay floor, an additional curb has been built up at the top of the stair to prevent water infiltration to the lower levels below. In addition to being incompliant, these also pose a safety and tripping hazard. Significant modifications would be required to make the stair areas compliant, however there is insufficient physical space available to do so.

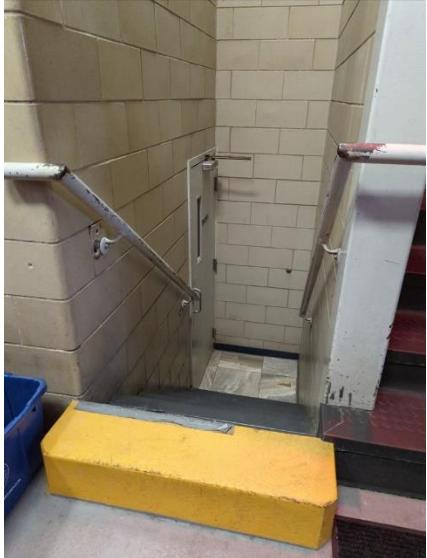
*Narrow stair with built up curb in Apparatus Bay*

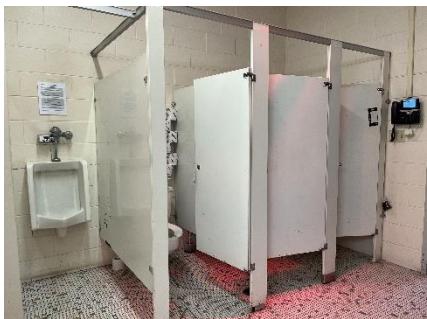
*Locker Room toilet area*

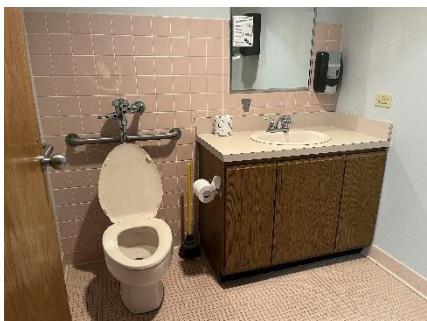
*Single user toilet room in administration wing*

On the administration side of the building, additional deficiencies with ADA and IAC guidelines were noted, particularly in the toilet areas. It is possible that the appropriate accessibility clearances might have been in place at the time of the initial construction of the addition, however these areas are no longer fully

compliant with current codes. If this portion of the building were to be renovated in the future, modifications would be required in order to meet compliance requirements. Toilet rooms would need to be increased in size and adjusted in configuration in order to provide greater clearances to fixtures as required.

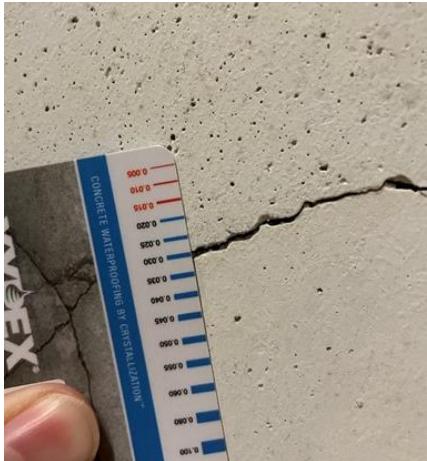
*Minor concrete crack at basement wall*

The foundation walls were in variable condition. We observed minor cracks in the EOC basement. However, we observed more significant cracks at the concrete wall adjacent to the basement stair. We also observed minor concrete cracks and spalls in the apparatus bay of the fire station, specifically at the trench drains.

We recommend that the concrete cracks at the basement stair be repaired. The cracks in the basement wall, as well as the cracks in the CMU, should be monitored for any future movement or worsening condition. We recommend crack monitors be installed and reviewed on a quarterly basis to provide a historical data set.

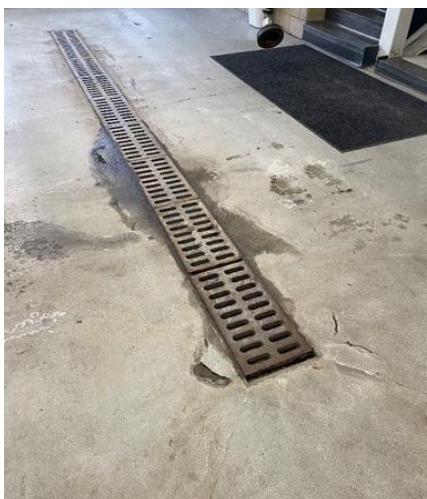
*Concrete cracks and spalls at the apparatus bay slab on grade*

4.	Parking Lots, Site Maintainability	Good Dated	CONCUR	
<b>STRUCTURAL EVALUATION</b>				
1a.	Foundation (Basement Wall)	Fair	CONCUR	Recommend to monitor minor cracks observed in basement walls. Epoxy inject as required.
1b.	Foundation (Exterior Wall)	Fair	REVISE - POOR	Concrete crack repair required at wall of exterior basement stair
1c.	Slab on Grade	Fair	CONCUR	Recommend that the concrete cracks/spalls at apparatus bay should be sealed/patched.

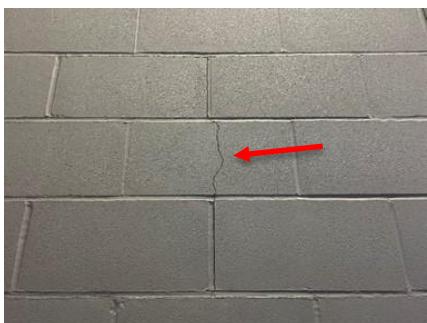
*Thru-block crack at masonry wall in stairwell*

We observed minor step and thru-block cracks at both the interior and exterior masonry walls. We did not observe evidence of water infiltration at the cracks.

2.	Floor Structural Systems	Good Current	CONCUR	
3.	Stairs, Ramps and Balconies	Good Current	CONCUR	
4.	Interior Bearing Walls	Good Current	REVISE - FAIR	Recommend to monitor sporadic CMU step and thru-block cracks.

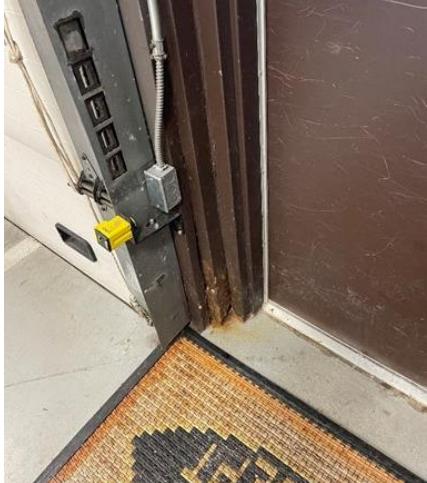
We also observed significant corrosion at the base of the steel columns in the apparatus bay.

*Significant corrosion at base of steel column in the Apparatus Bay*

5.	Exterior Bearing Wall	Fair	CONCUR	Recommend to monitor sporadic CMU step and thru-block cracks at both the station and storage building.
6.	Visible Steel Members	Poor	CONCUR*	It is our understanding repairs to the apparatus bay steel columns are scheduled. If completed, the assessment would be revised to GOOD CURRENT.

It is our understanding that the steel framing in the apparatus bay has already been scheduled to be repaired and/or replaced. As the new steel will continue to be susceptible to the exterior elements and chemicals (e.g. de-icing salts), we recommend that the new steel be scraped, primed and painted with a rust inhibiting coating periodically, as part of a regular maintenance schedule in the future.

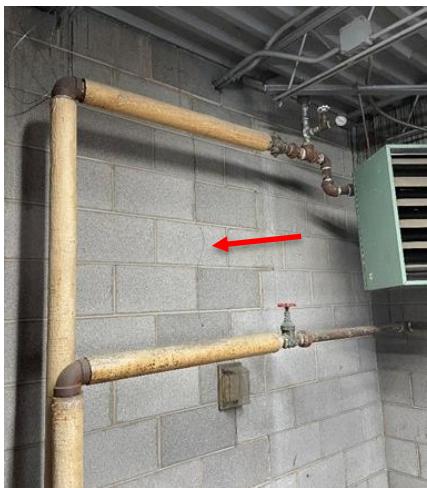
*Thru-block crack at hose tower*

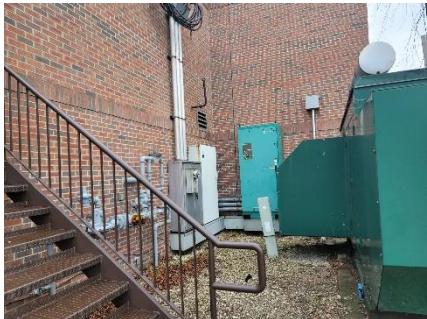
*Electrical services and generator, immediately west of train tracks*

The building has a permanently installed Cummins natural gas fired back-up generator set which powers the entire facility during power outages. Location of the generator equipment is adjacent the electrical service entrance and even more subject to train derailment damage than the service equipment. The generator system appears to be in overall fair condition. Relocation and replacement of the emergency generator and transfer switch and associated equipment with new better protected back-up generator equipment is recommended.

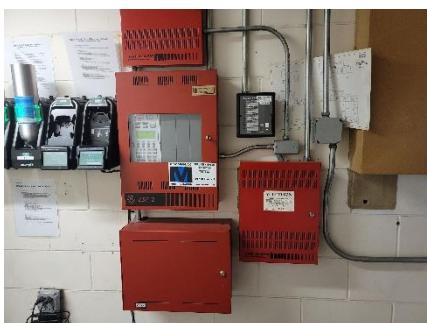
*Fire alarm controls*

Older EST 2 fire alarm system no longer current product offering in fair condition. Some coverage and annunciation appear to be lacking in the older sections of the building and the system is no longer a current product offering.

The system appears to have a wireless radio alarm communicator installed in the tower. Replacement of the existing fire alarm system and additional detections and annunciation device coverage in the older sections of the facility is recommended.

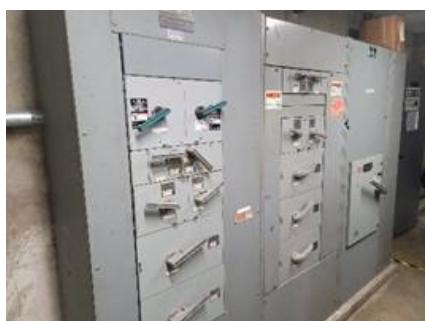
*Original electrical service board*

The electrical service is rated 1200 amperes at 208/120V-3Ph. The main service disconnect switch is located in the original 3-section ITE switchboard. The switchboard appears in fair condition however the 50+ year old electrical service equipment is nearing end of service life. Location of the service entrance is subject to train derailment damage. The distribution panels appear to be in fair condition. All branch panels are typical bolted circuit breaker type and appear to be anywhere from original and 50+ years of age to relatively new and in overall fair to good condition. Expansion capabilities are limited by physical breaker space and some older panels are serving as pass through wiring pull boxes. Relocation and replacement of the main electrical service entrance and associated equipment with new better protected service equipment is recommended.

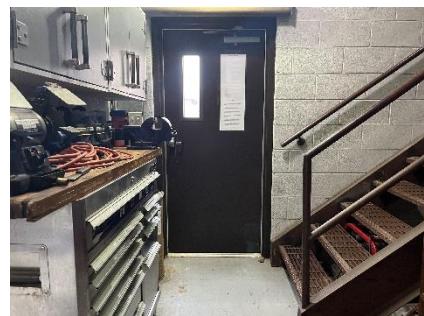
*Reduced clearances at Hose Tower stair and exterior exit door*

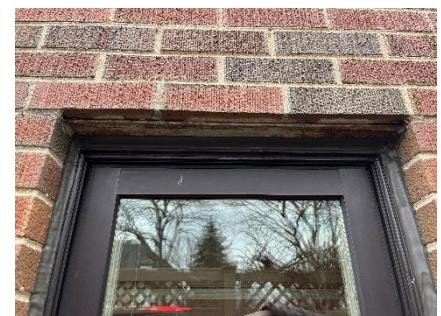
*Corrosion at exterior steel lintels*

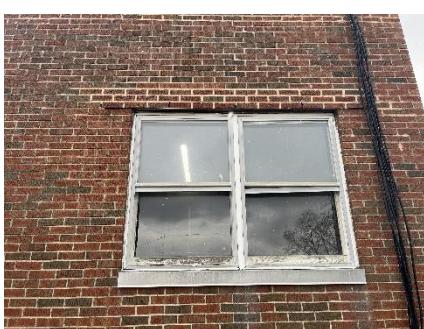
*Dated and inefficient exterior windows at Hose Tower*

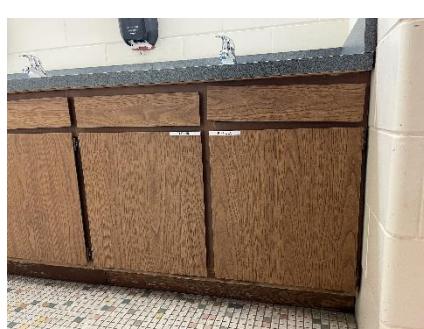
*Deterioration at plastic laminate countertops and Interior cabinetry observed in numerous areas*

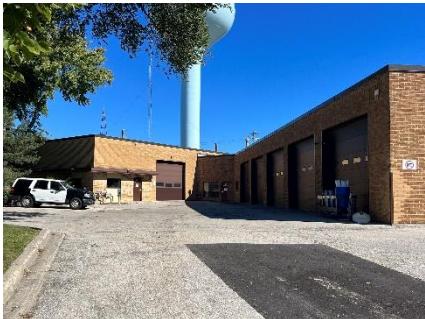
*No Main Entry Designated for Fleet*

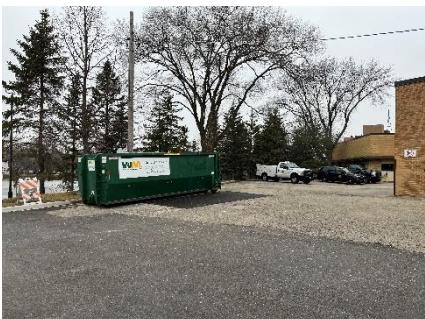
*No room on site for operations*

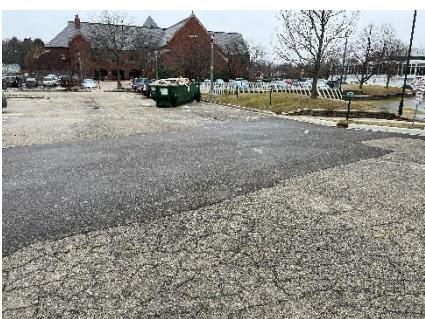
*Intermixed operations with public access*

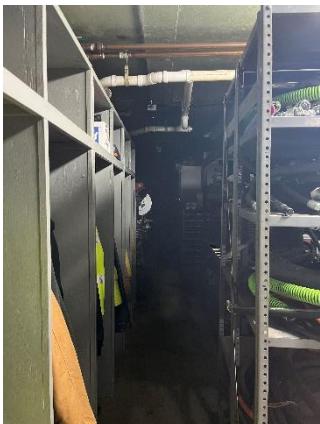
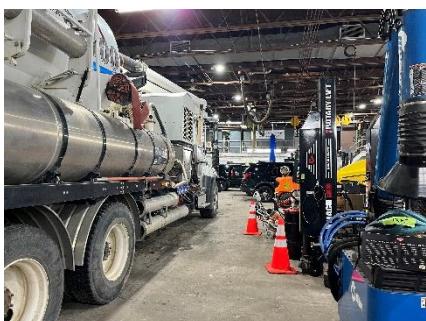
*Clearance Issues*

1. **Clearance Issues:** The height of the maintenance bays are low, and impeded by mechanical equipment and other obstructions, that reduce the heights to 16 feet or 13 feet, depending on which bay. This is inadequate to properly service fleet and heavy vehicles. Larger vehicles must be serviced outside year round. For example, aerial fire trucks must be repaired outside if cabs needs to be raised and their aerial can only be raised three feet for service in a specific location in the bays.

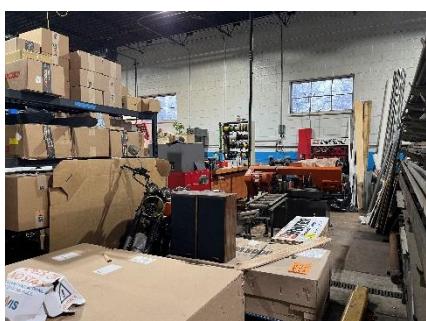
*No dedicated storage/ equipment*

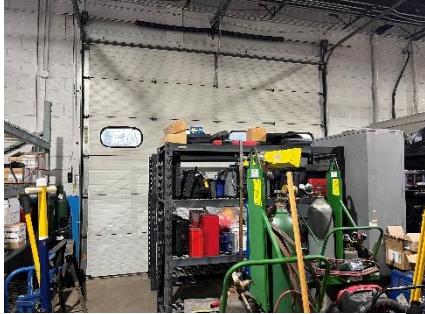
*Piled Storage: fluids, gases, tools . . .  
. – non-secure*

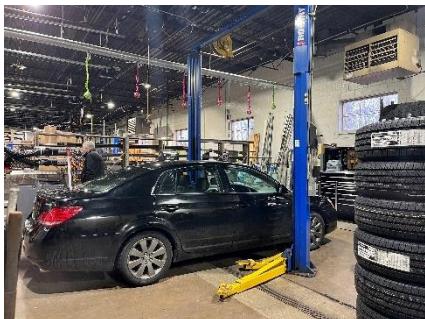
*Lack of designated storage*

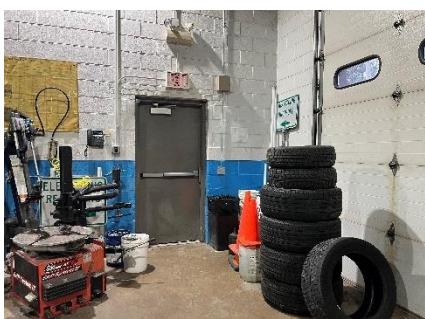
*Inefficient storage in multiple places*

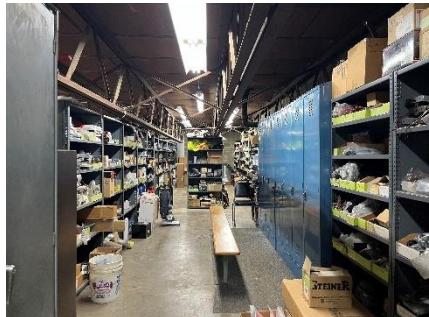
Locker space for staff is located on a storage mezzanine, which is open to bay particulates, and does not provide any privacy. It is inaccessible and inadequately sized for staff operations.

*Staff lockers located in storage area on mezzanine*

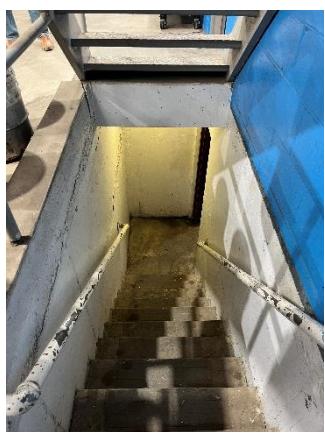
*Difficulty accessing storage from different levels*

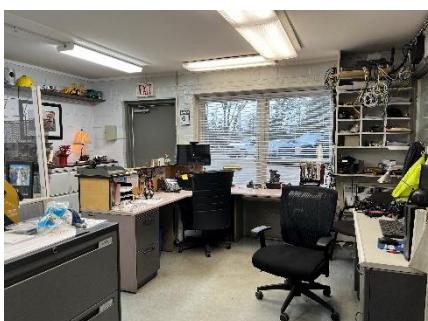
There is NO office privacy. They are currently open and available to anyone who wanders into the facility.

*Entry direct into office area, with no security. No space for mechanics*

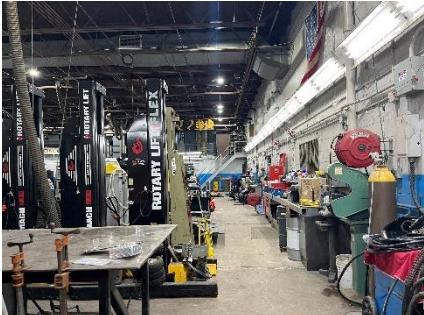
Welding and fabrication work occurs wherever space is available, and has no designated area. As such, improper ventilation/ no ventilation is provided, putting occupants as risk.

*No dedicated fabrication area*

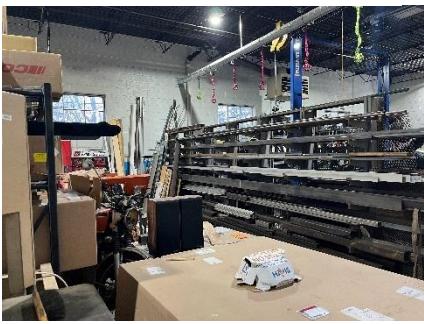
*No dedicated storage for fleet outfitting, resulting in loss of workspace*

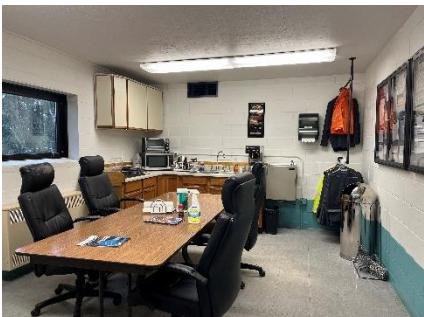
*Breakroom is only space for staff, and is also used by other departments*

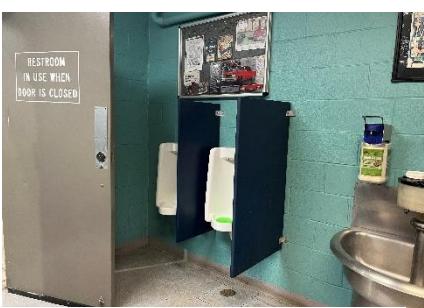
The limited toilet facility within the building ends up being a high traffic washroom, used by police and maintenance workers on the road, due to convenience or proximity. It is undersized for Department staff, not including the additional stress from other Village staff.

*Inadequate restrooms*

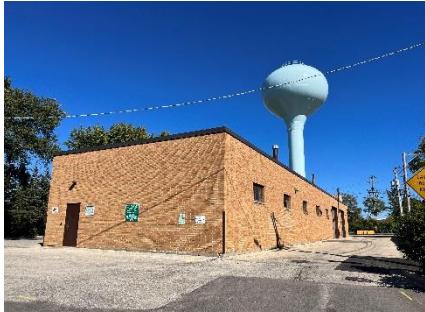
*Unsafe access from bays*

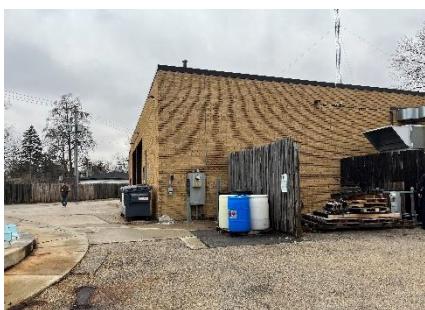
*Used fluids, scrap, mechanical, etc. all open and exposed to the neighborhood*

- There is NO outside secured storage. This means anything that would be required with its operation are subject to theft, public tampering, or increased damage. Outdoor storage of scrap metal, used oil filters, flammable absorbent pads are examples of potential risks.

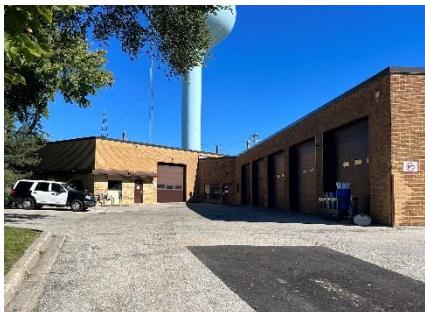
*Blind corner access, and difficult bay access for service*

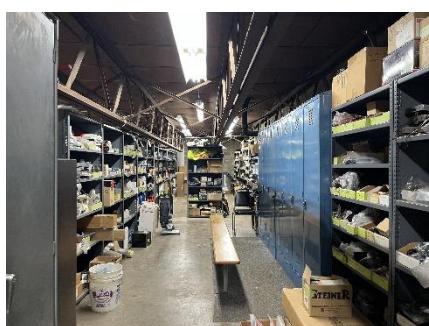
Mezzanine level Locker Room and storage area

Located on the mezzanine level, the locker room is entirely inaccessible and significantly deficient in adequate clear overhead height from the top of the floor to the underside of the exposed roof structure. Roof joists are precariously low in this area and can pose a hazard to staff that occupy this level.

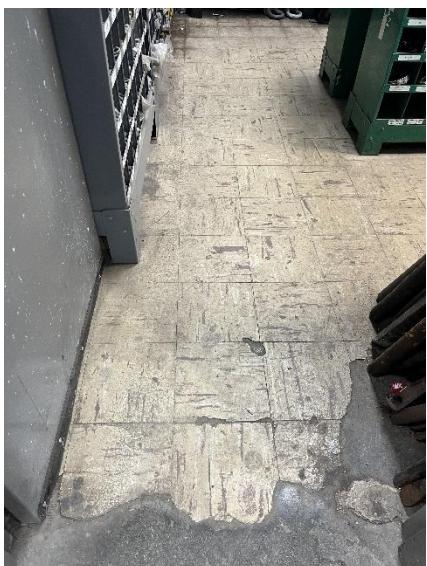
Suspected asbestos floor tile

This investigation did not include environmental testing. During the field observation, it was reported by staff that asbestos floor tile is believed to be present in the building. Should any renovations or remodeling to the facility occur, testing of any material suspected of containing asbestos should be performed prior to any new construction.

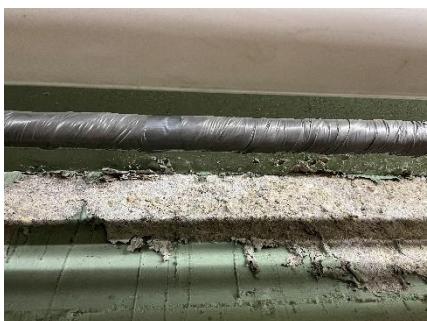
Deterioration at basement concrete wall

In the partial basement area, evidence of prior water infiltration is visible in numerous areas. Efflorescence at the concrete wall near the basement stair was observed, and deterioration of the concrete basement foundation wall

It is our opinion that structural repairs of the concrete walls are required. Additionally, we recommend that the slab-on-grade be repaired or replaced, with special attention paid to the slope of the slab so as to mitigate any drainage/water infiltration causing efflorescence at the basement walls.

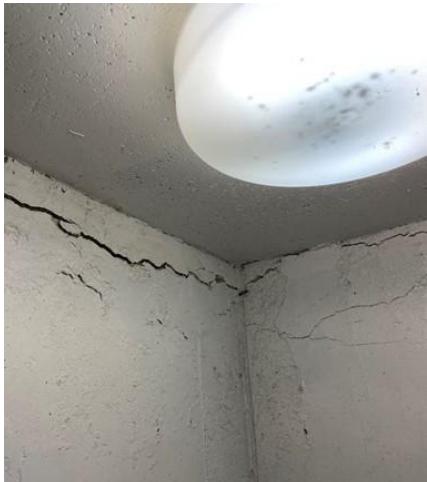
Concrete crack at basement stair

We observed localized areas of the foundation which were in poor condition. We observed moderate concrete cracks and minor efflorescence at the concrete wall adjacent to the basement stair. The most significant crack was observed at the base of the mezzanine stair. Localized areas of efflorescence were also found in the basement wall adjacent to the maintenance bays.

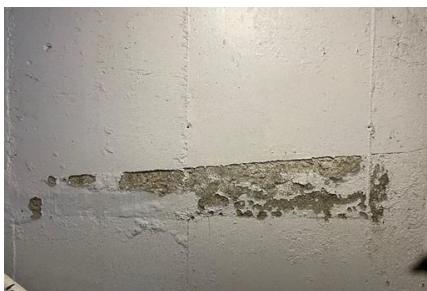
Efflorescence at basement stair

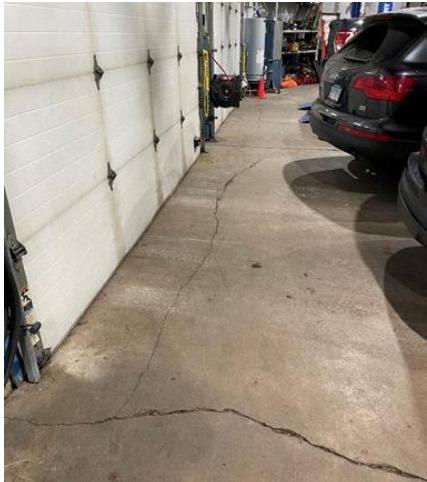
The slab-on-grade was in poor condition. We observed significant cracks and spalling globally throughout the maintenance bays.

*Global concrete cracks and spalls in the slab on grade*

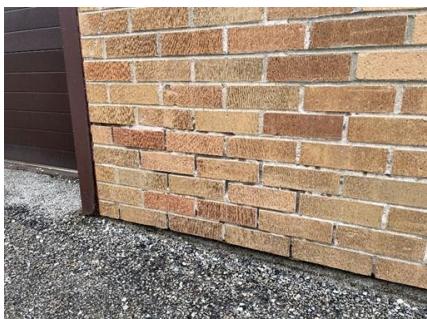
Along the exterior of the building, we observed several areas of damage. At the man-door in the southeast corner of Service Building #2, we observed significant step cracking and displacement of the concrete masonry (CMU) and clay brick masonry. We also observed deterioration and/or missing mortar at the base of the walls.

*Missing / deteriorated mortar at exterior wall*

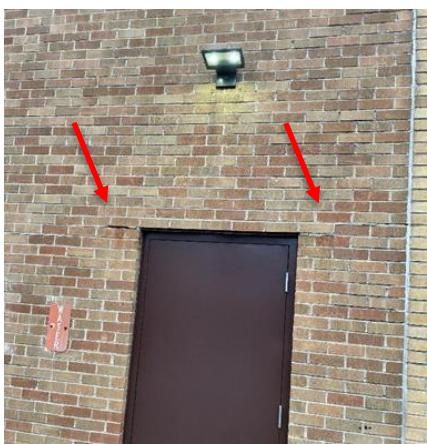
*Step cracks and masonry displacement*

We also recommend that the lintel over the aforementioned man-door be exposed, scraped, primed and painted with a rust-inhibiting coating. If section loss is found to be significant, we recommend the lintel be replaced. The masonry at each bearing end should be rebuilt in-kind, toothed in and flush

with the adjacent masonry.

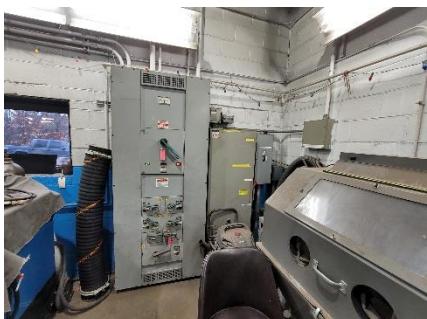
The electrical service is rated 600 amperes at 208/120V-3Ph. 30+ years of age undersized for a facility of this size with welding stations. Only adequate due to there being no air conditioning in the building. The main service disconnect switch is located in a Siemens fusible distribution panel that was manufactured in 1992. The distribution panel appears in fair condition. Power is distributed from the main distribution panel to a number of branch circuit panels. All

*Electrical service panels*

panels are typical bolted circuit breaker type and appear to be in fair overall condition. Expansion capabilities are limited by physical breaker space. A larger updated electrical service with integrated on site emergency generator back-up system is recommended.

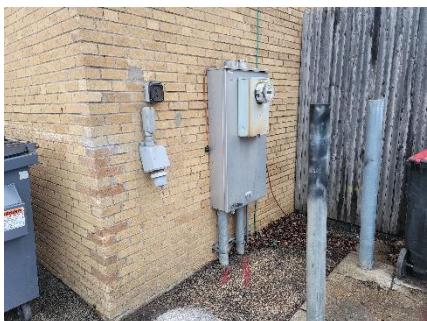
*Electric service and generator plug*

The building does not have a permanently installed back-up generator set and the portable generator set allotted for the facility is being utilized elsewhere at current. As such the facility is without power and of little functional use during power outages. A permanent on site back-up generator system for the facility is recommended to allow continued functionality during outages.

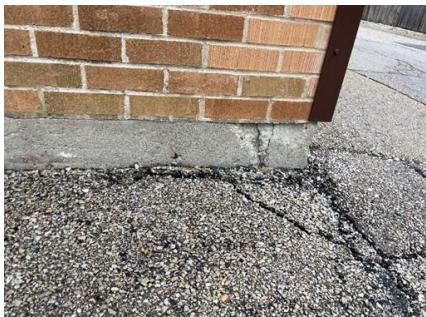
*Cracks and spalls at exterior wall*

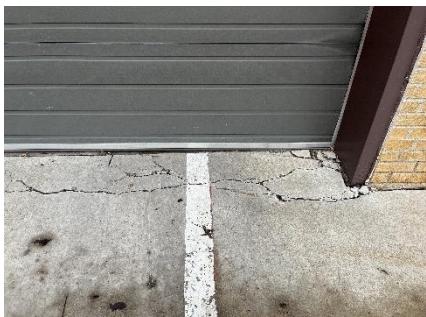
*Cracking at overhead door concrete  
apron*

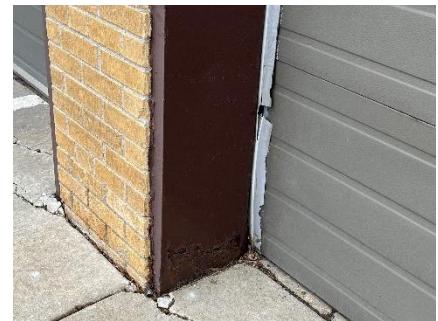
*Deterioration of steel at overhead door jamb / broken door seals*

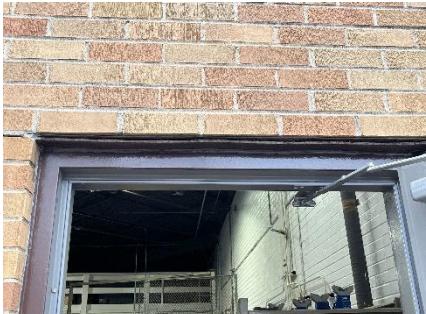
*Displacement and gap at lintel*

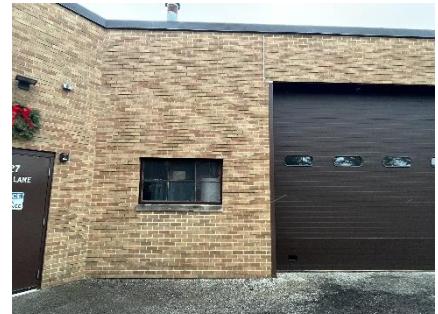
*Single pane window / typical overhead door*

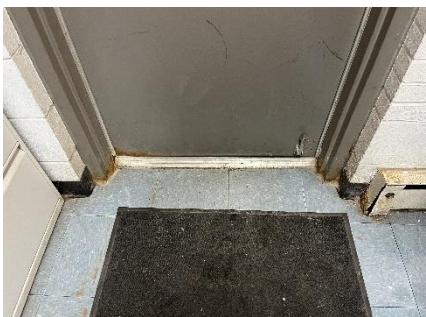
*Corrosion at hollow metal door and frame*

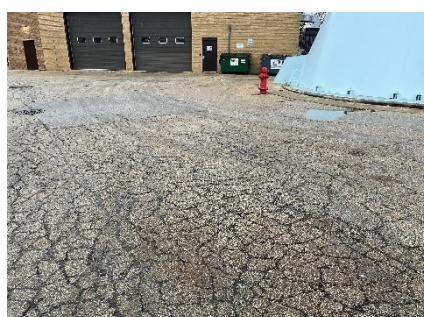
*Cracking in asphalt pavement*

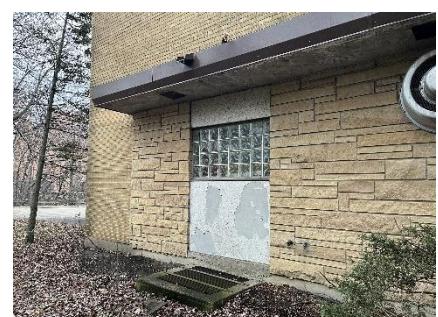
*Typical deteriorated conditions at exterior wall and soffits*

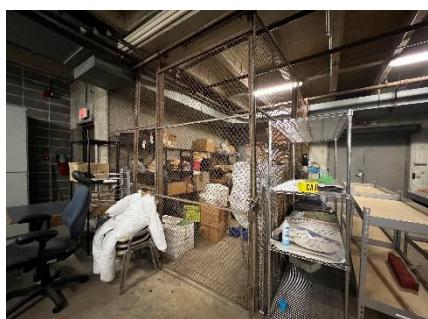
Evidence storage cage in parking garage

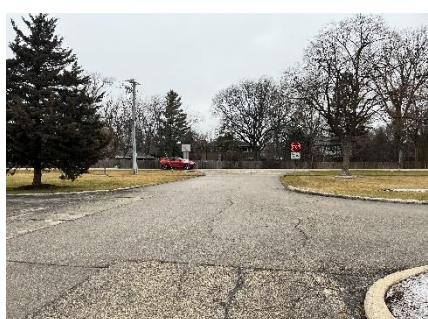
Unsecured police and staff entrance to east parking lot

1. Safety and Security: The site and building have many security issues. Examples include staff parking areas are easily accessible to pedestrians and vehicles. Within the building, there is a lack of separation between police staff, the public, and suspect/detainee traffic. For example, a potential suspect being interviewed do not have easy access to toilet

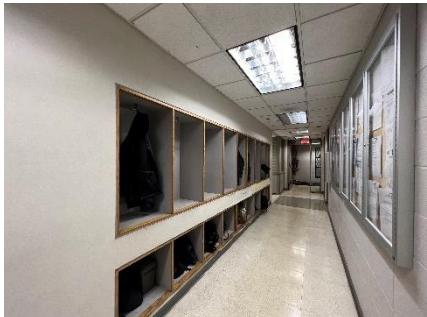
*Corridor with patrol gear storage and postings is too narrow for multi-purpose use*

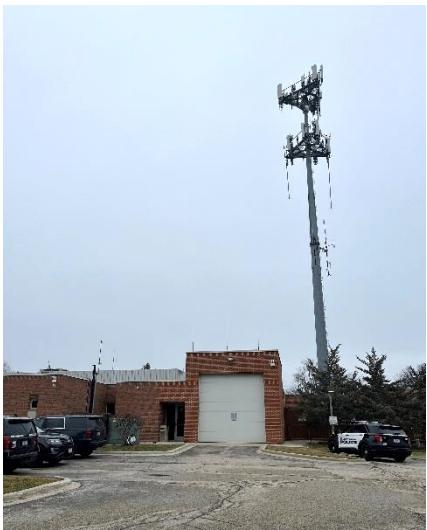
*Radio tower proximity is a risk to the police station*

5. Radio Tower Location: If the existing building is to be utilized as part of a solution, the current location of the radio tower is problematic. A police station is considered a critical facility, having a radio antenna next to the building is considered a hazard. For 911 center design, the best practice as per NFPA 1225 is not to have the building within the fall zone of the radio tower.

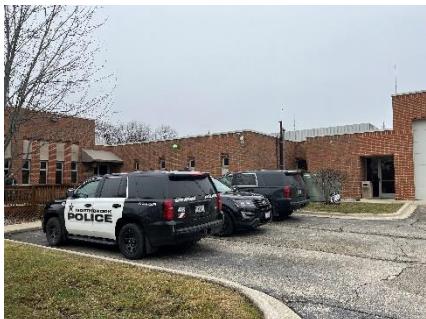
*Many police vehicles are parked outside which is detrimental to electronic equipment*

Patrol vehicles are parked in an open parking lot with staff and public parking. This leaves the vehicles exposed to the elements as well as to vandalism. Today's patrol vehicles contain equipment that is very costly and sensitive to extreme temperatures. Furthermore, garage storage will reduce the wear and tear on vehicles from the extreme weather we have been experiencing and prolong their service life. As police vehicles continue to evolve and become more sophisticated, it is important to protect them. We recommend the police fleet be stored indoors.

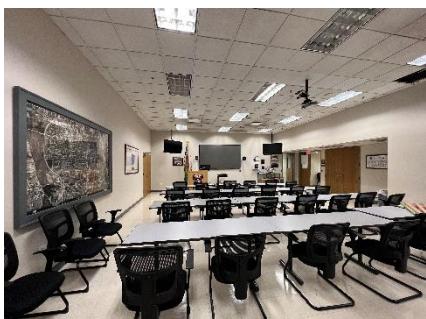
*Training room is too small to accommodate regional and federal training programs*

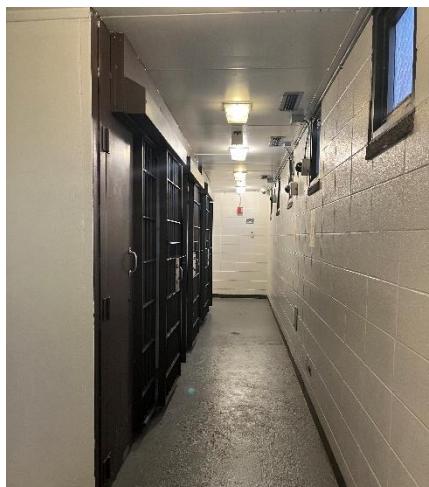
Narrow corridors in lock-up area

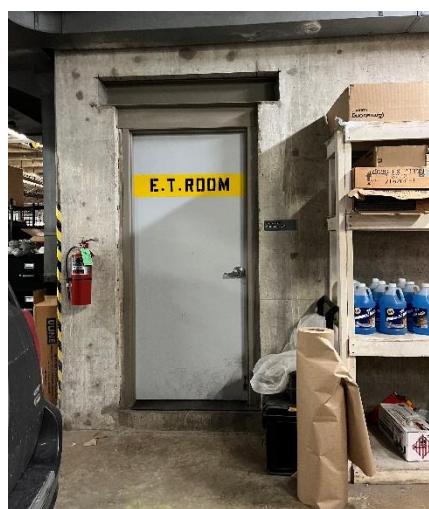
Evidence Technician's workspace is a converted storage room

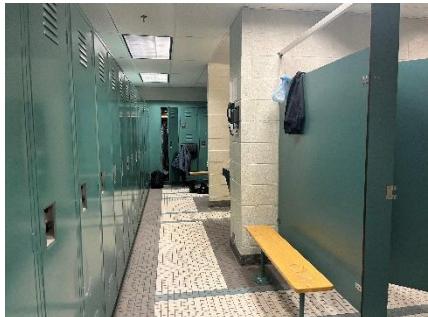
*Locker rooms with narrow aisles*

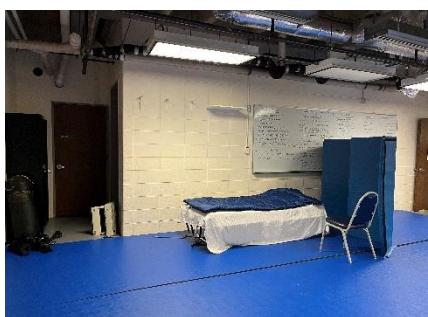
*Makeshift sleeping quarters in Defensive Tactics Training Room*

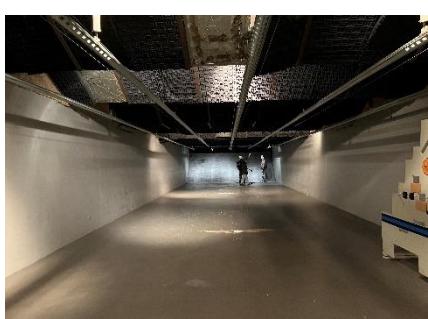
*Firing Range*

- Firing Range: The Firing Range is insufficient in its width and depth to accommodate the mandated scenario training activities using vehicles and other props. The original firing range bullet trap was replaced with more modern safer version, but that reduced the useable length of the range to less than 25 yards, which is a minimum standard. Range storage, preparation, and weapons cleaning areas are also insufficient to support training use.

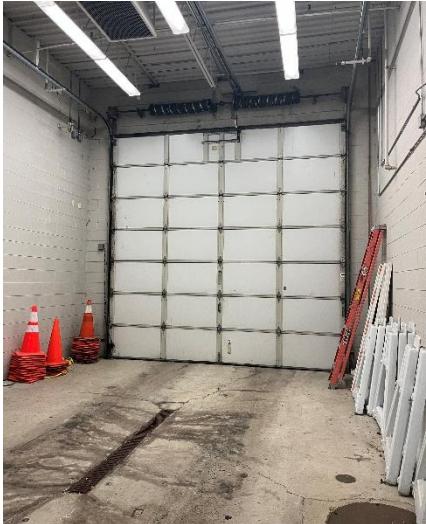
- Sally Port: A sally port is a secure garage used for safe transfer of detainees from a vehicle to the lockup area. The sally port lacks the

*Sally Port is narrow and does not accommodate multiple vehicles*

ability to accommodate multiple vehicles. It also lacks a "drive through" capability, requiring a vehicle to back out into a traffic drive.

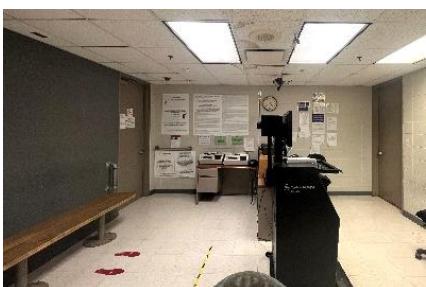
*Booking area with Live Scan, booking bench and breathalyzer in same area*

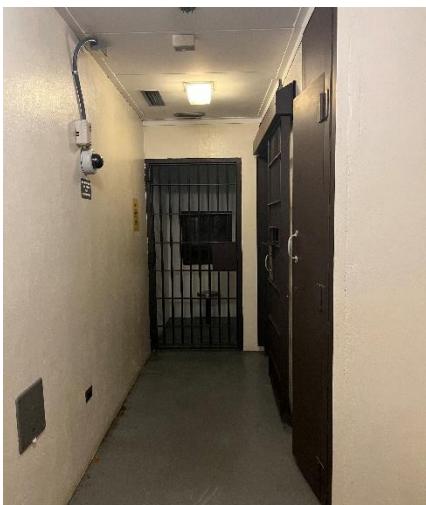
*Attorney-client visiting room offers little privacy from other detainees*

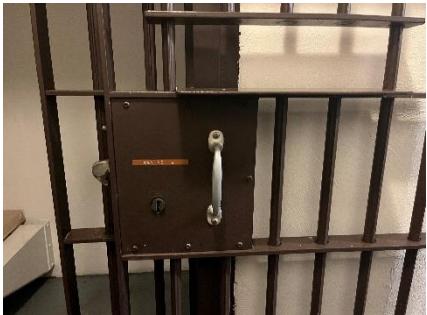
The existing cells have open steel bar cell fronts and doors which are unsafe as due to potential ligature risk (suicide by hanging) and the ability for detainees to spit and grab officers. The doors also lack any acoustic separation between prisoners requiring separate

*Cell doors are open steel bar fronts with manual locks*

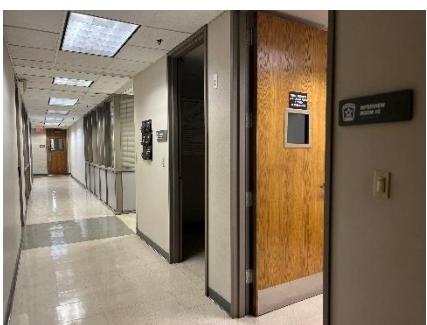
*Detainee interview rooms are across the hall from secure holding areas*

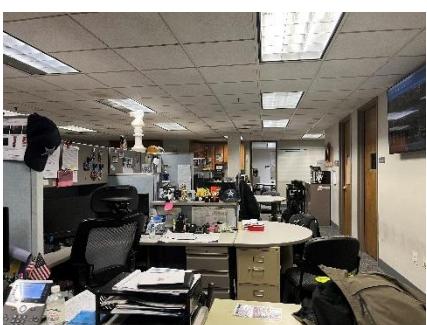
*Suspect interview rooms are adjacent to detective workstations*

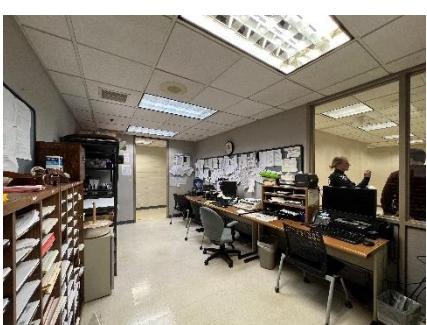
*Officer report writing area is congested*

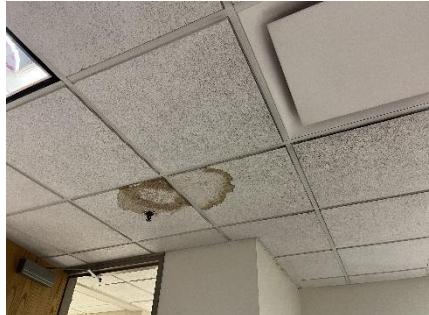
*Discolored ceiling tiles throughout*

In some areas, the acoustic ceiling tiles are stained due to roof leaks and/or piping leaks. Occasional leaks have also been observed and reported on the main floor in various areas. Continual water infiltration is of concern, as it

We also recommend any areas of water infiltration or leakage be repaired to prevent additional moisture from affecting the building framing.

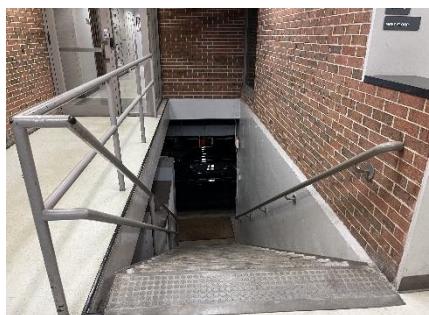
*Inadequate guardrail and handrails at stair to garage*

Some interior stairs have been retrofitted with handrail extensions where they were once lacking, however the handrails are not continuous as required by code. Insufficient guardrail and handrail extensions missing at stair to garage.

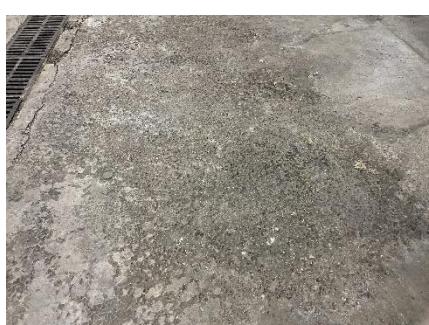
*Deterioration in surface condition of concrete in garage*

The slab on grade in the garage was pitted and deteriorated; however, previous repair patches were observed in a few locations within the garage. Cracking and spalling were most severe adjacent to existing trench drains.

We recommend that the garage slab-on-grade be repaired or replaced, particularly in areas adjacent to the trench drains. We also recommend existing trench drains be scraped, primed, and painted with a rust inhibiting coating to mitigate future corrosion.

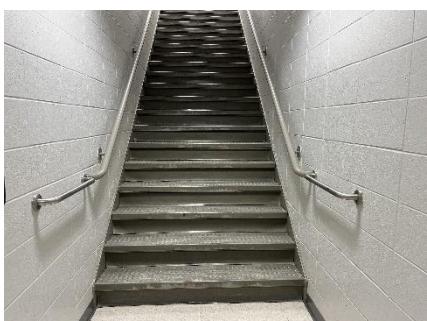
*Retrofitted stair handrail extensions*

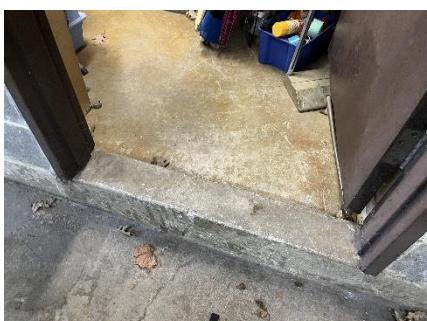
*Gas curb and change in floor level to support room adjacent to garage*

Accessible ramps are missing in multiple locations where changes in floor finish level occur. Areas include the presentation platform in the Training Room, range control room and at multiple rooms throughout the lower level adjacent to the garage, where existing gas curbs occur.

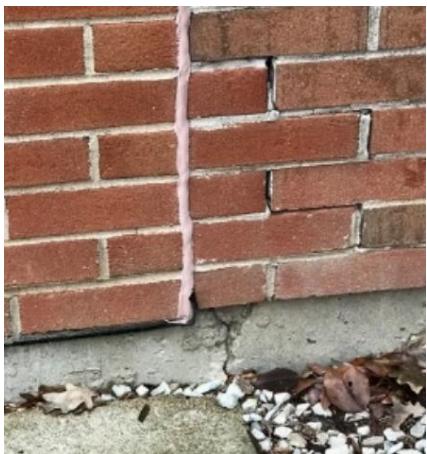
*Foundation cracking at building addition*

We observed localized foundation cracking. Moderate concrete cracks were observed in a concrete column adjacent to the basement garage door. Minor cracking was also observed from the exterior at construction joints where building additions had previously been constructed. Cracking was also observed at the base of an interior column in the garage space.

We recommend that the cracking in concrete walls and columns be repaired. The cracks at the additions should be monitored for future movement or worsening condition. We recommend crack monitors be installed and

reviewed on a quarterly basis to provide a historical data set.

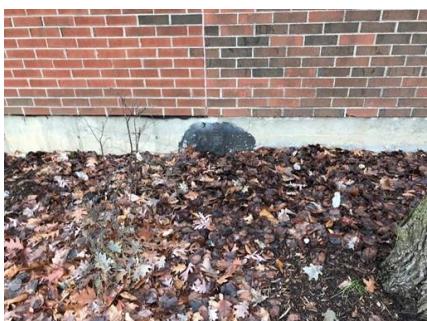
*Previously patched foundation cracking at building addition*

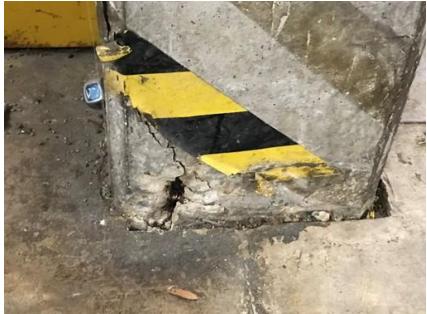
*Column cracking at garage column*

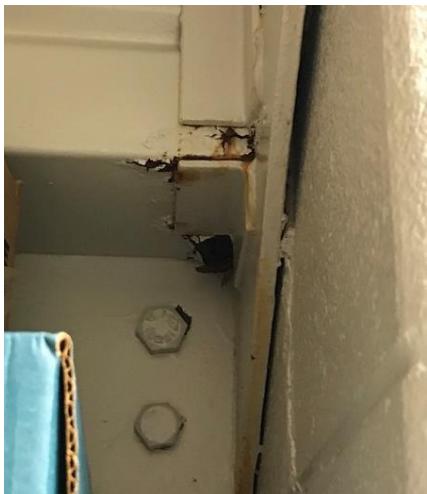
We observed minor corrosion to the steel framing in several locations. It is our understanding the roof was replaced within the last 10 years, and any existing water damage may have occurred prior to that. Additionally, existing piping and plumbing is being reviewed to determine if leaks are present. Corrosion was observed at stair framing at the southeast corner of the building. Corrosion was also observed on roof joists in the Server Room and over the Sally Port door. Exterior lintels also showed signs of corrosion.

*Corroded stair framing*

We recommend maintenance be performed on existing steel framing and lintels to remove corrosion via scraping, priming, and painting with a rust inhibiting coating to mitigate future corrosion.

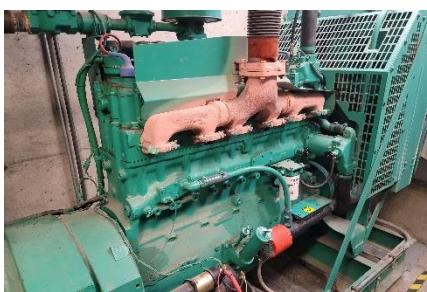
*Older generator set*

The building appears to have a permanently installed Cummins natural gas fired back-up generator set in the basement which appears to power only select systems and a portion of the facility during power outages. The generator system appears to be in overall fair condition however the system is from 1997 and is 25+ years of age and nearing end of useful service life. The communications and call center appear to have a new UPS system recently installed which appears to be in good condition. Replacement of the existing generator system with a larger full building back-up system to allow full facility functionality during power outages is recommended.

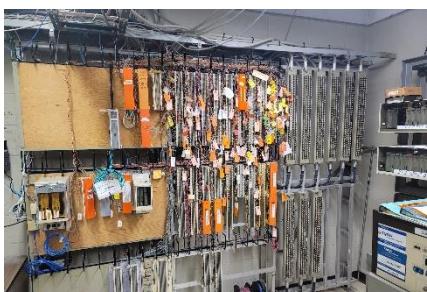
*Antiquated alarm boards*

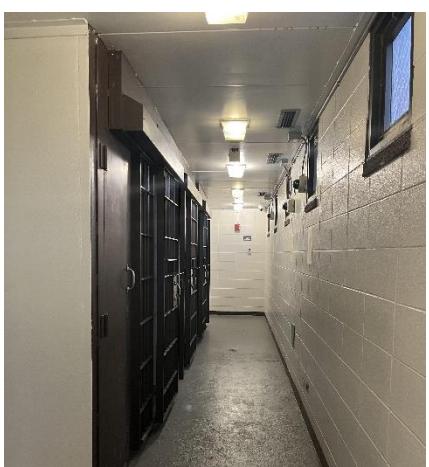
*Detention cell corridor*

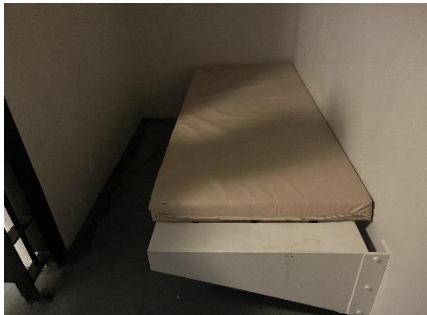
The detention area was designed and constructed before the State of Illinois issued the first Municipal Detention Code in the late 1970's. As a result, this portion of the facility does not meet any current standard or practices, including but not limited to:

*Detention cell*

Based upon site observations, should any further renovation of the facility be under consideration, there is very little in the existing detention area that can continue to be used. A new detention facility would be required to bring up to current codes and standards of a modern detention facility.

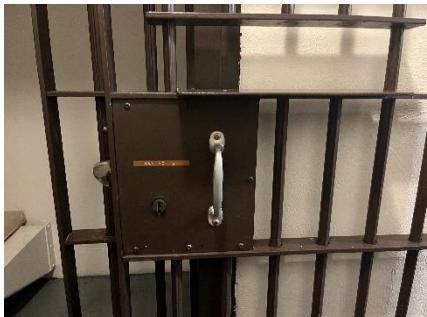
*Typical non-compliant cell door*

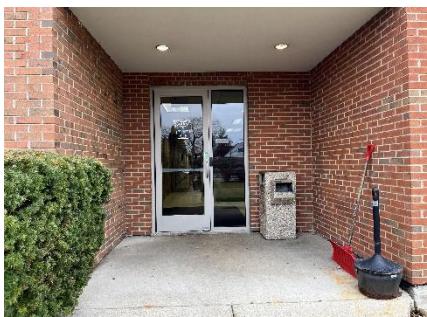
*Access control at staff entry door*

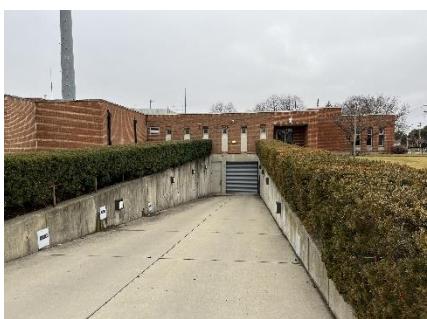
*Access drive to Squad Garage*

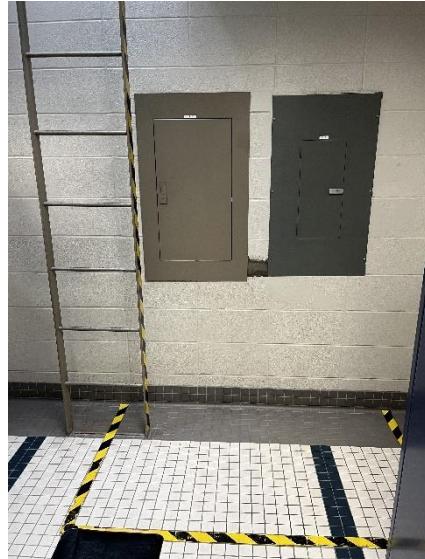
*Roof access ladder projecting into circulation area*

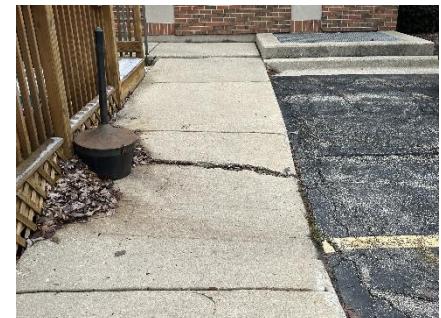
4. Parking Lots, Site Maintainability	Poor	CONCUR	Visible cracking in asphalt pavement. Multiple location of cracks and heaving in concrete sidewalks.
<b>STRUCTURAL EVALUATION</b>

*Cracks / heaving in concrete sidewalk and deteriorating asphalt*

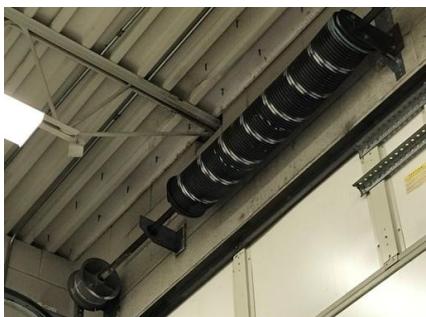
6.	Visible Steel Members	Good Dated	CONCUR	Most steel framing was not visible. Corrosion was observed on joists over the sally port door and in the server room. There were no signs of overloading in observable steel members.

*Surface corrosion at joist bearing*

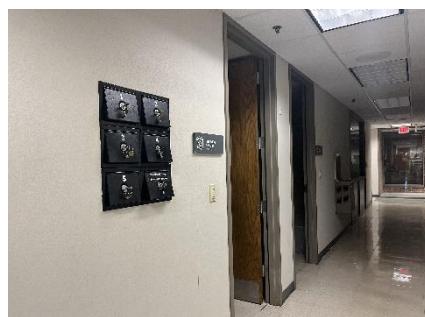
*Interview rooms outside of secure area*

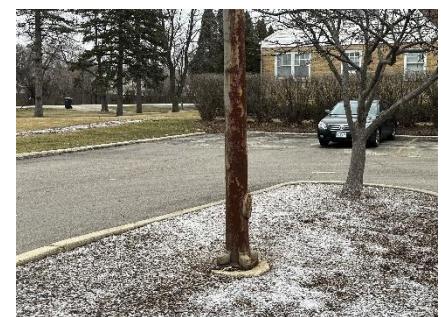
6.	Exterior Lighting	Fair	CONCUR	Older corroded and shorted lighting poles and heads at end of useful service life.
7.	Outlet Condition & Adequacy	Good Dated	REVISE - FAIR	Many older devices nearing end of useful service life quantity appears lacking in some areas where plug strips and extensions cords are utilized.

*Significant corrosion at exterior site light poles*

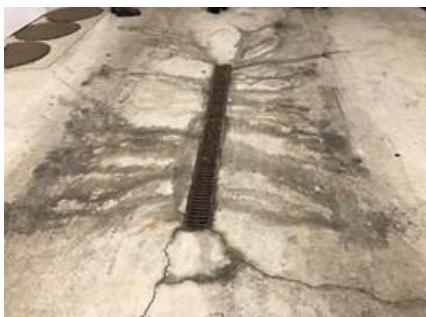
1. Foundation and Slab on Grade	Good Dated	CONCUR	Visible walls were in generally good condition. Foundation cracks were also observed at locations where previous additions had been built. The garage slab was pitted and cracking, particularly around corroded trench drains. There were no visible signs of seepage.

*Concrete cracking at garage trench drain*

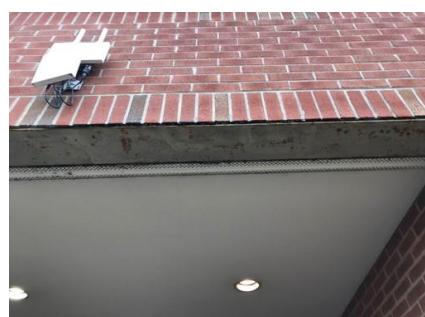
*Surface corrosion at exterior lintel*

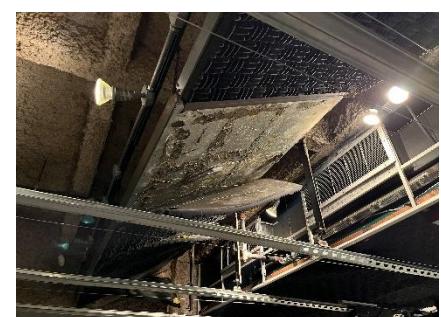
14.	Interior – Evidence	Fair	CONCUR	
15.	Interior – Range	Good Dated	REVISE - FAIR	Sound baffles delaminating from supports, deterioration of floor finish throughout.

*Sound baffles at range area delaminating from substrate*

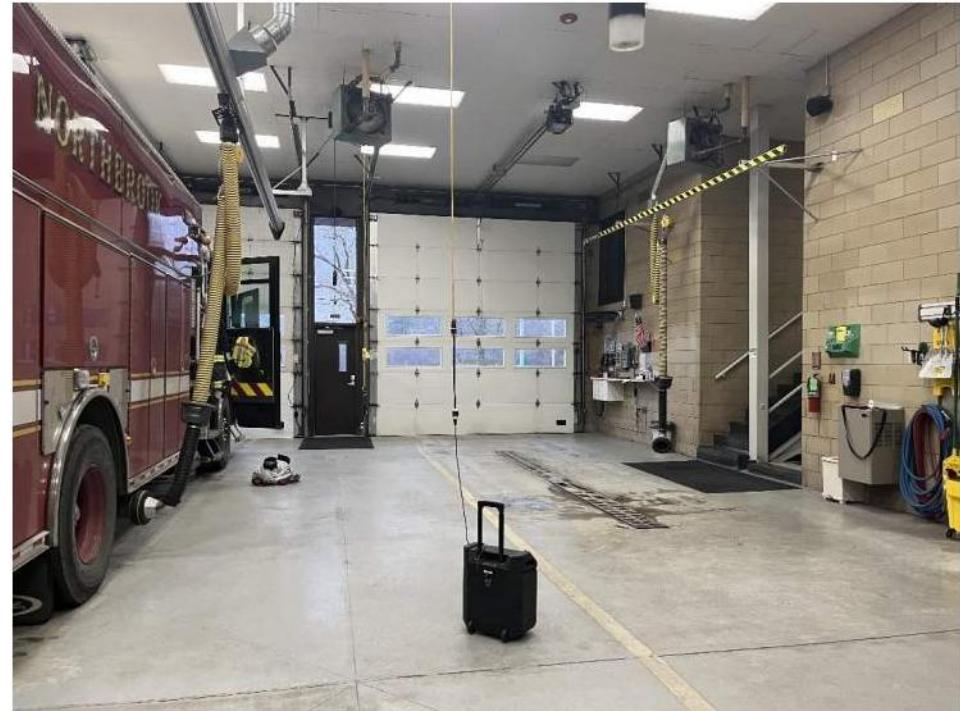
Apparatus Bay interior
