# Village of Northbrook

# MEMORANDUM

**TO:** CARA PAVLICEK, VILLAGE MANAGER  
**FROM:** KELLY HAMILL, PUBLIC WORKS DIRECTOR  
**DATE:** FEBRUARY 28, 2023  
**SUBJECT:** FACILITIES PLAN UPDATE

#### Existing Condition Analysis

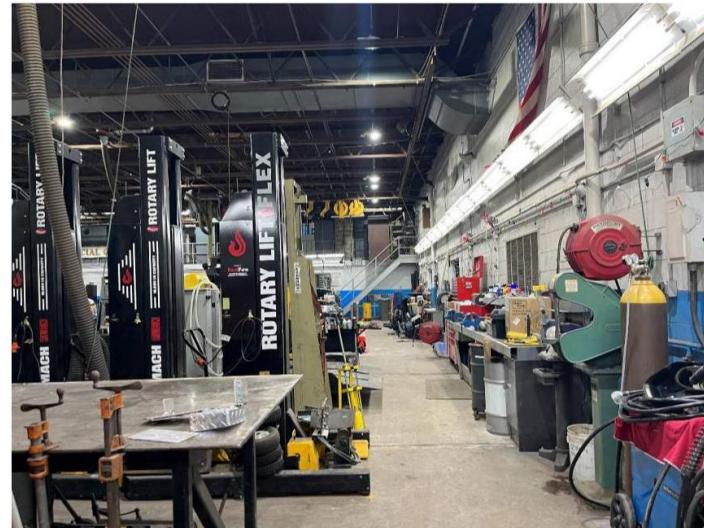
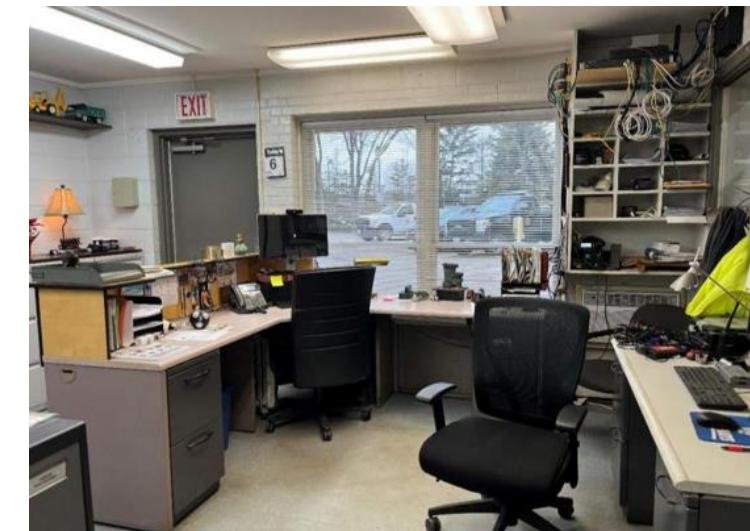
- Clearance Issues
- Village Program Storage
- Life Safety
- Storage
- Inefficiencies
- **Building Size Deficiencies / Lack of Space**
- Post Pandemic Changes

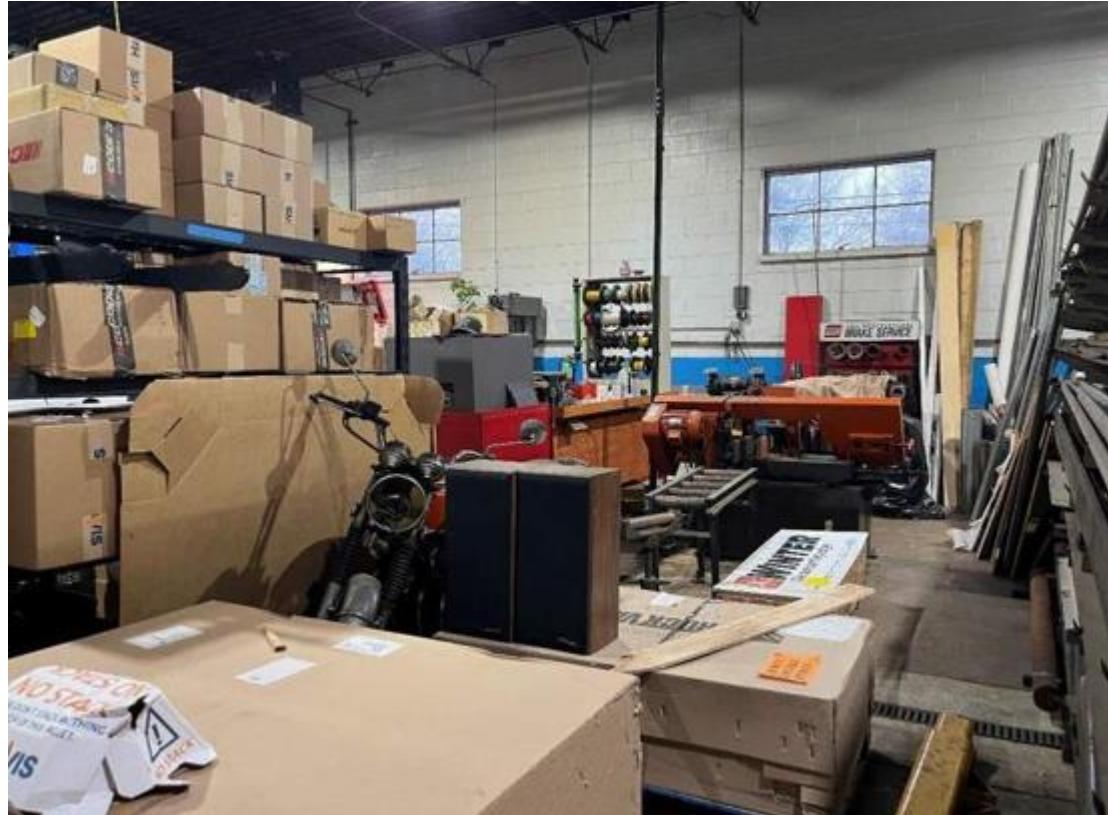
- Clearance Issues
- Village Program Storage
- Life Safety
- Storage
- Inefficiencies
- Building Size Deficiencies / Lack of Space
- **Post Pandemic Changes / Supply Chain**

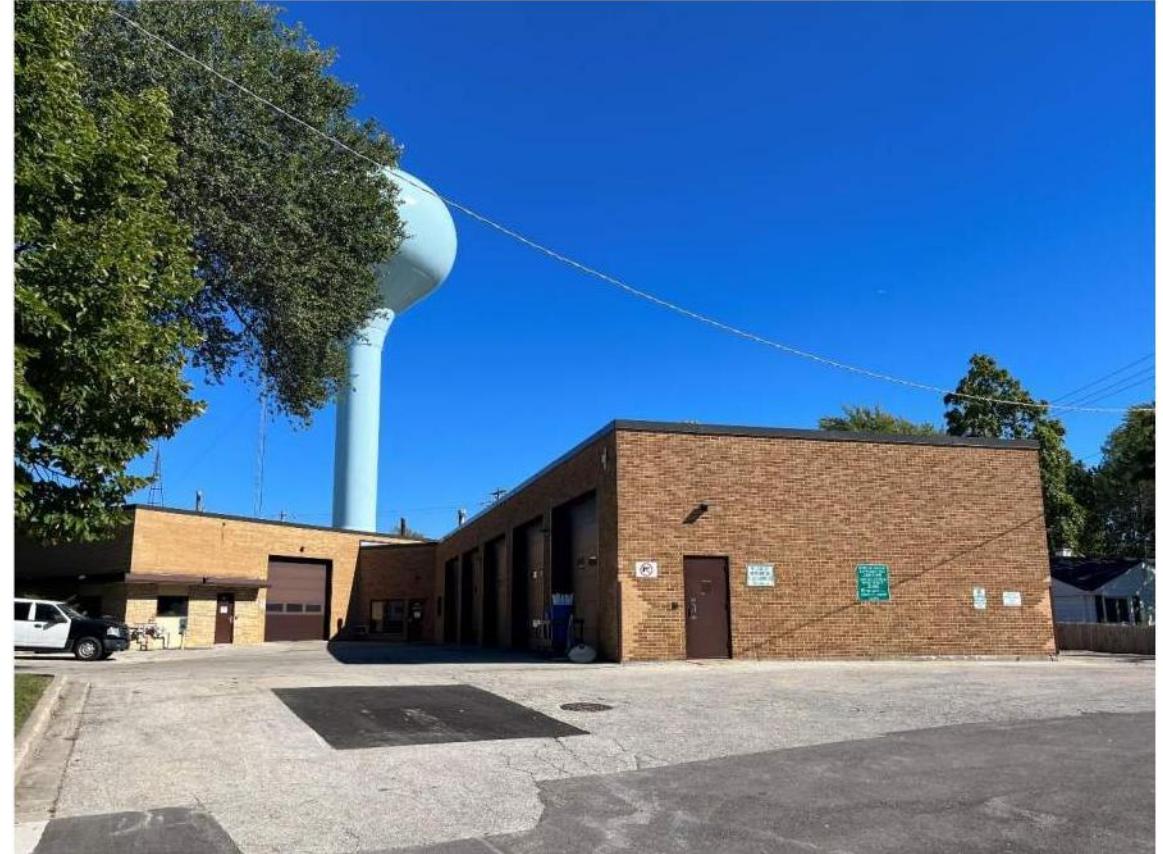
- o **Parking**
- o Secure Vehicle Storage
- o Outdoor Equipment Storage
- o Delivery Issues
- o Metra Commuter Traffic and Parking
- o Pedestrian Traffic

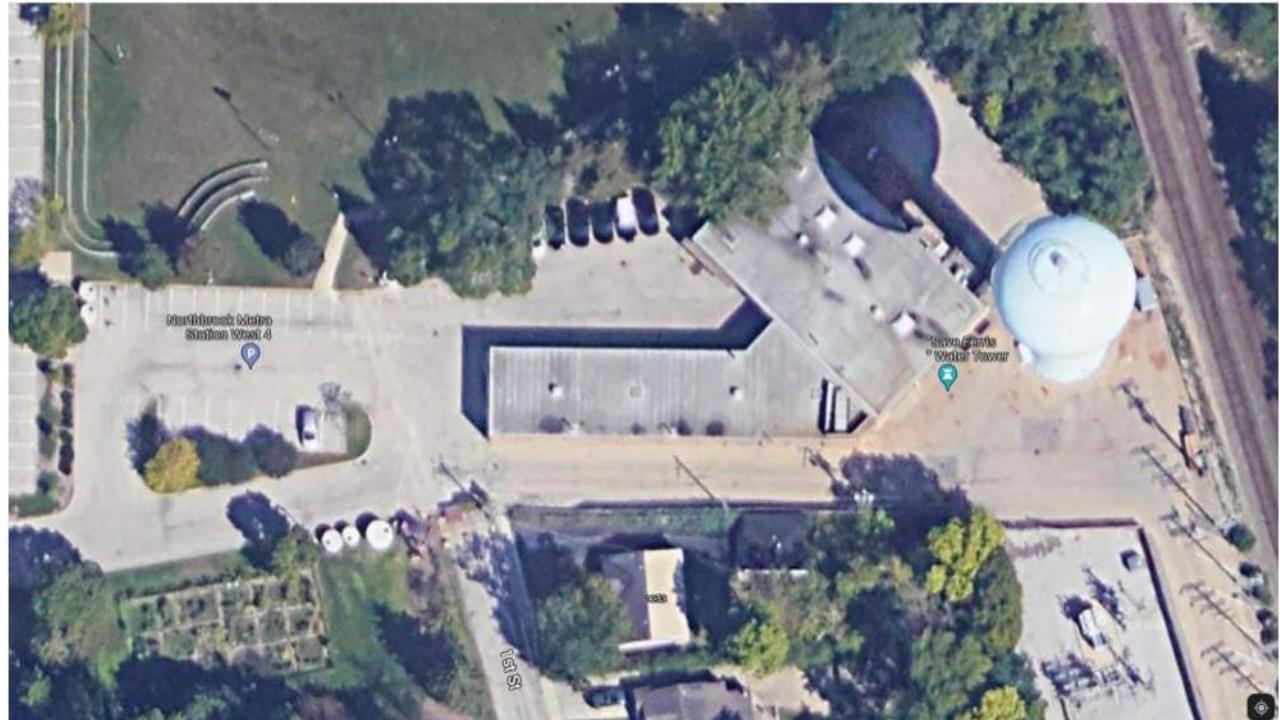
- Parking
- **Secure Vehicle Storage**
- Outdoor Equipment Storage
- Delivery Issues
- Metra Commuter Traffic and Parking
- Pedestrian Traffic

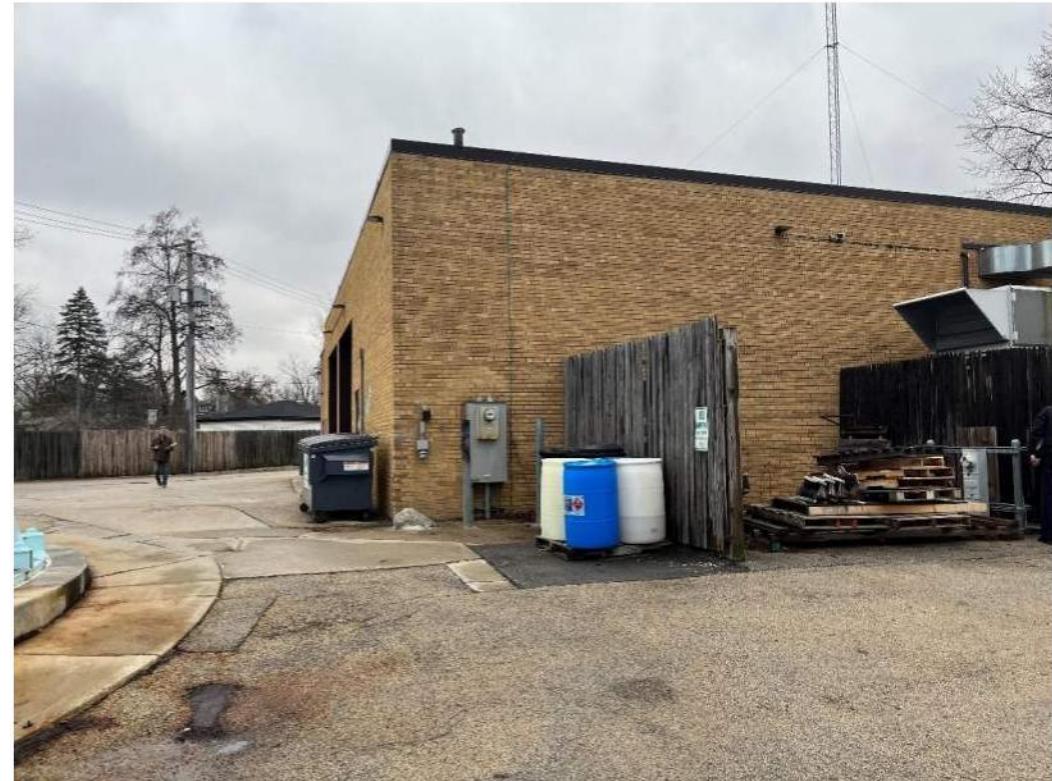
- Parking
- Secure Vehicle Storage
- **Outdoor Equipment Storage**
- Delivery Issues
- Metra Commuter Traffic and Parking
- Pedestrian Traffic

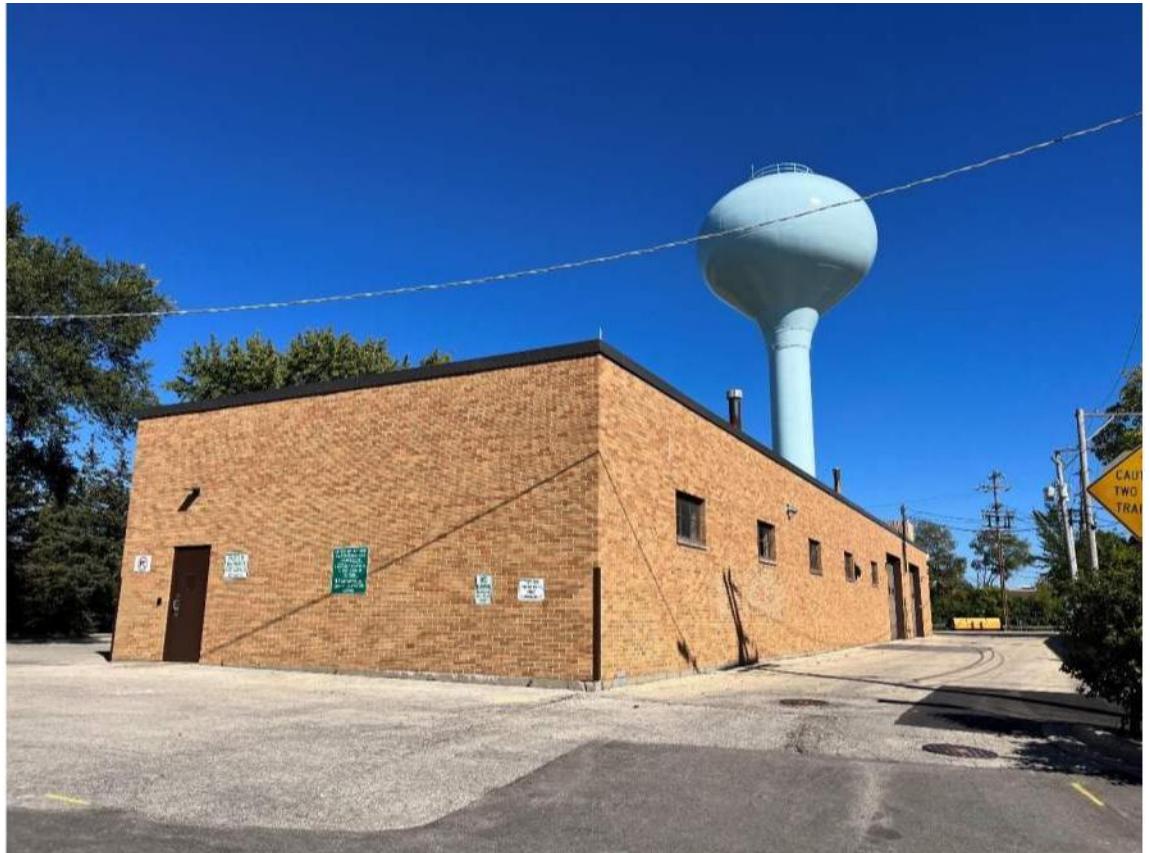
- Parking
- Secure Vehicle Storage
- Outdoor Equipment Storage
- **Delivery Issues**
- Metra Commuter Traffic and Parking
- Pedestrian Traffic

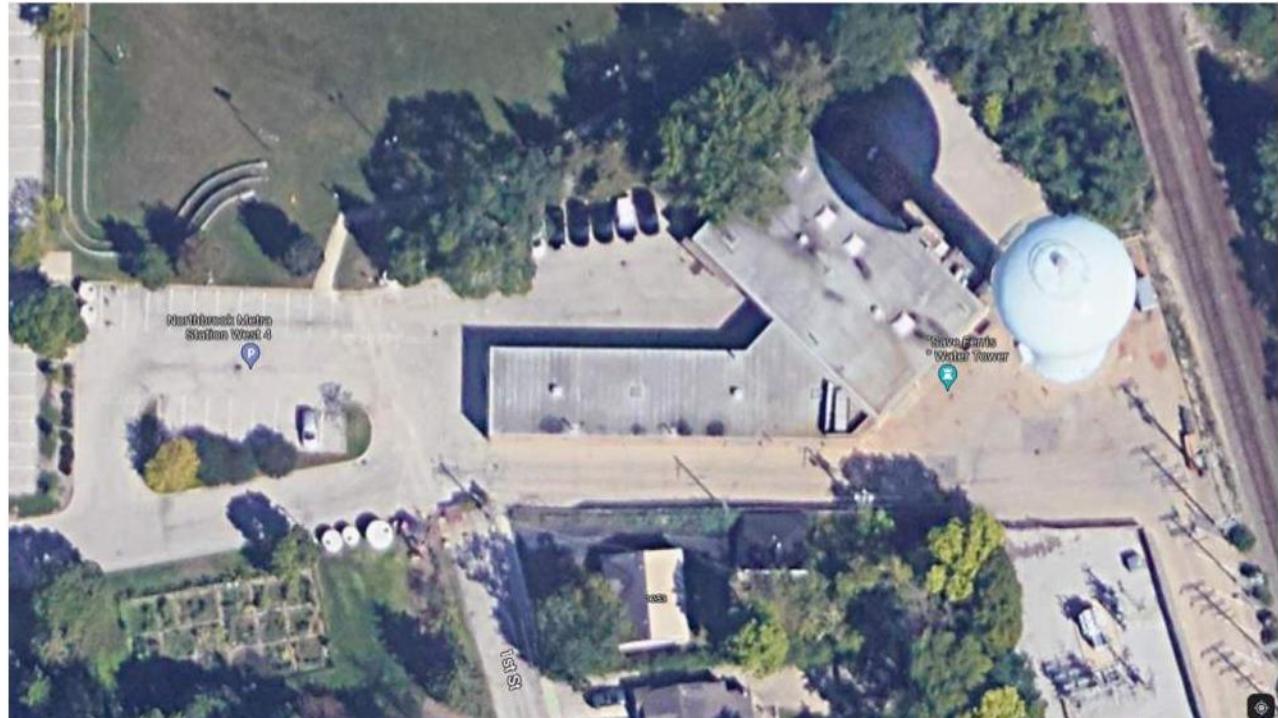
- Parking
- Secure Vehicle Storage
- Outdoor Equipment Storage
- Delivery Issues
- **Metra Commuter Traffic and Parking**
- Pedestrian Traffic

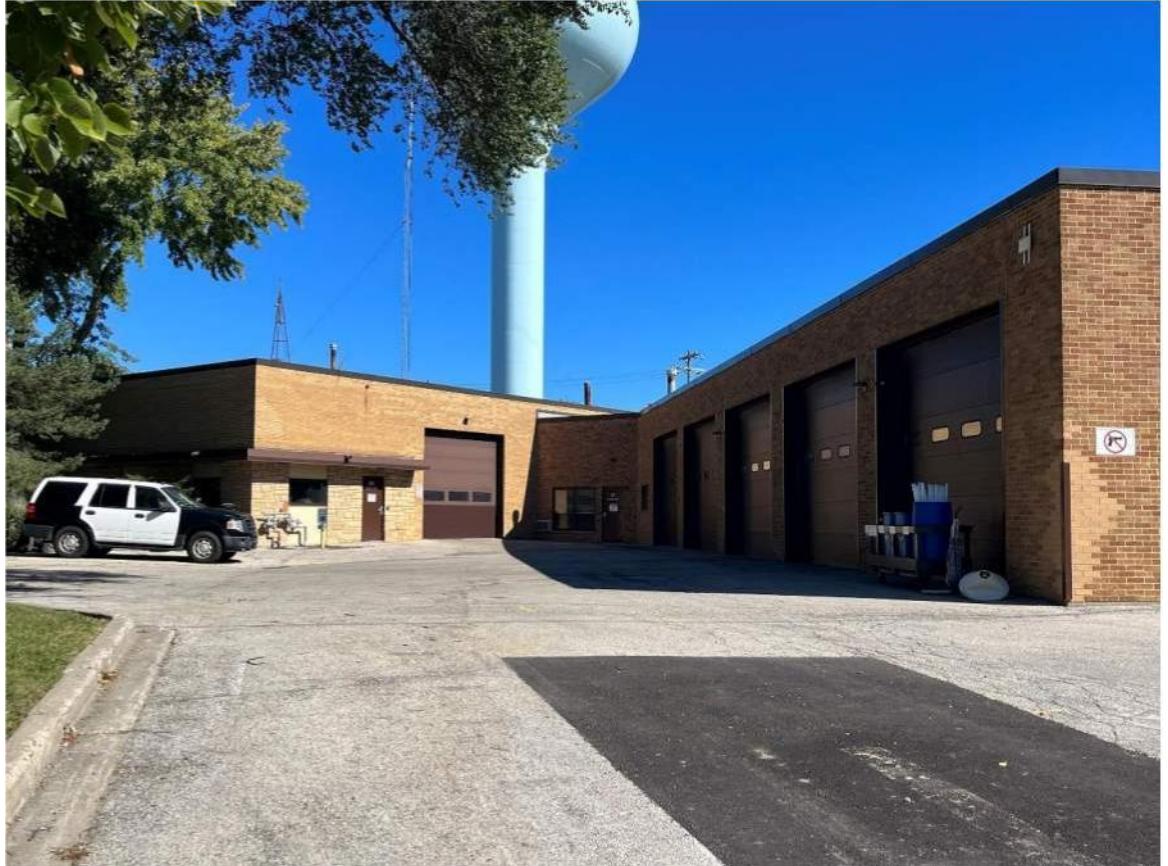
- o Blind Spots
- o Noise Pollution
- o Ice Falling from Water Tower
- o Site Aesthetics
- o Power Station Work
- o **Recycling Program Traffic**

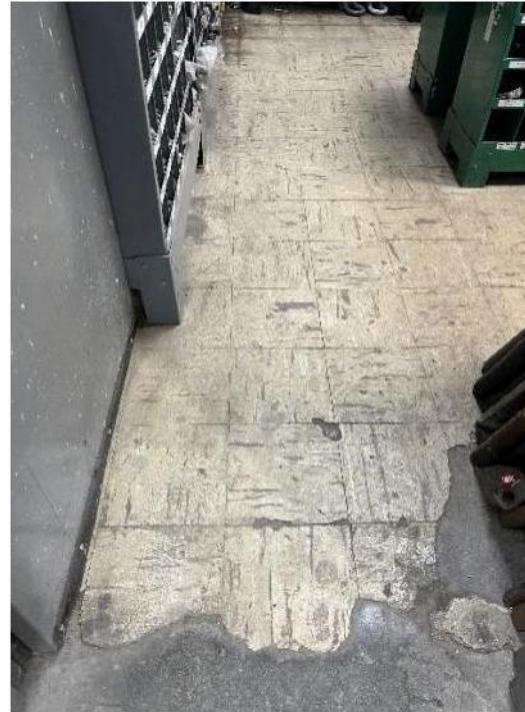
*Parts Storage Room*

- Inadequate clear overhead height at mezzanine
- **Asbestos material in floor tile suspected to be present**
- Miscellaneous structural deficiencies
- Evidence of prior water infiltration
- Inadequate toilet room facilities and accessibility concerns

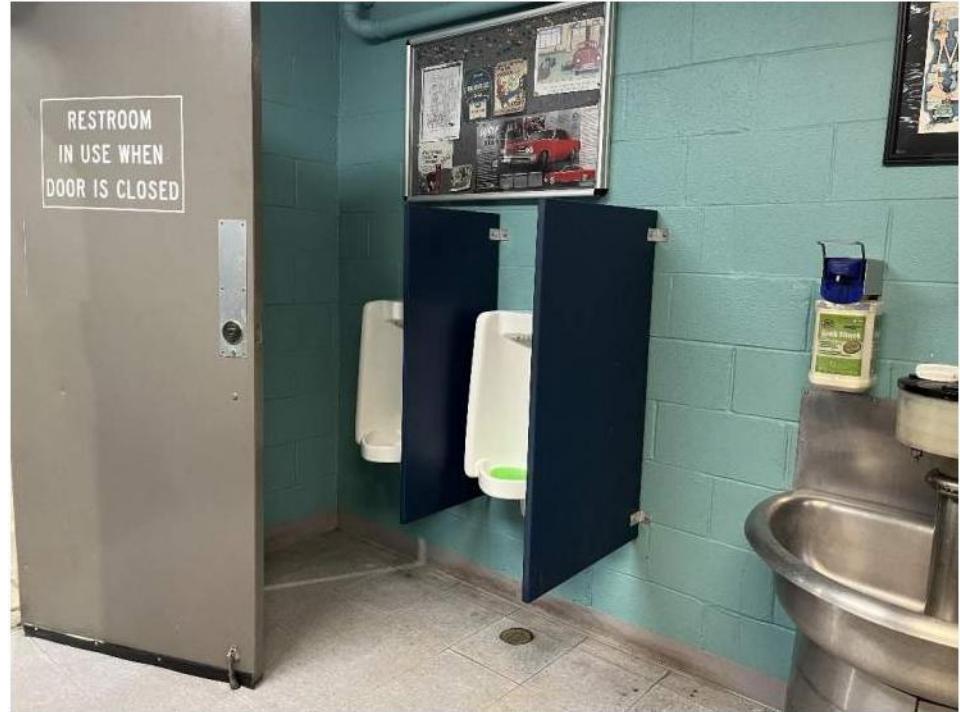
*Toilet Room*

- Inadequate clear overhead height at mezzanine
- Asbestos material in floor tile suspected to be present
- Miscellaneous structural deficiencies
- Evidence of prior water infiltration
- **Inadequate toilet room facilities and accessibility concerns**

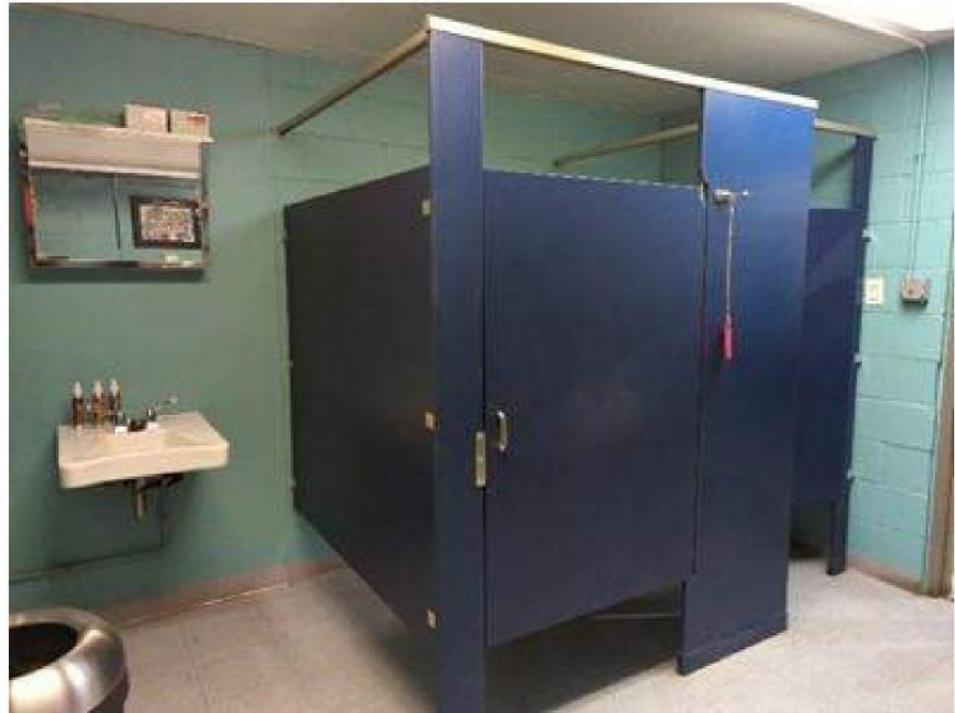
*Toilet Room*

- Inadequate clear overhead height at mezzanine
- Asbestos material in floor tile suspected to be present
- Miscellaneous structural deficiencies
- Evidence of prior water infiltration
- **Inadequate toilet room facilities and accessibility concerns**

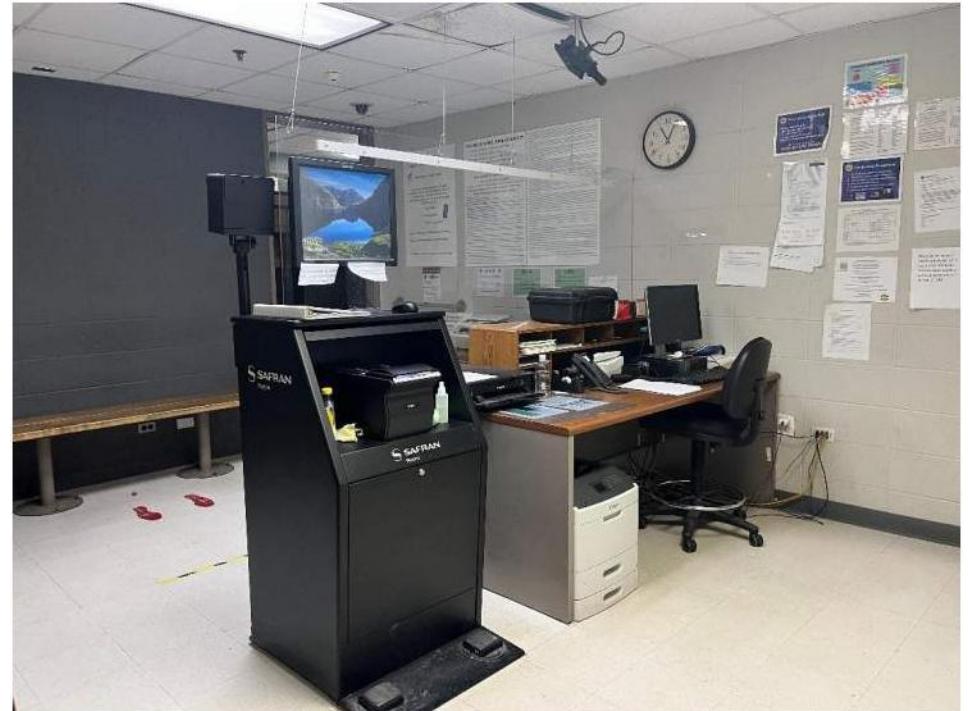
- Secure Parking
- Training
- Social Services / Counseling
- Officer Wellness
- **Holding Facility Issues**
- Evidence Technicians Workspace
- Evidentiary Vehicle Processing
- Evidence Packaging
- Evidence and Property Storage
- Computer Forensics

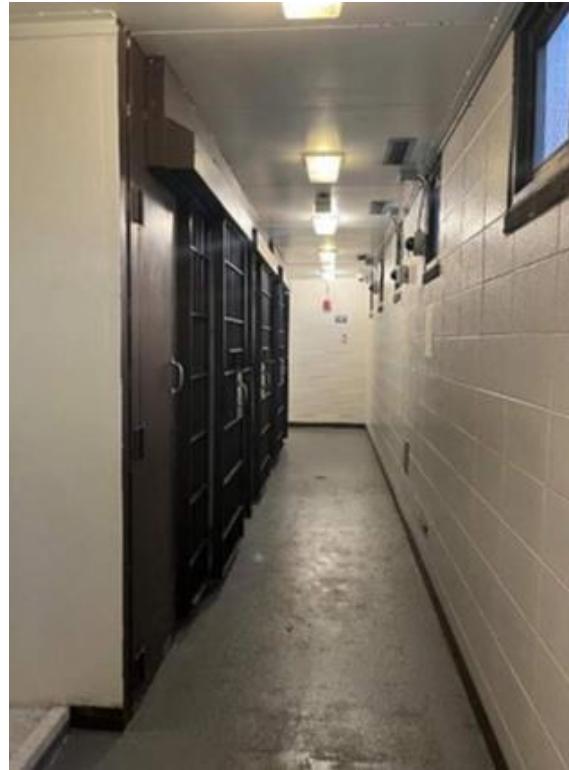
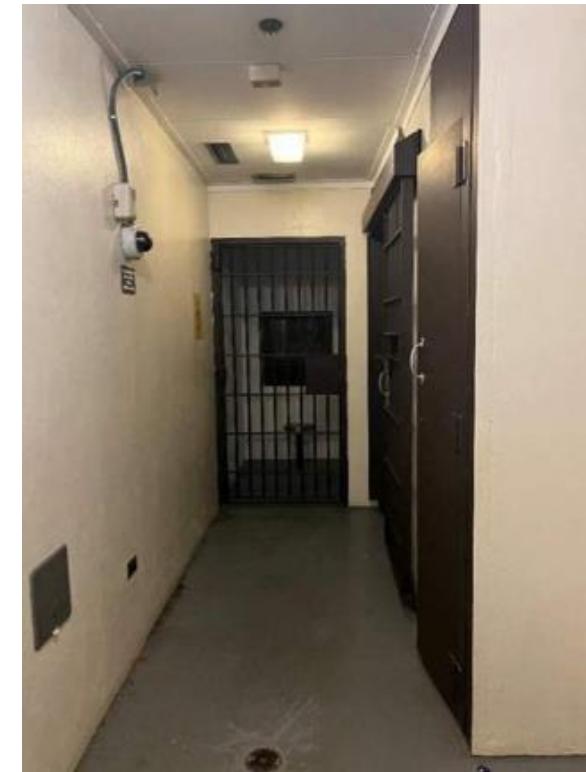
- Secure Parking
- Training
- Social Services / Counseling
- Officer Wellness
- **Holding Facility Issues**
- Evidence Technicians Workspace
- Evidentiary Vehicle Processing
- Evidence Packaging
- Evidence and Property Storage
- Computer Forensics

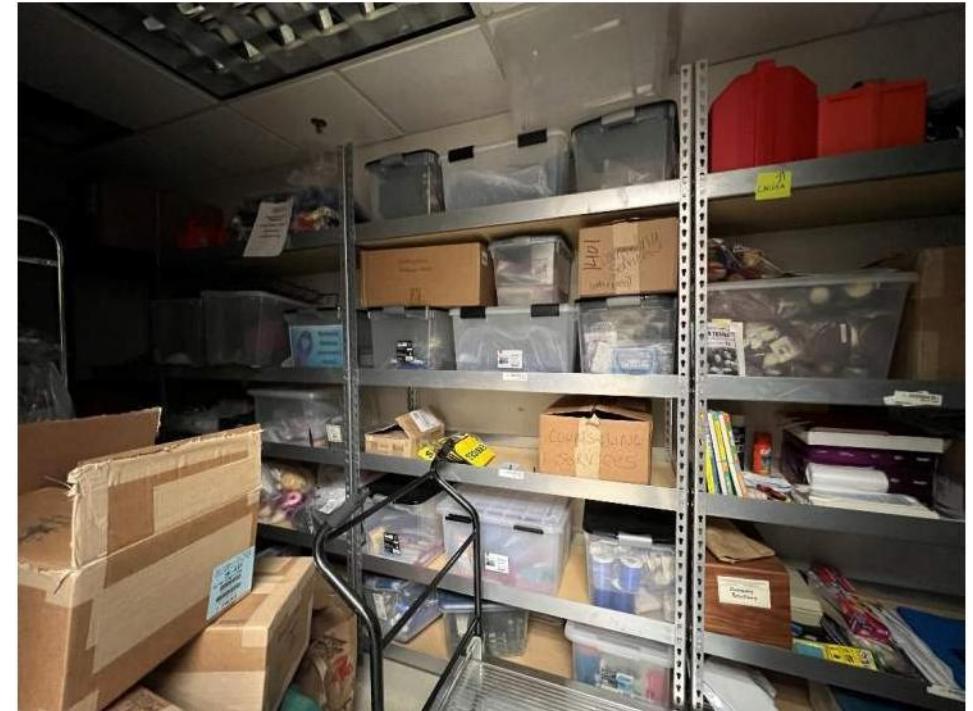
- o Staff Work Areas
- o **Storage**
- o Locker Rooms
- o Communications Center
- o Sleeping Quarters
- o Sally Port
- o Interview Rooms
- o Report Writing Room

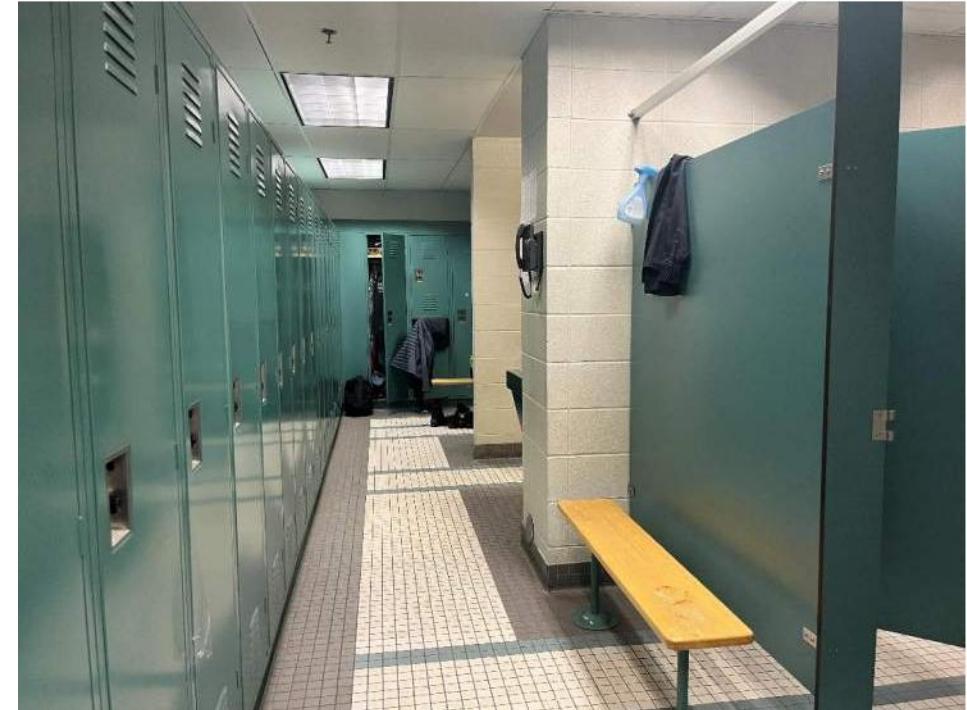
- o Staff Work Areas
- o Storage
- o Locker Rooms**
- o Communications Center
- o Sleeping Quarters
- o Sally Port
- o Interview Rooms
- o Report Writing Room

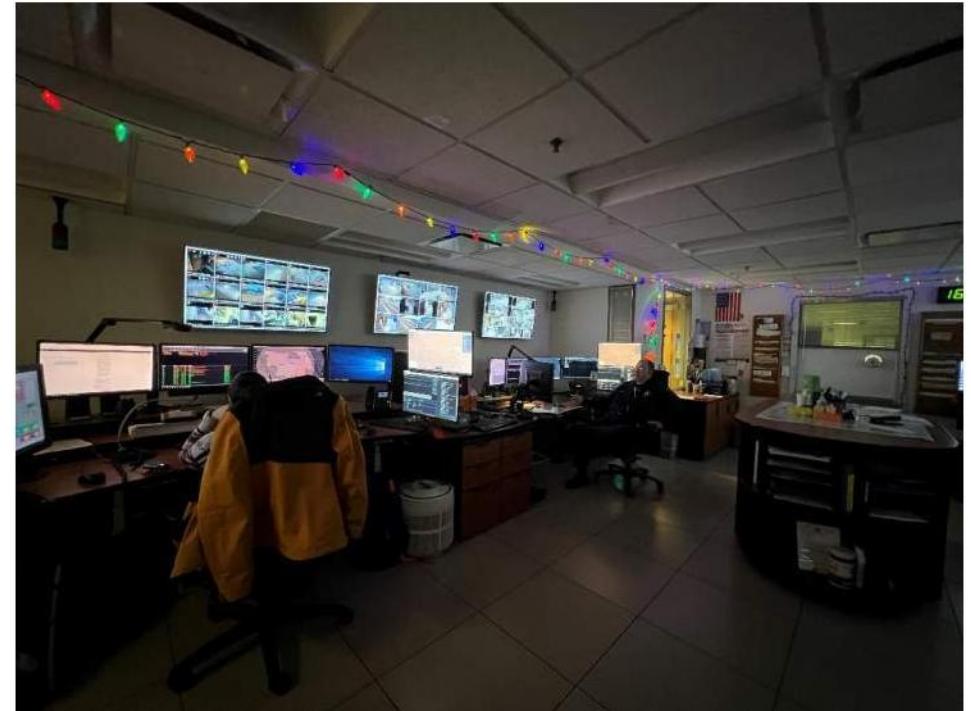
- o Staff Work Areas
- o Storage
- o Locker Rooms
- o **Communications Center**
- o Sleeping Quarters
- o Sally Port
- o Interview Rooms
- o Report Writing Room

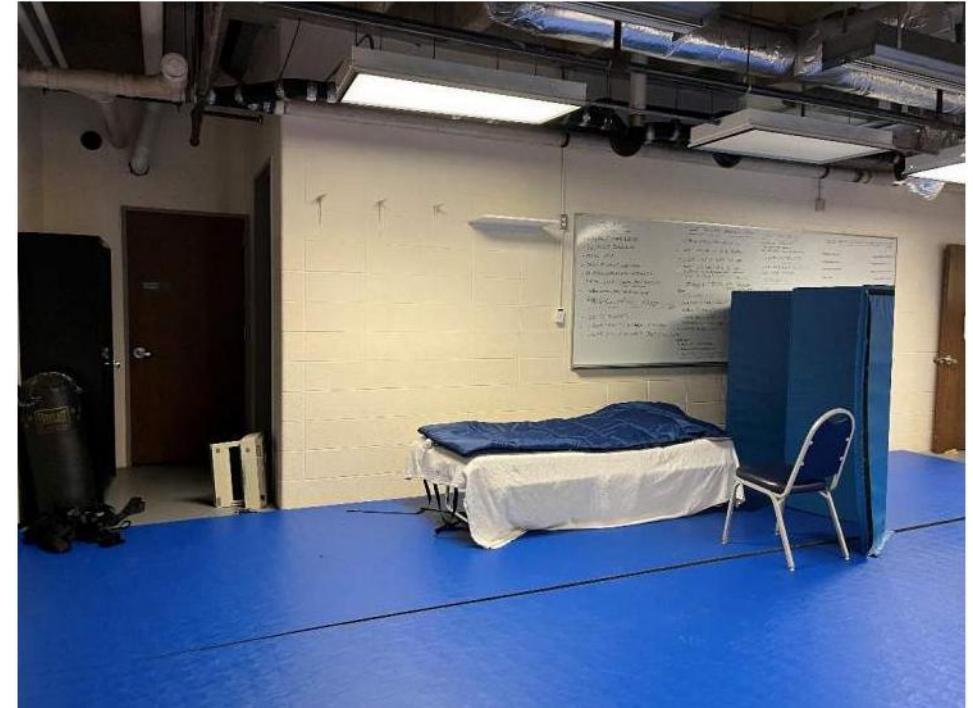
- o Staff Work Areas
- o Storage
- o Locker Rooms
- o Communications Center
- o **Sleeping Quarters**
- o Sally Port
- o Interview Rooms
- o Report Writing Room

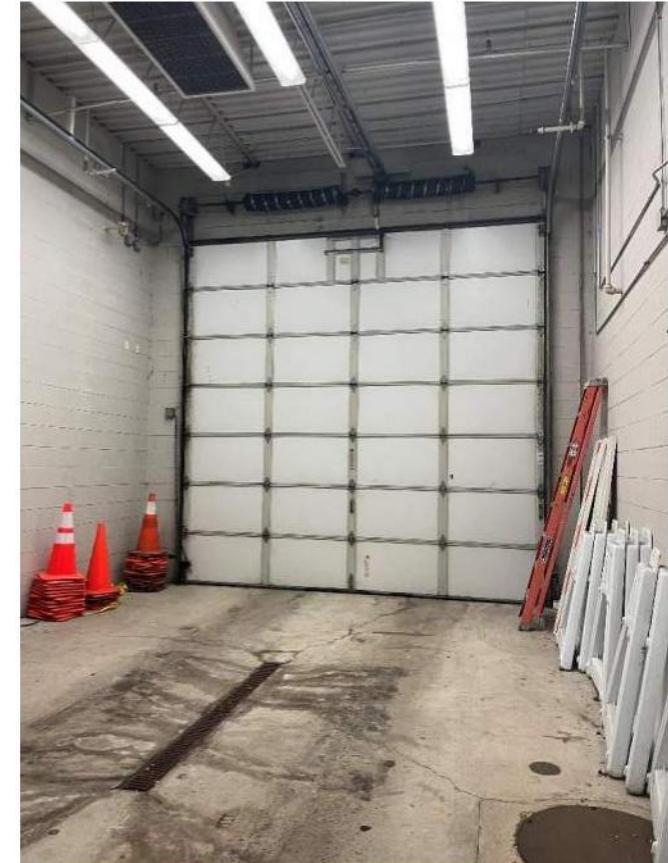
- o Staff Work Areas
- o Storage
- o Locker Rooms
- o Communications Center
- o Sleeping Quarters
- o **Sally Port**
- o Interview Rooms
- o Report Writing Room

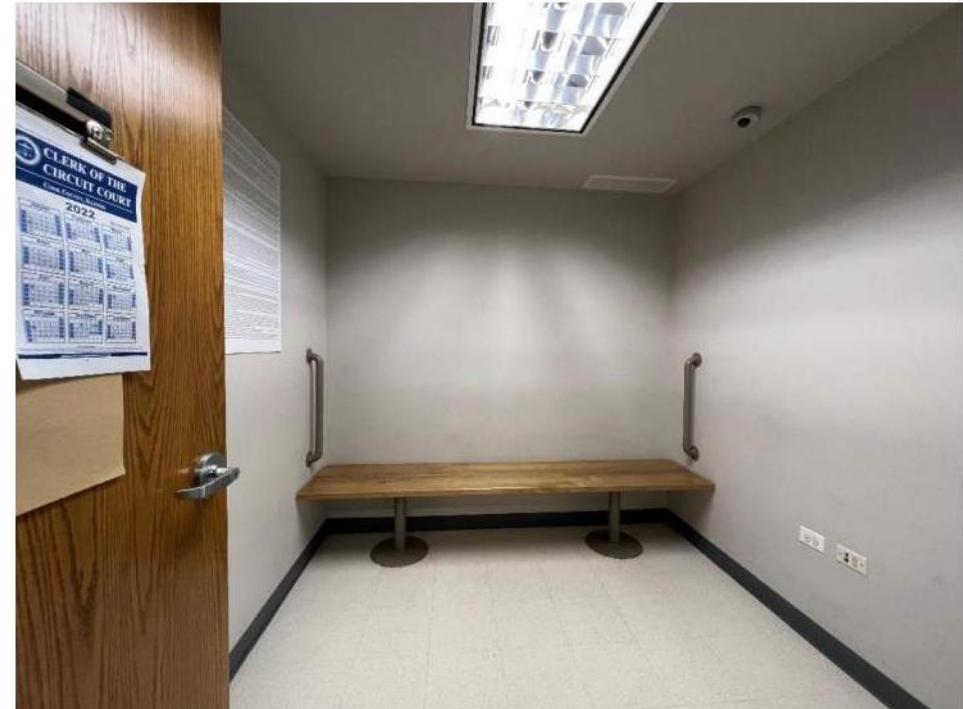
- o Staff Work Areas
- o Storage
- o Locker Rooms
- o Communications Center
- o Sleeping Quarters
- o Sally Port
- o **Interview Rooms**
- o Report Writing Room

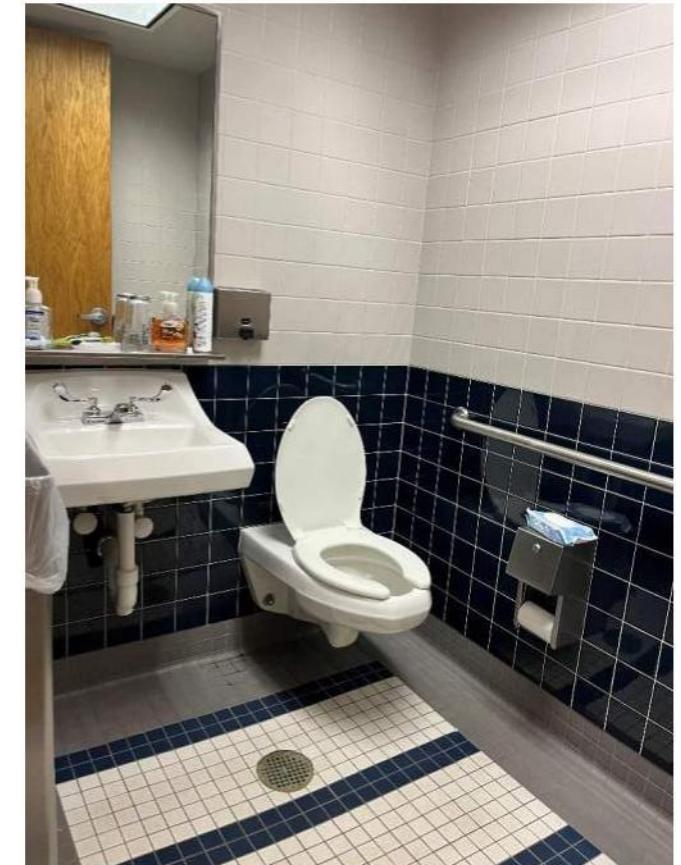
- Many changes have taken place since the building was constructed and renovated

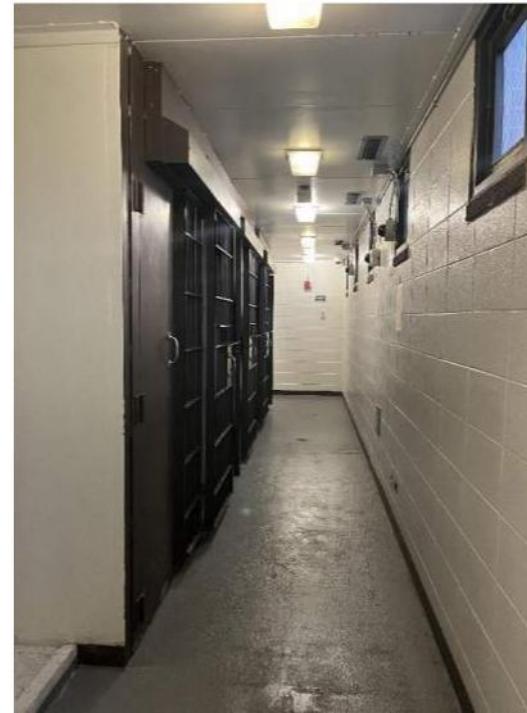
- Miscellaneous structural deficiencies
- Evidence of water infiltration / ongoing piping and roof leaks
- Miscellaneous accessibility concerns
- **Holding area concerns**
- Electrical system components nearing end of service life

*Detention cell corridor*
