Project 7
Curb Failure along WFNBCR
(Behind 1941 Cherry Lane)

PROJECT 7
CURB FAILURE ALONG WFNBCR
(Behind 1941 Cherry Lane)

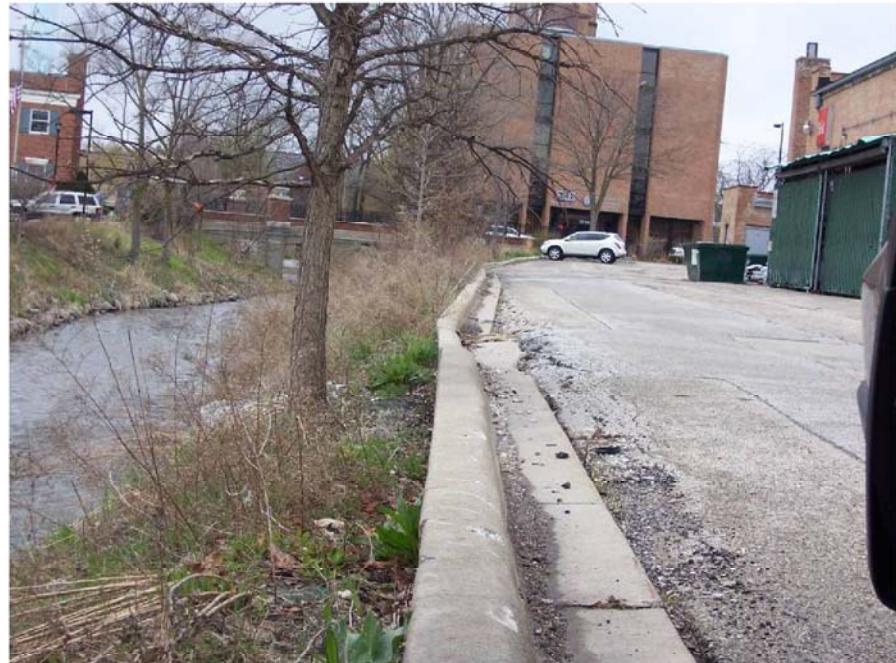
Curb Failure Looking Easterly

Curb and gutter section atop the steep bank of WFNBCR channel behind the shopping center at 1941 Cherry Lane has been settling. Contributing factors include weight of parked vehicles and weakened soil conditions due to saturation during channel flooding and spring thaws.

Pavement and channel bank slope deterioration will continue unless corrective action is taken. Major bank failure would result in restoration and permitting costs

- Remove curb and gutter and replace with extended post guardrail
- Back pitch 2' \pm paved surface slope under guard rail to proposed lateral/slotted drain
- Install pipe underdrain system to intercept ground water and minor surface runoff from proposed lateral/slotted drain
- Stabilize disturbed channel bank areas with erosion control blanket and native plantings
- Discourage truck parking in 200' \pm critical area along channel bank
